## Profile/Photo Observation Report

Date:	<b>03/28/2018</b>	Weather:		Coding:	<b>PACP 6.0</b>
Pipe Length (ft):	<b>198.6</b>	Owner:	<b>NA</b>	Pre Clean:	<b>Not Known</b>
P.O.#:		Surveyor:	<b>Selasie Honu</b>	PSR:	<b>P-803-016-015</b>
Customer:		Clean Date:	<b>01/01/1900</b>	Shape:	<b>C</b>

Street:	<b>ALLEY BETWEEN N LIBERTY ST &amp; N L</b>	Flow Control:	<b>Not Controlled</b>
City:	<b>Hobart, IN</b>	Year Renewed:	
Location:	<b>Other</b>	Tape/Media #:	
Purpose:	<b>Not Known</b>	Dia/Height:	<b>10"</b>
Use:	<b>Sanitary</b>	Material:	<b>VCP</b>
Drain Area:	<b>NA</b>	Lining:	
Category:	<b>NA</b>		
Comment:

Location Details:		Direction of Survey:	<b>Downstream</b>
US MH:	<b>M-803-015</b>	DS MH:	<b>M-803-016</b>
		Total Length Surveyed (ft):	<b>68.8</b>

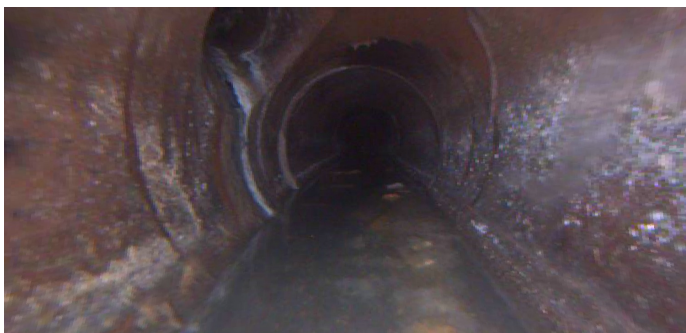
Code: **AMH**  
Description: **Manhole**

Distance (ft): **.0**  
Structural Grade: **0**  
O&M Grade: **0**  
Clock Start/From:  
Clock To:  
1st Value:  
2nd Value:  
Value Percent:  
Continuous Index:  
Within 8" of Joint: **NO**  
Remarks: **M-803-015**

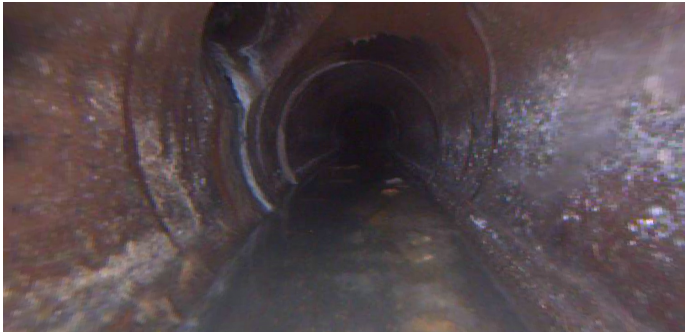
Code:	<b>MWL</b>
Description:	<b>Water Level</b>

Distance (ft):	<b>.0</b>
Structural Grade:	<b>0</b>
O&M Grade:	<b>0</b>
Clock Start/From:	
Clock To:	
1st Value:	
2nd Value:	
Value Percent:	<b>5.000</b>
Continuous Index:	
Within 8" of Joint:	<b>NO</b>
Remarks:

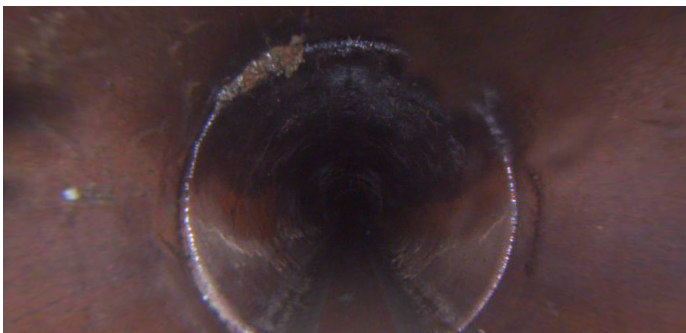
Code: **IW**  
Description: **Infil Weeper**

Distance (ft): **13.8**  
Structural Grade: **0**  
O&M Grade: **2**  
Clock Start/From: **8**  
Clock To: **4**  
1st Value:  
2nd Value:  
Value Percent:  
Continuous Index: **S01**  
Within 8" of Joint: **YES**  
Remarks:

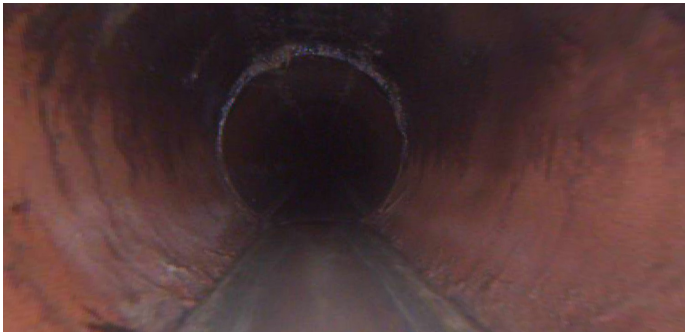
Code: **RFJ**  
Description: **Roots Fine Joint**

Distance (ft): **24.9**  
Structural Grade: **0**  
O&M Grade: **1**  
Clock Start/From: **9**  
Clock To: **3**  
1st Value:  
2nd Value:  
Value Percent:  
Continuous Index:  
Within 8" of Joint: **YES**  
Remarks:

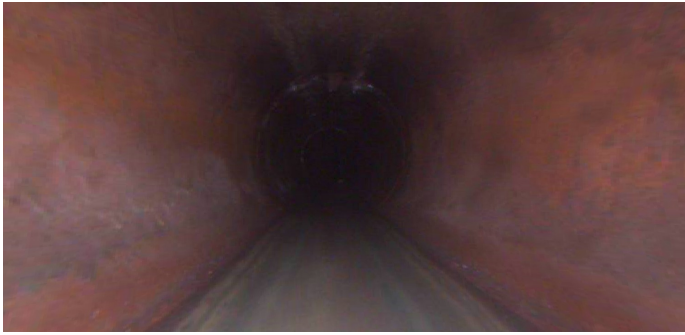
Code: **RFJ**  
Description: **Roots Fine Joint**

Distance (ft): **33.4**  
Structural Grade: **0**  
O&M Grade: **1**  
Clock Start/From: **11**  
Clock To: **1**  
1st Value:  
2nd Value:  
Value Percent:  
Continuous Index:  
Within 8" of Joint: **YES**  
Remarks:

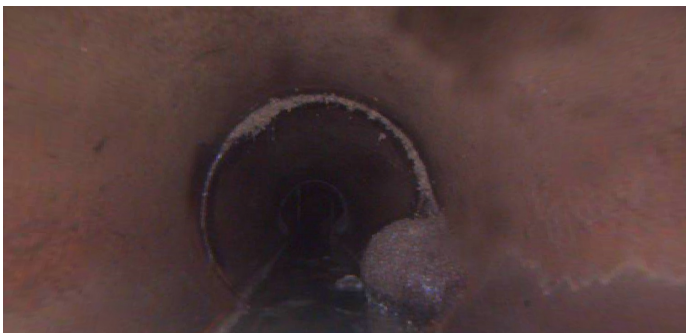
Code: **RMJ**  
Description: **Roots Medium Joint**

Distance (ft): **61.0**  
Structural Grade: **0**  
O&M Grade: **3**  
Clock Start/From: **7**  
Clock To: **5**  
1st Value:  
2nd Value:  
Value Percent: **15.000**  
Continuous Index:  
Within 8" of Joint: **YES**  
Remarks:

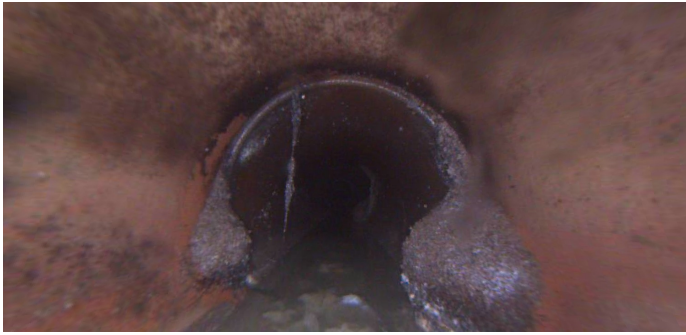
Code: **RMJ**  
Description: **Roots Medium Joint**

Distance (ft): **64.4**  
Structural Grade: **0**  
O&M Grade: **3**  
Clock Start/From: **8**  
Clock To: **4**  
1st Value:  
2nd Value:  
Value Percent: **10.000**  
Continuous Index:  
Within 8" of Joint: **YES**  
Remarks:

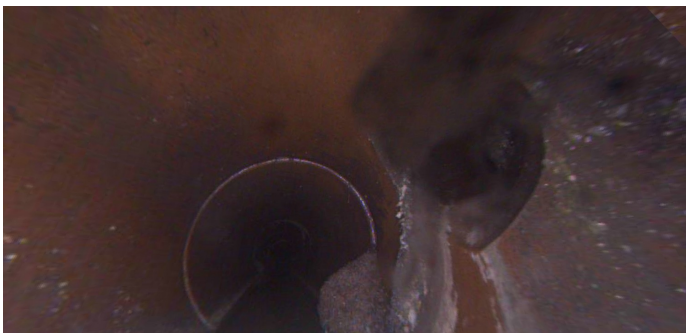
Code: **TFD**  
Description: **Tap Factory Defective**

Distance (ft): **67.0**  
Structural Grade: **0**  
O&M Grade: **2**  
Clock Start/From: **2**  
Clock To:  
1st Value: **4.000**  
2nd Value:  
Value Percent:  
Continuous Index:  
Within 8" of Joint:  
Remarks: **ROOTS**

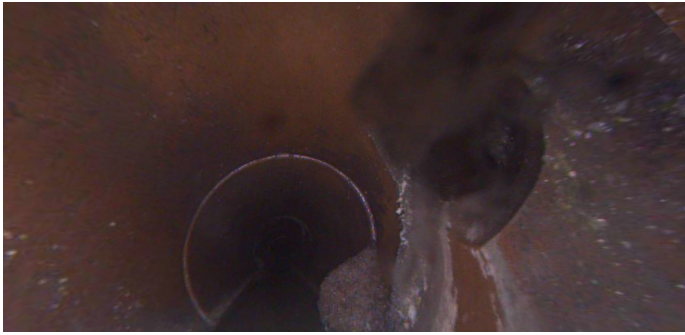
Code: **RFL**  
Description: **Roots Fine Lateral**

Distance (ft): **67.0**  
Structural Grade: **0**  
O&M Grade: **1**  
Clock Start/From: **2**  
Clock To:  
1st Value:  
2nd Value:  
Value Percent:  
Continuous Index:  
Within 8" of Joint: **NO**  
Remarks:

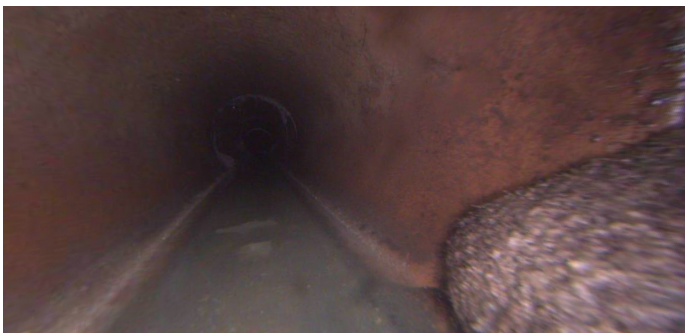
Code: **RMJ**  
Description: **Roots Medium Joint**

Distance (ft): **68.1**  
Structural Grade: **0**  
O&M Grade: **3**  
Clock Start/From: **3**  
Clock To: **5**  
1st Value:  
2nd Value:  
Value Percent: **10.000**  
Continuous Index:  
Within 8" of Joint: **YES**  
Remarks:

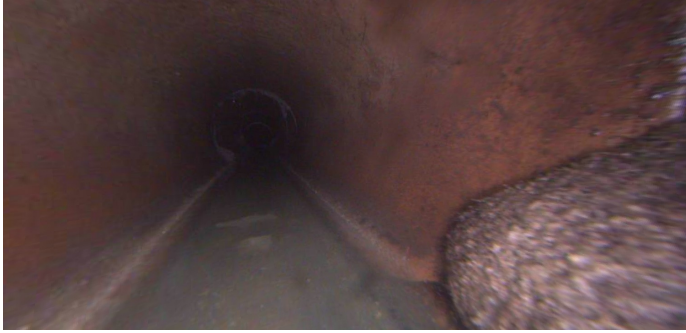
Code: **IW**  
Description: **Infil Weeper**

Distance (ft): **68.1**  
Structural Grade: **0**  
O&M Grade: **2**  
Clock Start/From: **8**  
Clock To: **4**  
1st Value:  
2nd Value:  
Value Percent:  
Continuous Index: **F01**  
Within 8" of Joint: **YES**  
Remarks:

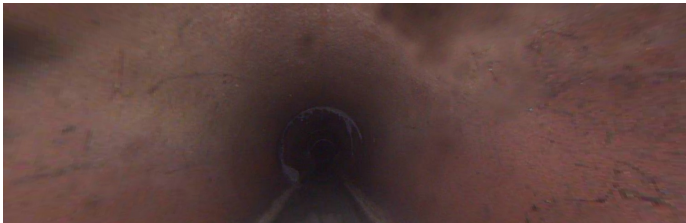
Code: **MSA**  
Description: **Abandoned Survey**

Distance (ft): **68.8**  
Structural Grade: **0**  
O&M Grade: **0**  
Clock Start/From:  
Clock To:  
1st Value:  
2nd Value:  
Value Percent:  
Continuous Index:  
Within 8" of Joint: **NO**  
Remarks: **CAMERA STOPPED**
