Profile/Photo Observation Report

Street:	N LIBERTY	Flow Control:	Not Controlled
City:	Hobart, IN	Year Renewed:	
Location:	Other	Tape/Media #:	
Purpose:	Not Known	Dia/Height:	10"
Use:	Sanitary	Material:	VCP
Drain Area:	NA	Lining:	
Category:	NA		
Comment:

Location Details:		Direction of Survey:	Downstream
US MH:	M-803-015	DS MH:	M-803-016
		Total Length Surveyed (ft):	68.8

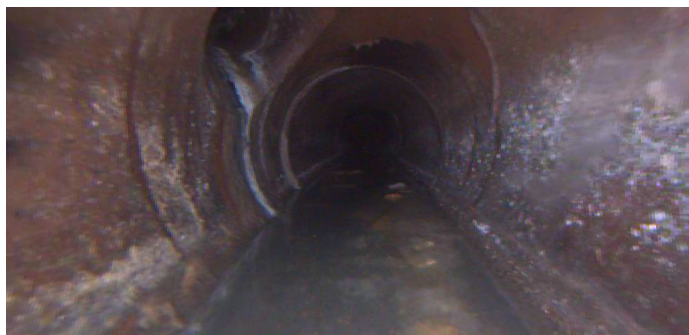
Code: **AMH**
Description: **Manhole**

Distance (ft): **.0**
Structural Grade: **0**
O&M Grade: **0**
Clock Start/From:
Clock To:
1st Value:
2nd Value:
Value Percent:
Continuous Index:
Within 8" of Joint: **NO**
Remarks: **M-803-015**

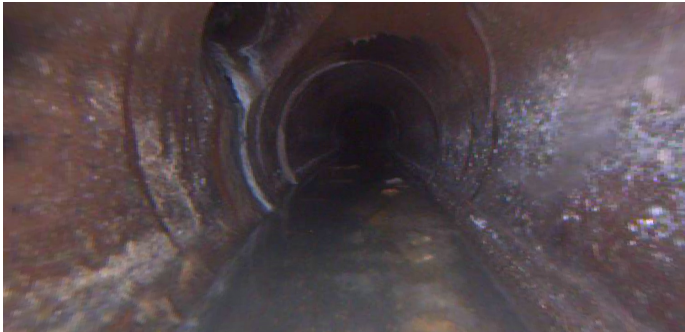
Code:	MWL
Description:	Water Level

Distance (ft):	.0
Structural Grade:	0
O&M Grade:	0
Clock Start/From:	
Clock To:	
1st Value:	
2nd Value:	
Value Percent:	5.000
Continuous Index:	
Within 8" of Joint:	NO
Remarks:

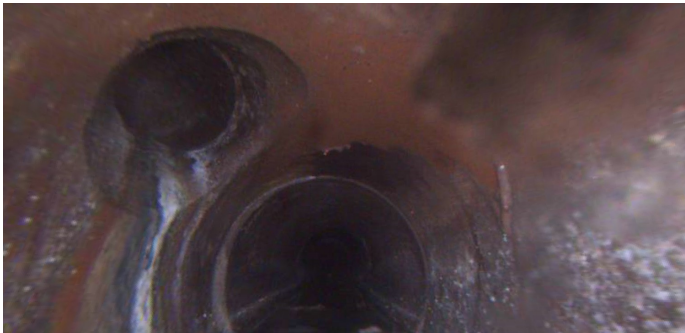
Code:	TFA
Description:	Tap Factory Active

Distance (ft):	.5
Structural Grade:	0
O&M Grade:	0
Clock Start/From:	10
Clock To:	
1st Value:	4.000
2nd Value:	
Value Percent:	
Continuous Index:	
Within 8" of Joint:	
Remarks:

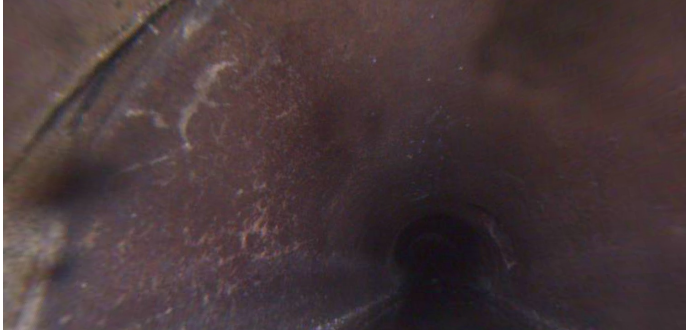
Code: **CM**
Description: **Crack Multiple**

Distance (ft): **2.6**
Structural Grade: **3**
O&M Grade: **0**
Clock Start/From: **9**
Clock To: **10**
1st Value:
2nd Value:
Value Percent:
Continuous Index:
Within 8" of Joint: **YES**
Remarks:

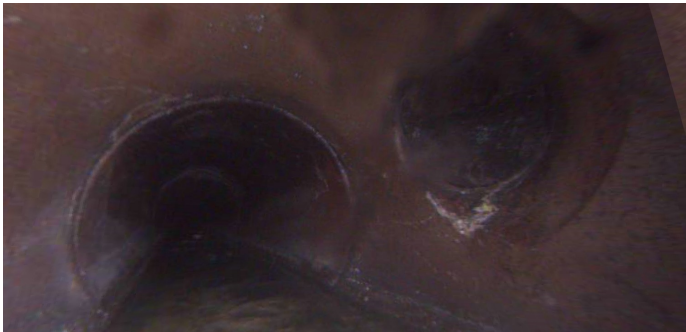
Code: **TF**
Description: **Tap Factory**

Distance (ft): **4.5**
Structural Grade: **0**
O&M Grade: **0**
Clock Start/From: **2**
Clock To:
1st Value: **4.000**
2nd Value:
Value Percent:
Continuous Index:
Within 8" of Joint:
Remarks:

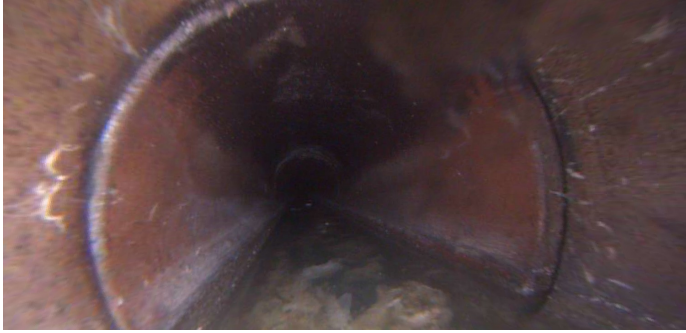
Code: **CM**
Description: **Crack Multiple**

Distance (ft): **5.2**
Structural Grade: **3**
O&M Grade: **0**
Clock Start/From: **8**
Clock To: **4**
1st Value:
2nd Value:
Value Percent:
Continuous Index:
Within 8" of Joint: **YES**
Remarks:

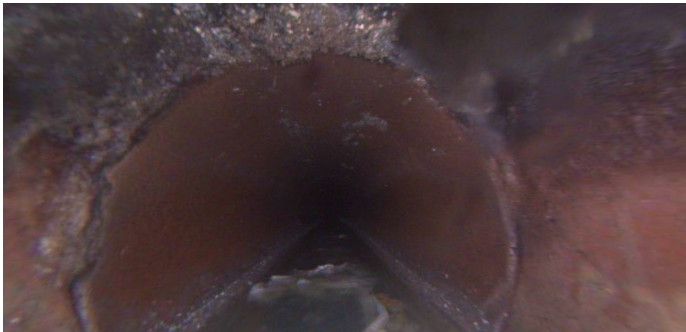
Code: **DAE**
Description: **Deposits Attached Encrustation**

Distance (ft): **8.1**
Structural Grade: **0**
O&M Grade: **2**
Clock Start/From: **8**
Clock To: **4**
1st Value:
2nd Value:
Value Percent: **5.000**
Continuous Index:
Within 8" of Joint: **YES**
Remarks:

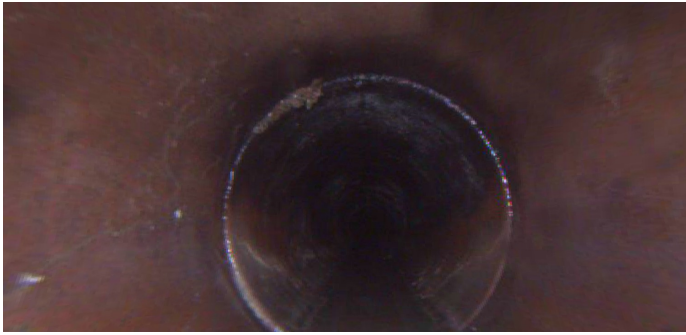
Code: **RFJ**
Description: **Roots Fine Joint**

Distance (ft): **13.5**
Structural Grade: **0**
O&M Grade: **1**
Clock Start/From: **10**
Clock To: **11**
1st Value:
2nd Value:
Value Percent:
Continuous Index:
Within 8" of Joint: **YES**
Remarks:

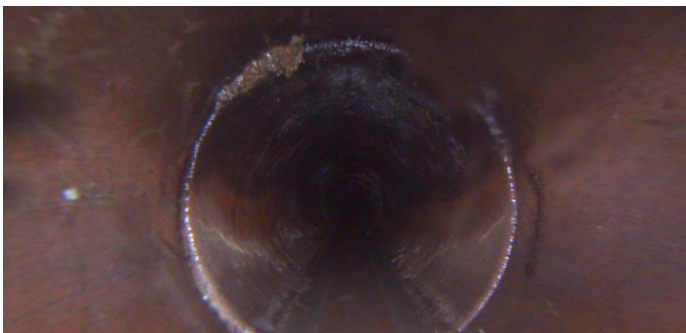
Code: **IW**
Description: **Infil Weeper**

Distance (ft): **13.8**
Structural Grade: **0**
O&M Grade: **2**
Clock Start/From: **8**
Clock To: **4**
1st Value:
2nd Value:
Value Percent:
Continuous Index: **S01**
Within 8" of Joint: **YES**
Remarks:

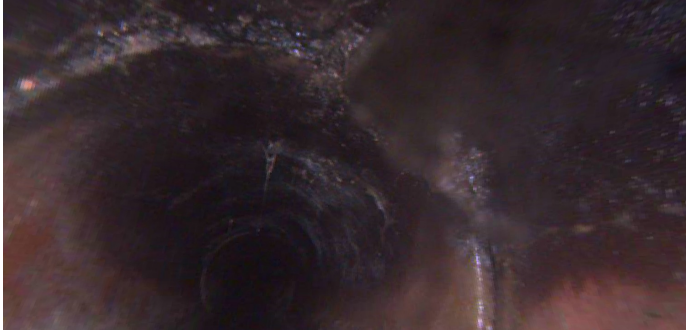
Code: **RFJ**
Description: **Roots Fine Joint**

Distance (ft): **16.9**
Structural Grade: **0**
O&M Grade: **1**
Clock Start/From: **12**
Clock To: **2**
1st Value:
2nd Value:
Value Percent:
Continuous Index:
Within 8" of Joint: **YES**
Remarks:

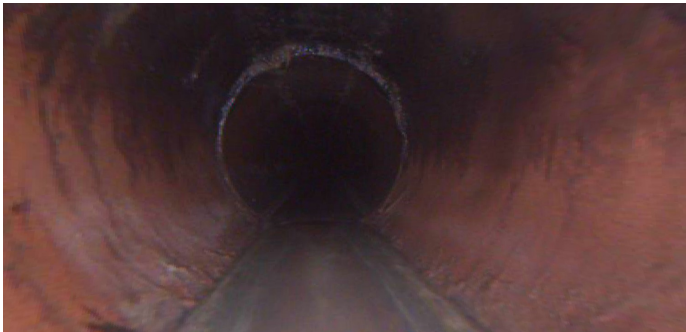
Code: **RFJ**
Description: **Roots Fine Joint**

Distance (ft): **24.9**
Structural Grade: **0**
O&M Grade: **1**
Clock Start/From: **9**
Clock To: **3**
1st Value:
2nd Value:
Value Percent:
Continuous Index:
Within 8" of Joint: **YES**
Remarks:

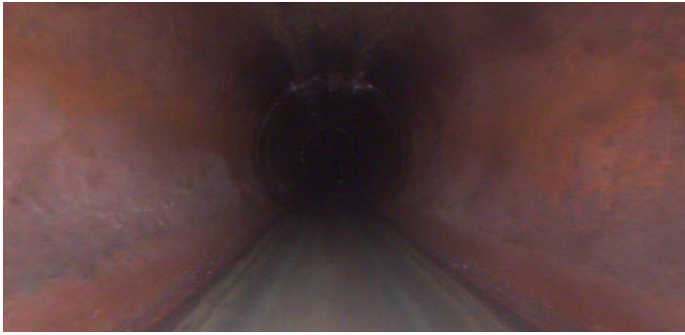
Code: **RFJ**
Description: **Roots Fine Joint**

Distance (ft): **33.4**
Structural Grade: **0**
O&M Grade: **1**
Clock Start/From: **11**
Clock To: **1**
1st Value:
2nd Value:
Value Percent:
Continuous Index:
Within 8" of Joint: **YES**
Remarks:

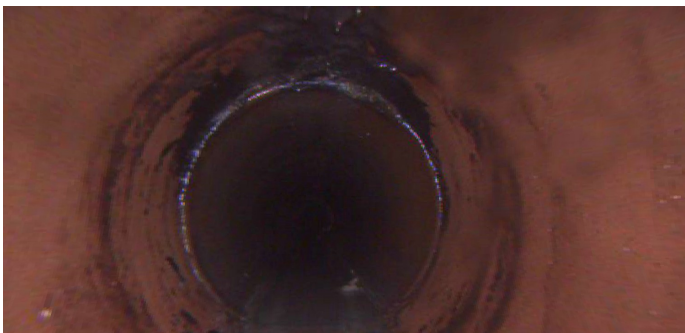
Code: **RFJ**
Description: **Roots Fine Joint**

Distance (ft): **37.2**
Structural Grade: **0**
O&M Grade: **1**
Clock Start/From: **11**
Clock To: **1**
1st Value:
2nd Value:
Value Percent:
Continuous Index:
Within 8" of Joint: **YES**
Remarks:

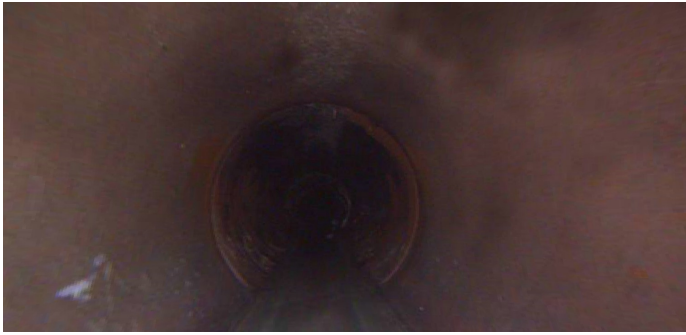
Code: **RFJ**
Description: **Roots Fine Joint**

Distance (ft): **39.9**
Structural Grade: **0**
O&M Grade: **1**
Clock Start/From: **12**
Clock To:
1st Value:
2nd Value:
Value Percent:
Continuous Index:
Within 8" of Joint: **YES**
Remarks:

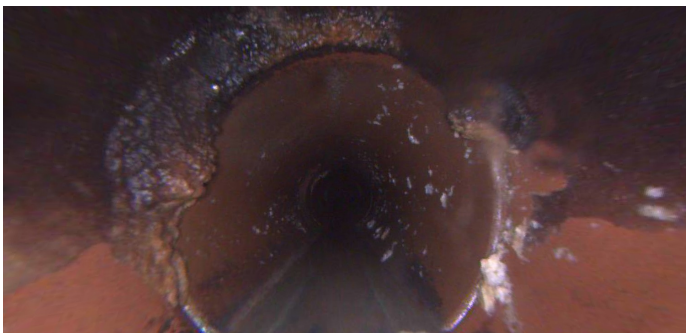
Code: **DAE**
Description: **Deposits Attached Encrustation**

Distance (ft): **43.7**
Structural Grade: **0**
O&M Grade: **2**
Clock Start/From: **8**
Clock To: **4**
1st Value:
2nd Value:
Value Percent: **10.000**
Continuous Index:
Within 8" of Joint: **YES**
Remarks:

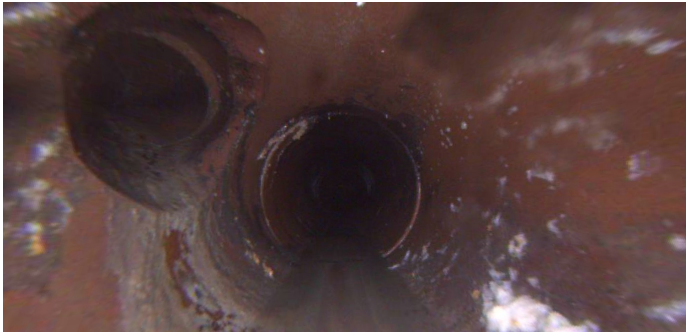
Code: **TF**
Description: **Tap Factory**

Distance (ft): **45.9**
Structural Grade: **0**
O&M Grade: **0**
Clock Start/From: **10**
Clock To:
1st Value: **4.000**
2nd Value:
Value Percent:
Continuous Index:
Within 8" of Joint:
Remarks:

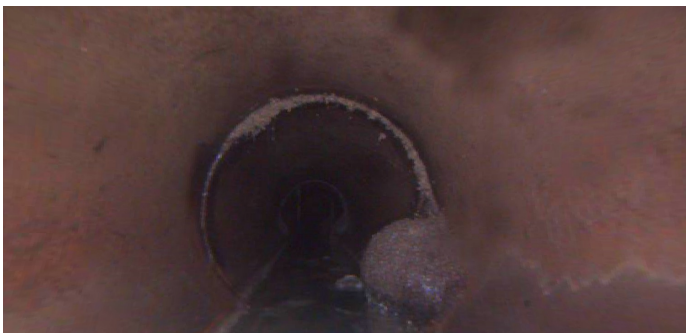
Code: **RMJ**
Description: **Roots Medium Joint**

Distance (ft): **61.0**
Structural Grade: **0**
O&M Grade: **3**
Clock Start/From: **7**
Clock To: **5**
1st Value:
2nd Value:
Value Percent: **15.000**
Continuous Index:
Within 8" of Joint: **YES**
Remarks:

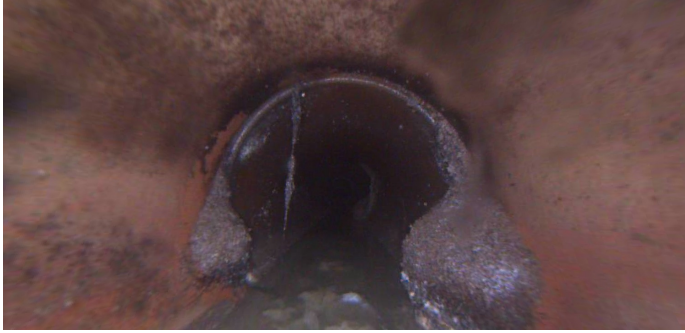
Code: **RMJ**
Description: **Roots Medium Joint**

Distance (ft): **64.4**
Structural Grade: **0**
O&M Grade: **3**
Clock Start/From: **8**
Clock To: **4**
1st Value:
2nd Value:
Value Percent: **10.000**
Continuous Index:
Within 8" of Joint: **YES**
Remarks:

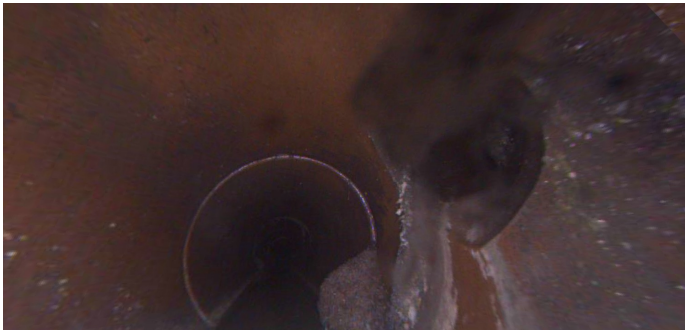
Code: **TFD**
Description: **Tap Factory Defective**

Distance (ft): **67.0**
Structural Grade: **0**
O&M Grade: **2**
Clock Start/From: **2**
Clock To:
1st Value: **4.000**
2nd Value:
Value Percent:
Continuous Index:
Within 8" of Joint:
Remarks: **ROOTS**

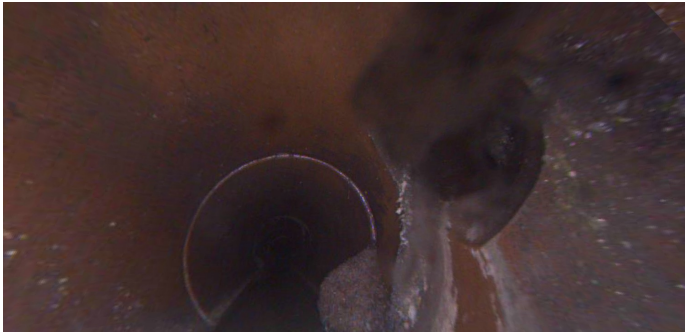
Code: **RFL**
Description: **Roots Fine Lateral**

Distance (ft): **67.0**
Structural Grade: **0**
O&M Grade: **1**
Clock Start/From: **2**
Clock To:
1st Value:
2nd Value:
Value Percent:
Continuous Index:
Within 8" of Joint: **NO**
Remarks:

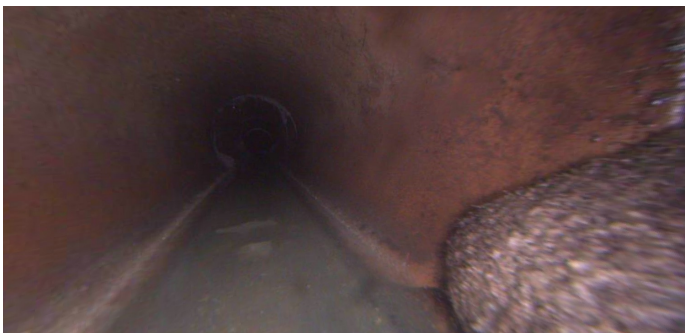
Code: **RMJ**
Description: **Roots Medium Joint**

Distance (ft): **68.1**
Structural Grade: **0**
O&M Grade: **3**
Clock Start/From: **3**
Clock To: **5**
1st Value:
2nd Value:
Value Percent: **10.000**
Continuous Index:
Within 8" of Joint: **YES**
Remarks:

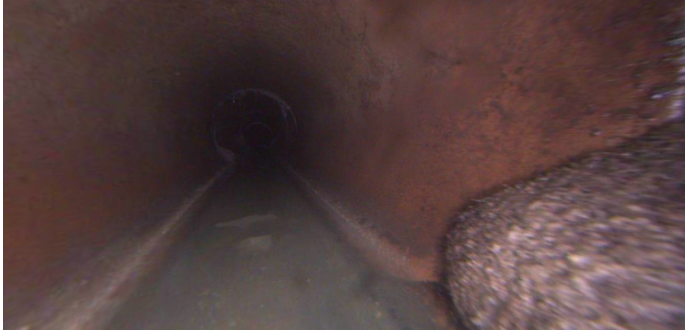
Code: **IW**
Description: **Infil Weeper**

Distance (ft): **68.1**
Structural Grade: **0**
O&M Grade: **2**
Clock Start/From: **8**
Clock To: **4**
1st Value:
2nd Value:
Value Percent:
Continuous Index: **F01**
Within 8" of Joint: **YES**
Remarks:

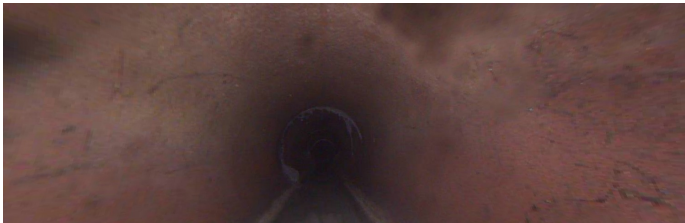
Code: **MSA**
Description: **Abandoned Survey**

Distance (ft): **68.8**
Structural Grade: **0**
O&M Grade: **0**
Clock Start/From:
Clock To:
1st Value:
2nd Value:
Value Percent:
Continuous Index:
Within 8" of Joint: **NO**
Remarks: **CAMERA STOPPED**
