## Profile/Photo Observation Report

Date:	10/01/2018	Weather:		Coding:	PACP 6.0
Pipe Length (ft):	209.4	Owner:	NA	Pre Clean:	Not Known
P.O.#:		Surveyor:	Justin Gonzales	PSR:	P-803-016-015
Customer:		Clean Date:	01/01/1900	Shape:	C

Street:	ALLEY BETWEEN N LIBERTY ST & N L	Flow Control:	Not Controlled
City:	Hobart, IN	Year Renewed:	
Location:	Light Highway	Tape/Media #:	
Purpose:	Routine Assessment	Dia/Height:	12"
Use:	Sanitary	Material:	VCP
Drain Area:	NA	Lining:	
Category:	NA		
Comment:

Location Details:		Direction of Survey:	Downstream
US MH:	M-803-015	DS MH:	M-803-016
		Total Length Surveyed (ft):	150.3

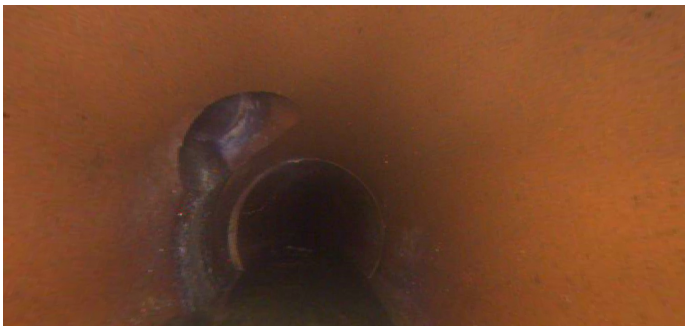
Code: **MWL**  
Description: **Water Level**

Distance (ft): **.0**  
Structural Grade: **0**  
O&M Grade: **0**  
Clock Start/From:  
Clock To:  
1st Value:  
2nd Value:  
Value Percent: **10.000**  
Continuous Index:  
Within 8" of Joint: **NO**  
Remarks:

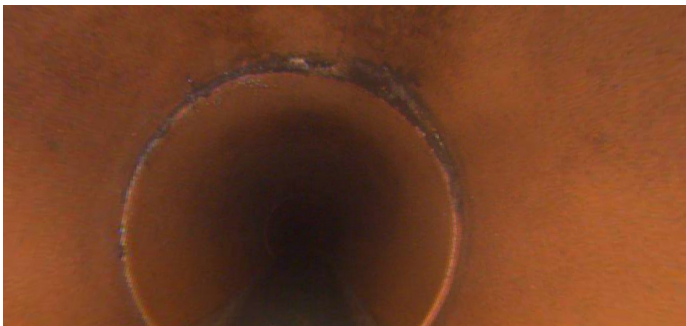
Code: **RFJ**  
Description: **Roots Fine Joint**

Distance (ft): **15.7**  
Structural Grade: **0**  
O&M Grade: **1**  
Clock Start/From: **10**  
Clock To: **2**  
1st Value:  
2nd Value:  
Value Percent:  
Continuous Index:  
Within 8" of Joint: **YES**  
Remarks:

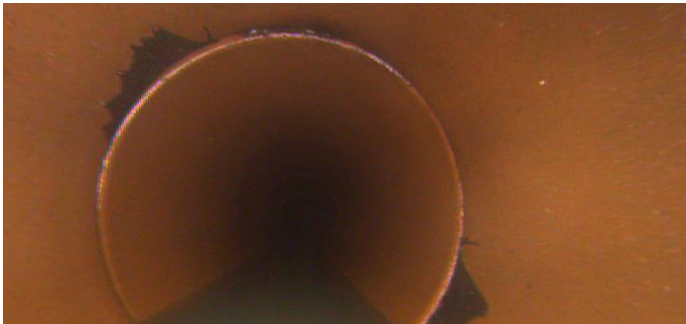
Code: **MGO**  
Description: **General Observation**

Distance (ft): **30.4**  
Structural Grade: **0**  
O&M Grade: **0**  
Clock Start/From:  
Clock To:  
1st Value:  
2nd Value:  
Value Percent:  
Continuous Index:  
Within 8" of Joint: **NO**  
Remarks: **SEALANT STAINS**

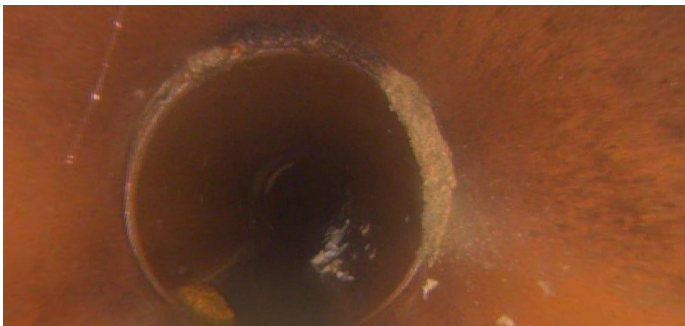
Code: **RFJ**  
Description: **Roots Fine Joint**

Distance (ft): **42.0**  
Structural Grade: **0**  
O&M Grade: **1**  
Clock Start/From: **11**  
Clock To: **1**  
1st Value:  
2nd Value:  
Value Percent:  
Continuous Index:  
Within 8" of Joint: **YES**  
Remarks:

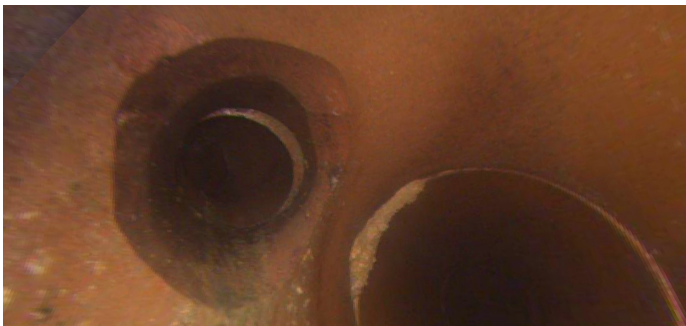
Code: **TF**  
Description: **Tap Factory**

Distance (ft): **44.6**  
Structural Grade: **0**  
O&M Grade: **0**  
Clock Start/From: **10**  
Clock To:  
1st Value: **4.000**  
2nd Value:  
Value Percent:  
Continuous Index:  
Within 8" of Joint:  
Remarks:

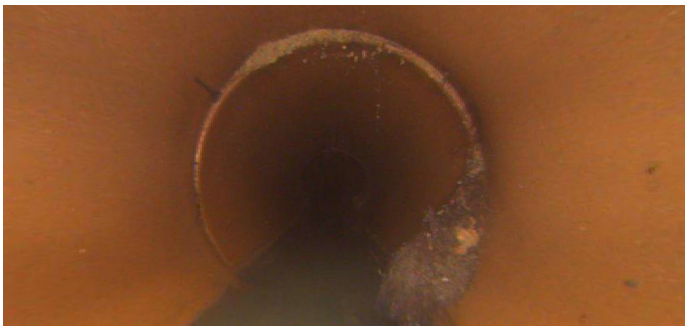
Code: **DAE**  
Description: **Deposits Attached Encrustation**

Distance (ft): **59.3**  
Structural Grade: **0**  
O&M Grade: **2**  
Clock Start/From: **11**  
Clock To: **1**  
1st Value:  
2nd Value:  
Value Percent: **5.000**  
Continuous Index:  
Within 8" of Joint: **YES**  
Remarks:

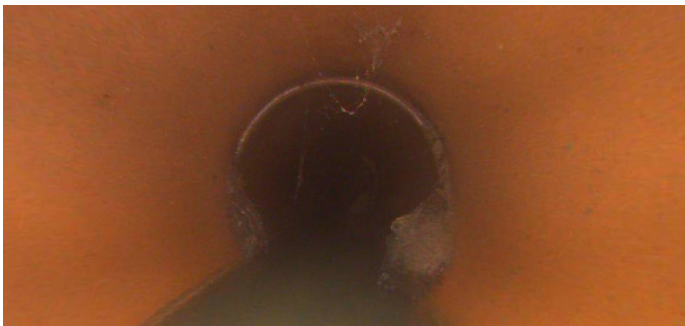
Code: **RMJ**  
Description: **Roots Medium Joint**

Distance (ft): **61.9**  
Structural Grade: **0**  
O&M Grade: **3**  
Clock Start/From: **7**  
Clock To: **5**  
1st Value:  
2nd Value:  
Value Percent: **10.000**  
Continuous Index:  
Within 8" of Joint: **YES**  
Remarks:

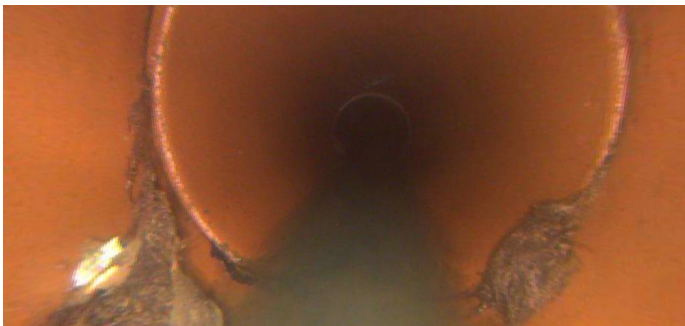
Code: **RFJ**  
Description: **Roots Fine Joint**

Distance (ft): **70.5**  
Structural Grade: **0**  
O&M Grade: **1**  
Clock Start/From: **7**  
Clock To: **5**  
1st Value:  
2nd Value:  
Value Percent:  
Continuous Index:  
Within 8" of Joint: **YES**  
Remarks:

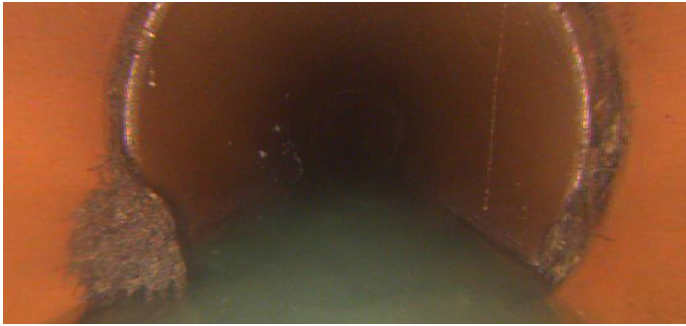
Code: **RFJ**  
Description: **Roots Fine Joint**

Distance (ft): **73.1**  
Structural Grade: **0**  
O&M Grade: **1**  
Clock Start/From: **7**  
Clock To: **5**  
1st Value:  
2nd Value:  
Value Percent:  
Continuous Index:  
Within 8" of Joint: **YES**  
Remarks:

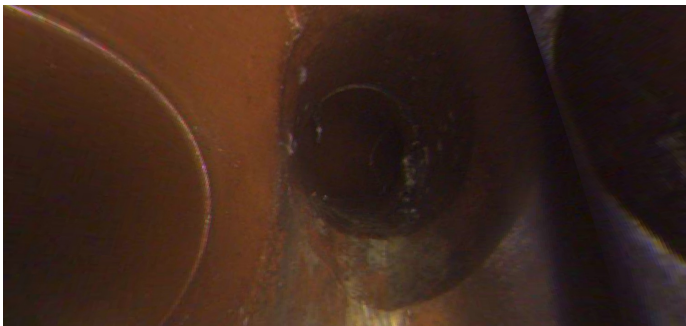
Code: **TF**  
Description: **Tap Factory**

Distance (ft): **75.1**  
Structural Grade: **0**  
O&M Grade: **0**  
Clock Start/From: **2**  
Clock To:  
1st Value: **4.000**  
2nd Value:  
Value Percent:  
Continuous Index:  
Within 8" of Joint:  
Remarks:

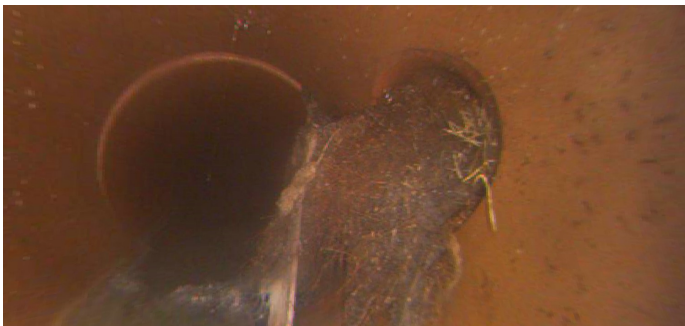
Code: **TFD**  
Description: **Tap Factory Defective**

Distance (ft): **138.8**  
Structural Grade: **0**  
O&M Grade: **2**  
Clock Start/From: **2**  
Clock To:  
1st Value: **4.000**  
2nd Value:  
Value Percent:  
Continuous Index:  
Within 8" of Joint:  
Remarks: **RM COMING FROM TAP**

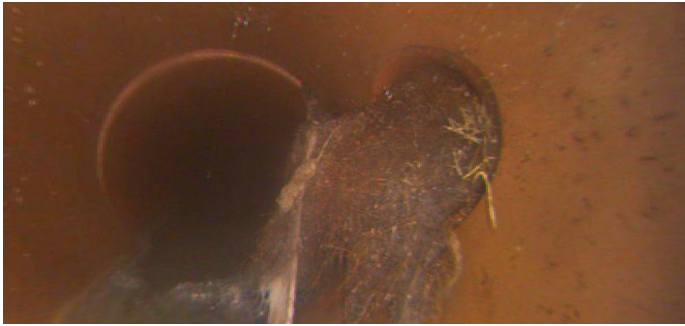
Code: **RMB**  
Description: **Roots Medium Barrel**

Distance (ft): **138.8**  
Structural Grade: **0**  
O&M Grade: **4**  
Clock Start/From: **2**  
Clock To: **5**  
1st Value:  
2nd Value:  
Value Percent: **10.000**  
Continuous Index:  
Within 8" of Joint: **NO**  
Remarks:

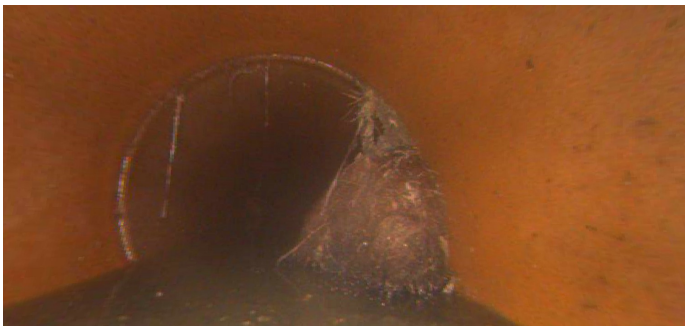
Code: **RMB**  
Description: **Roots Medium Barrel**

Distance (ft): **144.4**  
Structural Grade: **0**  
O&M Grade: **4**  
Clock Start/From: **10**  
Clock To: **5**  
1st Value:  
2nd Value:  
Value Percent: **15.000**  
Continuous Index:  
Within 8" of Joint: **NO**  
Remarks:
