Profile/Photo Observation Report

Street:	40th. Ave.	Flow Control:	Not Controlled
City:	Hobart, IN	Year Renewed:	
Location:	Light Highway	Tape/Media #:	
Purpose:	Routine Assessment	Dia/Height:	12"
Use:	Sanitary	Material:	VCP
Drain Area:	NA	Lining:	
Category:	NA		
Comment:

Location Details:		Direction of Survey:	Downstream
US MH:	M-803-015	DS MH:	M-803-016
		Total Length Surveyed (ft):	150.3

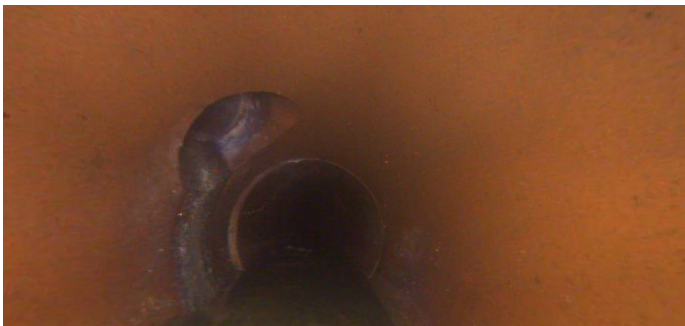
Code: **MWL**
Description: **Water Level**

Distance (ft): **.0**
Structural Grade: **0**
O&M Grade: **0**
Clock Start/From:
Clock To:
1st Value:
2nd Value:
Value Percent: **10.000**
Continuous Index:
Within 8" of Joint: **NO**
Remarks:

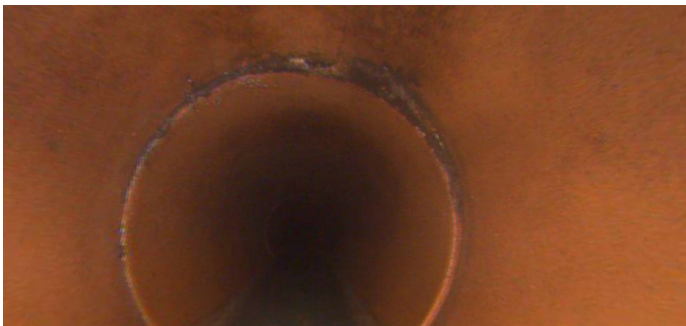
Code: **RFJ**
Description: **Roots Fine Joint**

Distance (ft): **15.7**
Structural Grade: **0**
O&M Grade: **1**
Clock Start/From: **10**
Clock To: **2**
1st Value:
2nd Value:
Value Percent:
Continuous Index:
Within 8" of Joint: **YES**
Remarks:

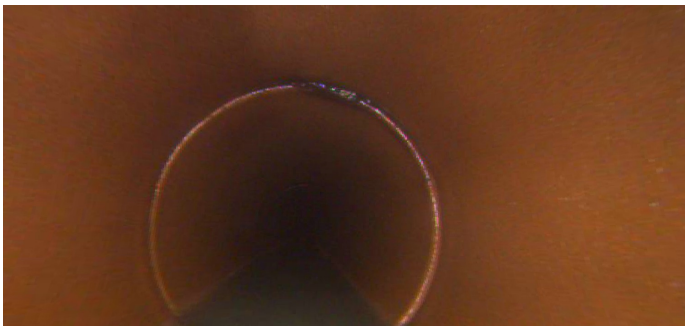
Code: **IS**
Description: **Infil Stain**

Distance (ft): **27.3**
Structural Grade: **0**
O&M Grade: **0**
Clock Start/From: **12**
Clock To: **1**
1st Value:
2nd Value:
Value Percent:
Continuous Index:
Within 8" of Joint: **YES**
Remarks:

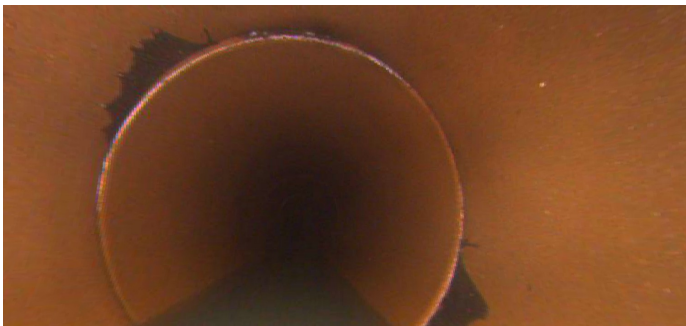
Code: **MGO**
Description: **General Observation**

Distance (ft): **30.4**
Structural Grade: **0**
O&M Grade: **0**
Clock Start/From:
Clock To:
1st Value:
2nd Value:
Value Percent:
Continuous Index:
Within 8" of Joint: **NO**
Remarks: **SEALANT STAINS**

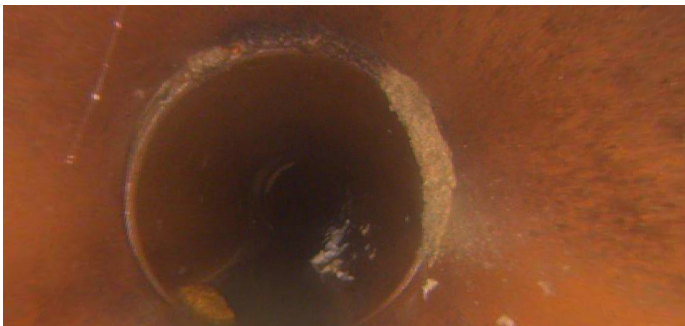
Code: **RFJ**
Description: **Roots Fine Joint**

Distance (ft): **42.0**
Structural Grade: **0**
O&M Grade: **1**
Clock Start/From: **11**
Clock To: **1**
1st Value:
2nd Value:
Value Percent:
Continuous Index:
Within 8" of Joint: **YES**
Remarks:

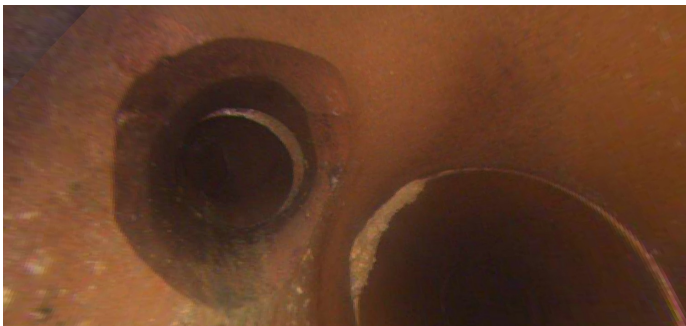
Code: **TF**
Description: **Tap Factory**

Distance (ft): **44.6**
Structural Grade: **0**
O&M Grade: **0**
Clock Start/From: **10**
Clock To:
1st Value: **4.000**
2nd Value:
Value Percent:
Continuous Index:
Within 8" of Joint:
Remarks:

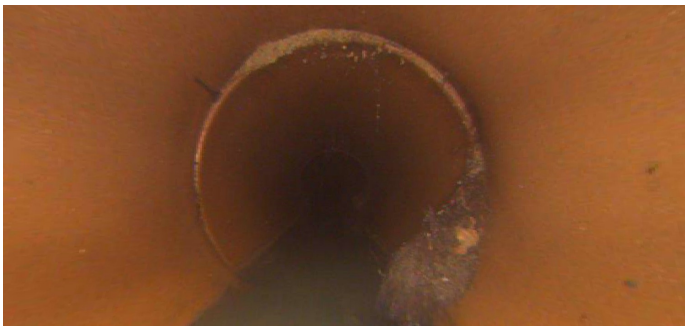
Code: **DAE**
Description: **Deposits Attached Encrustation**

Distance (ft): **59.3**
Structural Grade: **0**
O&M Grade: **2**
Clock Start/From: **11**
Clock To: **1**
1st Value:
2nd Value:
Value Percent: **5.000**
Continuous Index:
Within 8" of Joint: **YES**
Remarks:

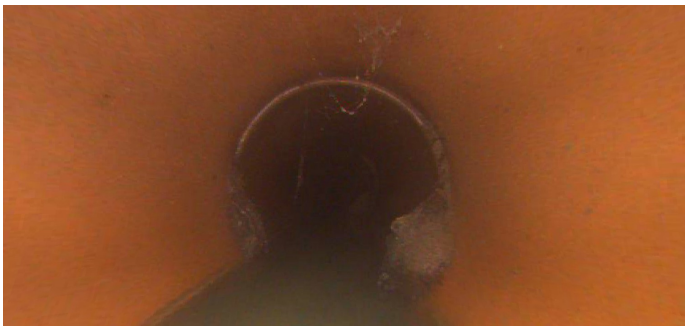
Code: **RMJ**
Description: **Roots Medium Joint**

Distance (ft): **61.9**
Structural Grade: **0**
O&M Grade: **3**
Clock Start/From: **7**
Clock To: **5**
1st Value:
2nd Value:
Value Percent: **10.000**
Continuous Index:
Within 8" of Joint: **YES**
Remarks:

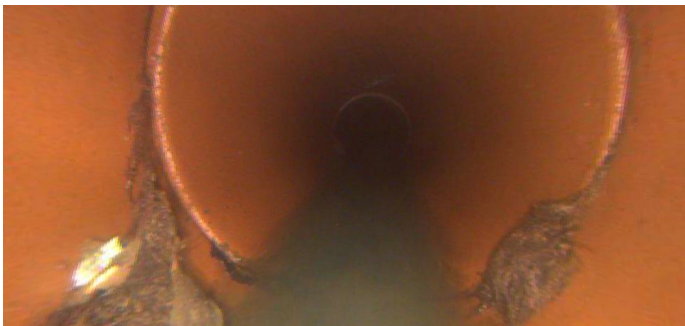
Code: **RFJ**
Description: **Roots Fine Joint**

Distance (ft): **70.5**
Structural Grade: **0**
O&M Grade: **1**
Clock Start/From: **7**
Clock To: **5**
1st Value:
2nd Value:
Value Percent:
Continuous Index:
Within 8" of Joint: **YES**
Remarks:

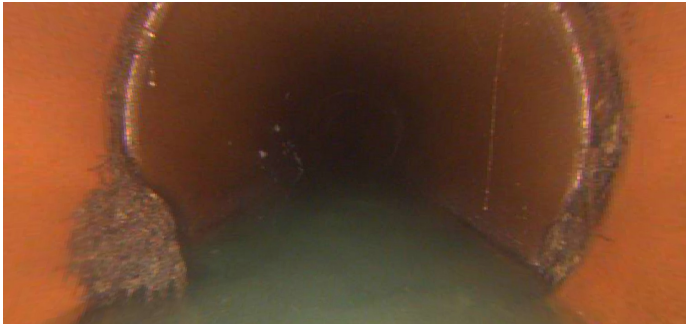
Code: **RFJ**
Description: **Roots Fine Joint**

Distance (ft): **73.1**
Structural Grade: **0**
O&M Grade: **1**
Clock Start/From: **7**
Clock To: **5**
1st Value:
2nd Value:
Value Percent:
Continuous Index:
Within 8" of Joint: **YES**
Remarks:

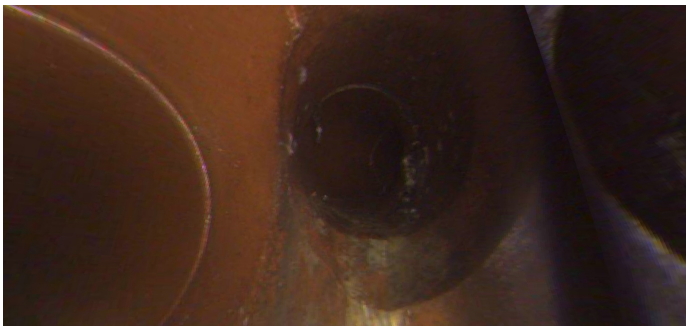
Code: **TF**
Description: **Tap Factory**

Distance (ft): **75.1**
Structural Grade: **0**
O&M Grade: **0**
Clock Start/From: **2**
Clock To:
1st Value: **4.000**
2nd Value:
Value Percent:
Continuous Index:
Within 8" of Joint:
Remarks:

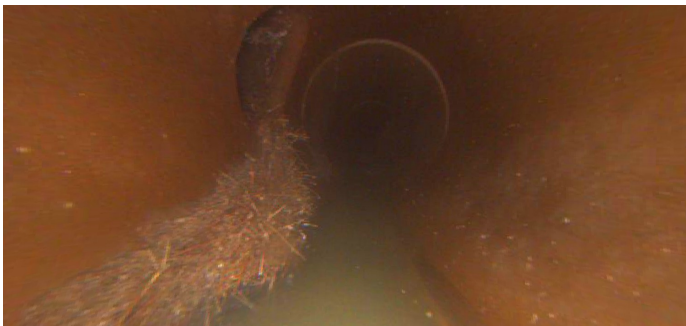
Code: **RMB**
Description: **Roots Medium Barrel**

Distance (ft): **135.5**
Structural Grade: **0**
O&M Grade: **4**
Clock Start/From: **7**
Clock To:
1st Value:
2nd Value:
Value Percent: **10.000**
Continuous Index:
Within 8" of Joint: **NO**
Remarks:

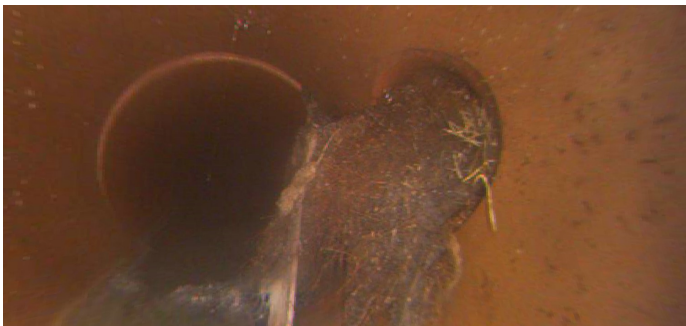
Code: **TFD**
Description: **Tap Factory Defective**

Distance (ft): **138.8**
Structural Grade: **0**
O&M Grade: **2**
Clock Start/From: **2**
Clock To:
1st Value: **4.000**
2nd Value:
Value Percent:
Continuous Index:
Within 8" of Joint:
Remarks: **RM COMING FROM TAP**

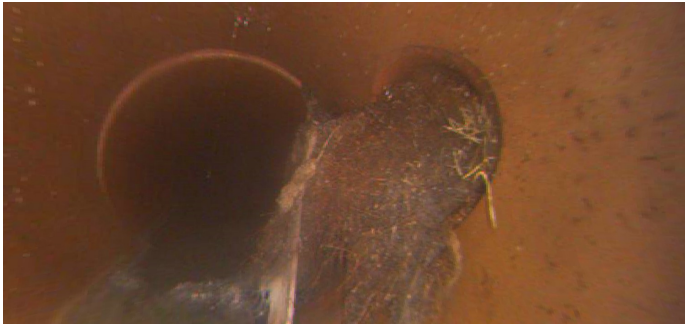
Code: **RMB**
Description: **Roots Medium Barrel**

Distance (ft): **138.8**
Structural Grade: **0**
O&M Grade: **4**
Clock Start/From: **2**
Clock To: **5**
1st Value:
2nd Value:
Value Percent: **10.000**
Continuous Index:
Within 8" of Joint: **NO**
Remarks:

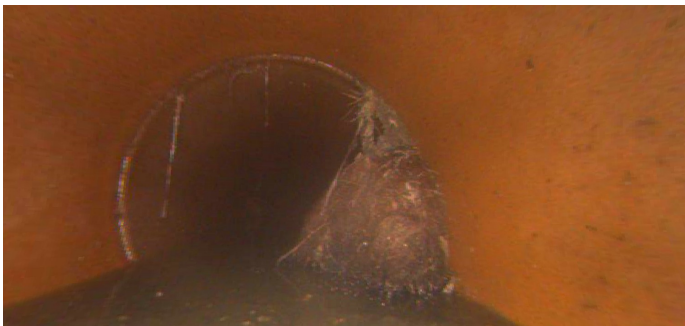
Code: **RMB**
Description: **Roots Medium Barrel**

Distance (ft): **144.4**
Structural Grade: **0**
O&M Grade: **4**
Clock Start/From: **10**
Clock To: **5**
1st Value:
2nd Value:
Value Percent: **15.000**
Continuous Index:
Within 8" of Joint: **NO**
Remarks:
