Profile/Photo Observation Report

Date:	10/01/2018	Weather:		Coding:	PACP 6.0
Pipe Length (ft):	213.4	Owner:	NA	Pre Clean:	Not Known
P.O.#:		Surveyor:	Michael Carlino	PSR:	P-803-017-016
Customer:		Clean Date:	01/01/1900	Shape:	C

Street:	ALLEY BETWEEN N LIBERTY ST & N L	Flow Control:	Not Controlled
City:	Hobart, IN	Year Renewed:	
Location:	Light Highway	Tape/Media #:	
Purpose:	Routine Assessment	Dia/Height:	12"
Use:	Sanitary	Material:	VCP
Drain Area:	NA	Lining:	
Category:	NA		
Comment:

Location Details:		Direction of Survey:	Downstream
US MH:	M-803-016	DS MH:	M-803-017
		Total Length Surveyed (ft):	24.1

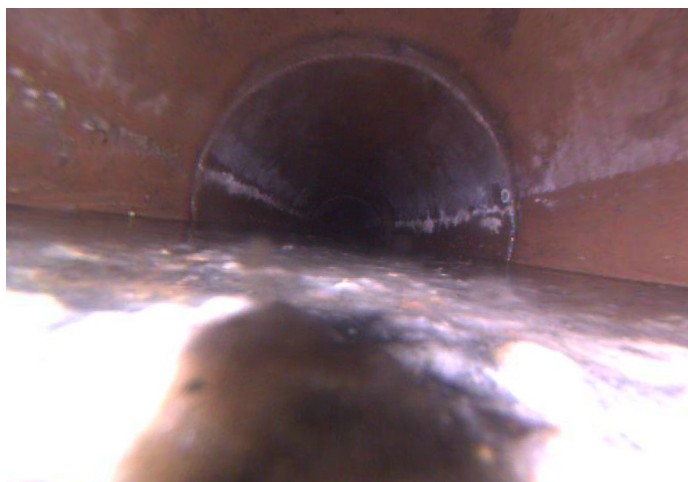
Code: **AMH**
Description: **Manhole**

Distance (ft): **.0**
Structural Grade: **0**
O&M Grade: **0**
Clock Start/From:
Clock To:
1st Value:
2nd Value:
Value Percent:
Continuous Index:
Within 8" of Joint: **NO**
Remarks: **M-803-016**

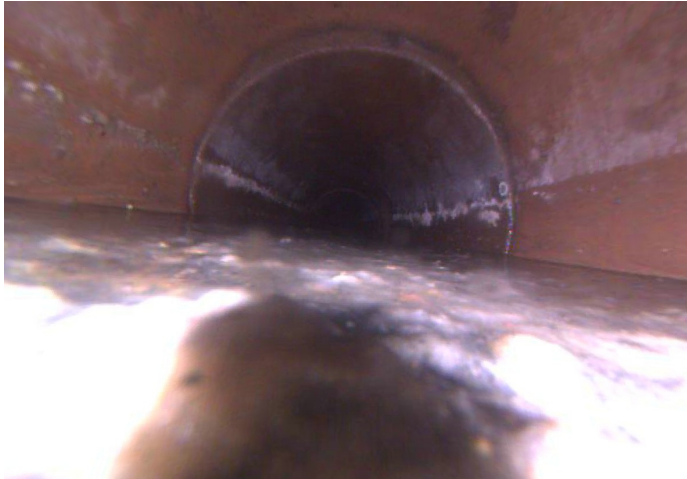
Code: **MWL**
Description: **Water Level**

Distance (ft): **.0**
Structural Grade: **0**
O&M Grade: **0**
Clock Start/From:
Clock To:
1st Value:
2nd Value:
Value Percent: **25.000**
Continuous Index:
Within 8" of Joint: **NO**
Remarks:

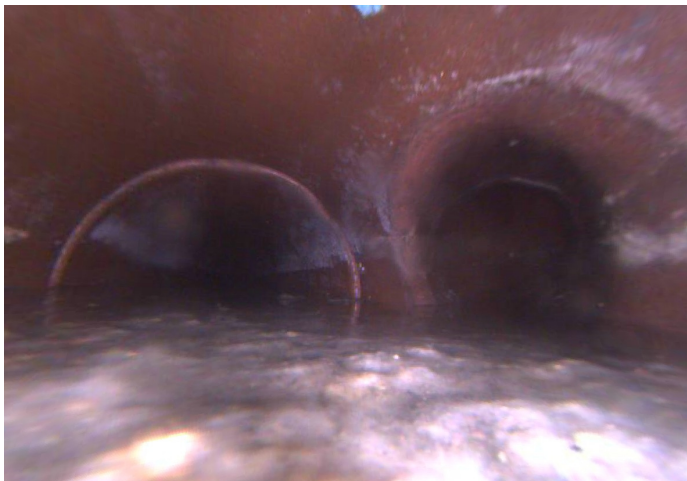
Code: **TF**
Description: **Tap Factory**

Distance (ft): **3.8**
Structural Grade: **0**
O&M Grade: **0**
Clock Start/From: **3**
Clock To:
1st Value: **6.000**
2nd Value:
Value Percent:
Continuous Index:
Within 8" of Joint:
Remarks:

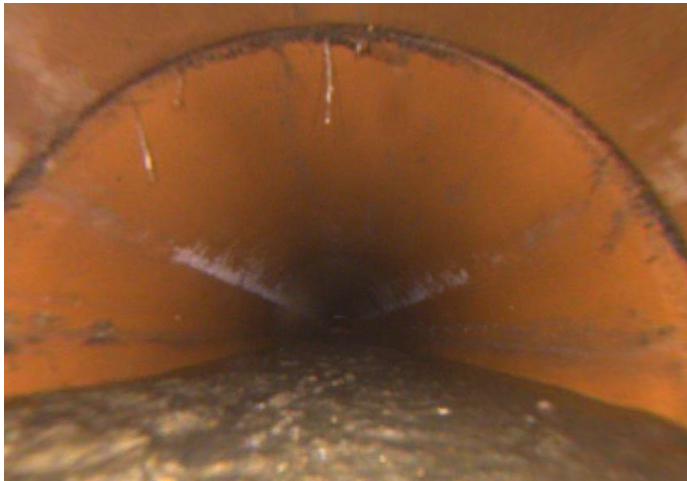
Code: **RFJ**
Description: **Roots Fine Joint**

Distance (ft): **10.4**
Structural Grade: **0**
O&M Grade: **1**
Clock Start/From: **11**
Clock To: **12**
1st Value:
2nd Value:
Value Percent:
Continuous Index:
Within 8" of Joint: **YES**
Remarks:

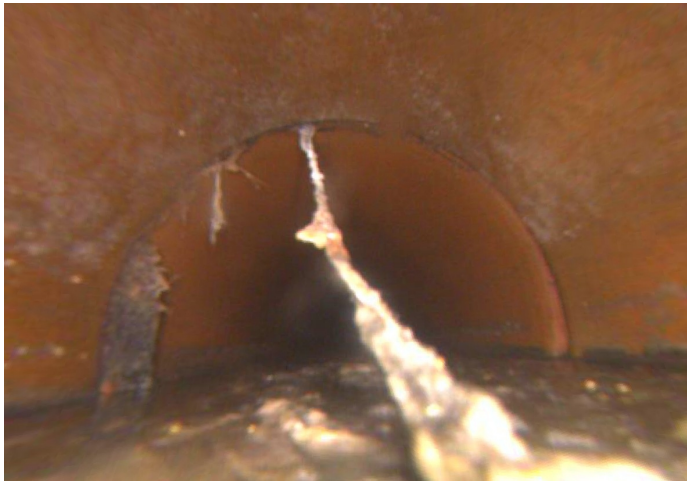
Code: **RFJ**
Description: **Roots Fine Joint**

Distance (ft): **19.3**
Structural Grade: **0**
O&M Grade: **1**
Clock Start/From: **9**
Clock To: **12**
1st Value:
2nd Value:
Value Percent:
Continuous Index:
Within 8" of Joint: **YES**
Remarks:

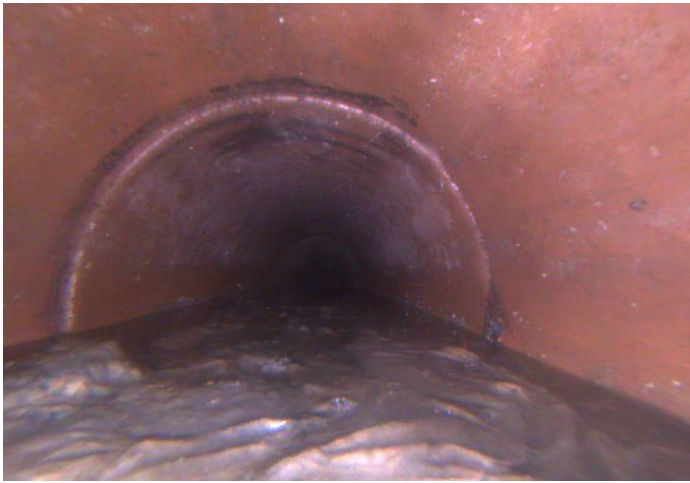
Code:	MSA
Description:	Abandoned Survey
Distance (ft):	24.1
Structural Grade:	0
O&M Grade:	0
Clock Start/From:	
Clock To:	
1st Value:	
2nd Value:	
Value Percent:	
Continuous Index:	
Within 8" of Joint:	NO
Remarks:	Possible Debris
