Profile/Photo Observation Report

Street:	HIGH ST	Flow Control:	Not Controlled
City:	Hobart, IN	Year Renewed:	
Location:	Other	Tape/Media #:	
Purpose:	Not Known	Dia/Height:	10"
Use:	Sanitary	Material:	VCP
Drain Area:	NA	Lining:	
Category:	NA		
Comment:

Location Details:		Direction of Survey:	Upstream
US MH:	M-803-018	DS MH:	M-804-044
		Total Length Surveyed (ft):	4.5

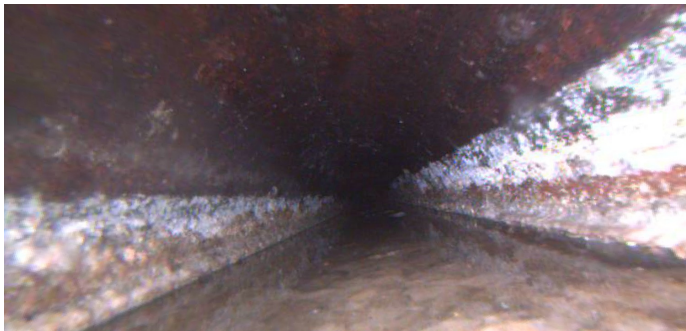
Position	Code	Observation	Video (sec)	Grade
.0	DAGS	Deposits Attached Grease	10	M 2
.0	AMH	Manhole	22	NA
.0	MWL	Water Level	33	NA
4.5	MSA	Abandoned Survey	53	NA

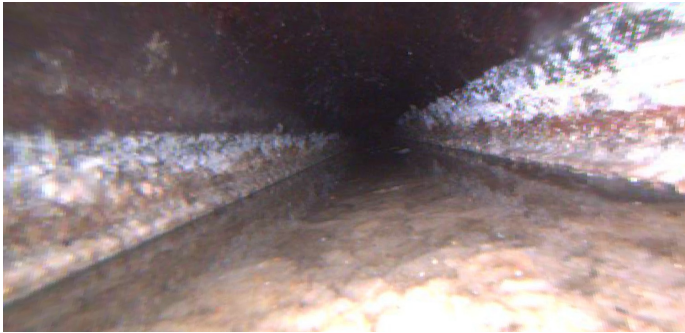
Code:	AMH
Description:	Manhole

Distance (ft):	.0
Structural Grade:	0
O&M Grade:	0
Clock Start/From:	
Clock To:	
1st Value:	
2nd Value:	
Value Percent:	
Continuous Index:	
Within 8" of Joint:	NO
Remarks:	M-804-044

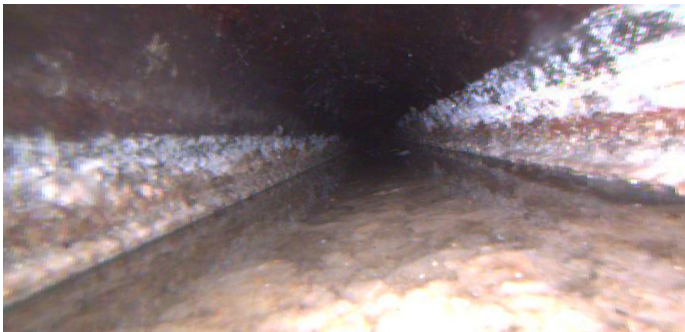
Code:	MWL
Description:	Water Level

Distance (ft):	.0
Structural Grade:	0
O&M Grade:	0
Clock Start/From:	
Clock To:	
1st Value:	
2nd Value:	
Value Percent:	5.000
Continuous Index:	
Within 8" of Joint:	NO
Remarks:

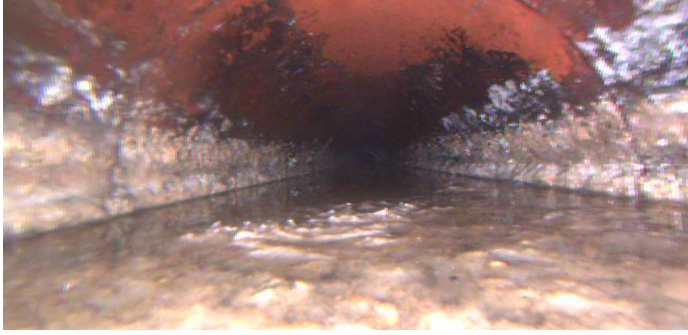
Code:	MSA
Description:	Abandoned Survey
Distance (ft):	4.5
Structural Grade:	0
O&M Grade:	0
Clock Start/From:	
Clock To:	
1st Value:	
2nd Value:	
Value Percent:	
Continuous Index:	
Within 8" of Joint:	NO
Remarks:	camera stopped
