Profile/Photo Observation Report

Date:	10/01/2018	Weather:		Coding:	PACP 6.0
Pipe Length (ft):	233.0	Owner:	NA	Pre Clean:	Not Known
P.O.#:		Surveyor:	Michael Carlino	PSR:	P-804-044-018
Customer:		Clean Date:	01/01/1900	Shape:	C

Location Details:		Direction of Survey:	Downstream
US MH:	M-803-018	DS MH:	M-804-044
		Total Length Surveyed (ft):	4.3

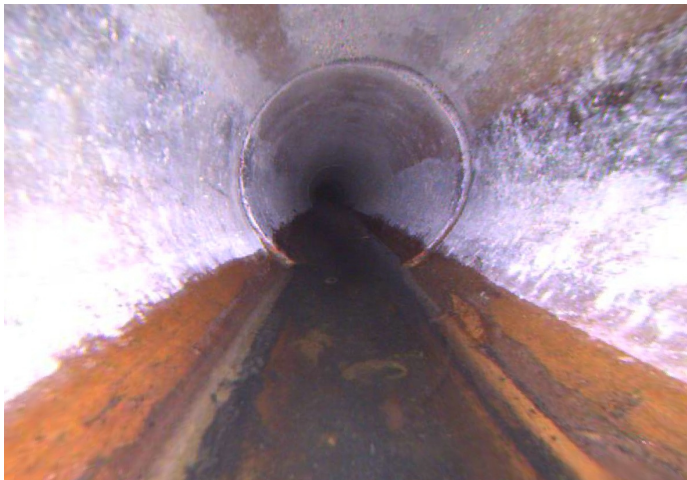
Code:	AMH
Description:	Manhole
Distance (ft):	.0
Structural Grade:	0
O&M Grade:	0
Clock Start/From:	
Clock To:	
1st Value:	
2nd Value:	
Value Percent:	
Continuous Index:	
Within 8" of Joint:	NO
Remarks:	M-803-018

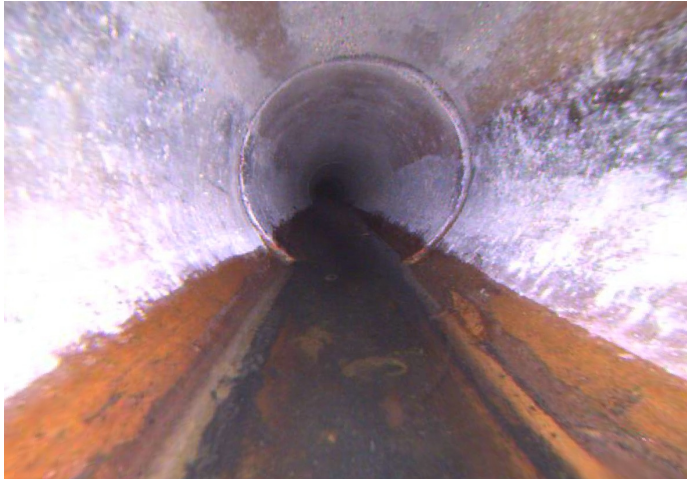
Code: **MWL**
Description: **Water Level**

Distance (ft): **.0**
Structural Grade: **0**
O&M Grade: **0**
Clock Start/From:
Clock To:
1st Value:
2nd Value:
Value Percent: **5.000**
Continuous Index:
Within 8" of Joint: **NO**
Remarks:

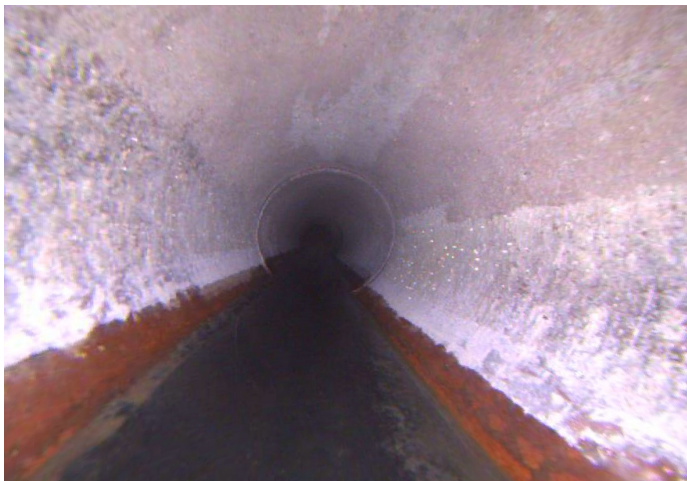
Code: **MSA**
Description: **Abandoned Survey**

Distance (ft): **4.3**
Structural Grade: **0**
O&M Grade: **0**
Clock Start/From:
Clock To:
1st Value:
2nd Value:
Value Percent:
Continuous Index:
Within 8" of Joint: **NO**
Remarks: **Unknown**
