Profile/Photo Observation Report

Street:	41st. Ave.	Flow Control:	Not Controlled
City:	Hobart, IN	Year Renewed:	
Location:	Light Highway	Tape/Media #:	
Purpose:	Routine Assessment	Dia/Height:	12"
Use:	Sanitary	Material:	VCP
Drain Area:	NA	Lining:	
Category:	NA		
Comment:

Location Details:		Direction of Survey:	Downstream
US MH:	M-803-018	DS MH:	M-804-044
		Total Length Surveyed (ft):	4.3

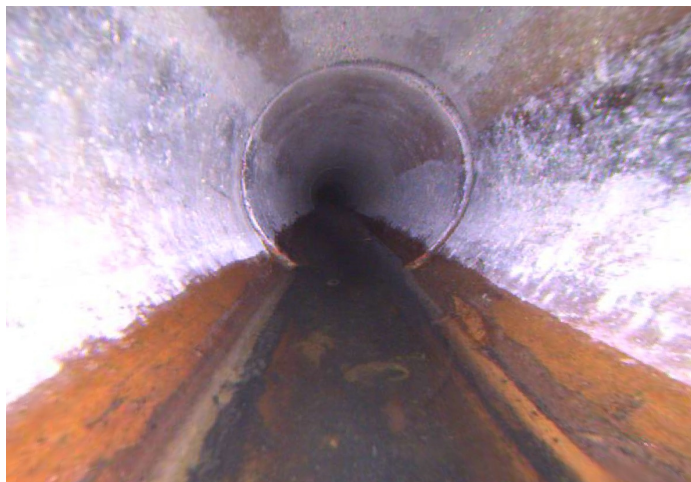
Code: **AMH**
Description: **Manhole**

Distance (ft): **.0**
Structural Grade: **0**
O&M Grade: **0**
Clock Start/From:
Clock To:
1st Value:
2nd Value:
Value Percent:
Continuous Index:
Within 8" of Joint: **NO**
Remarks: **M-803-018**

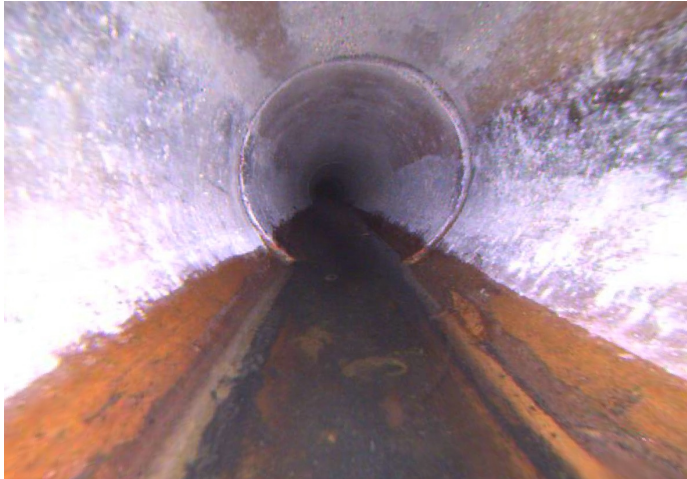
Code: **MWL**
Description: **Water Level**

Distance (ft): **.0**
Structural Grade: **0**
O&M Grade: **0**
Clock Start/From:
Clock To:
1st Value:
2nd Value:
Value Percent: **5.000**
Continuous Index:
Within 8" of Joint: **NO**
Remarks:

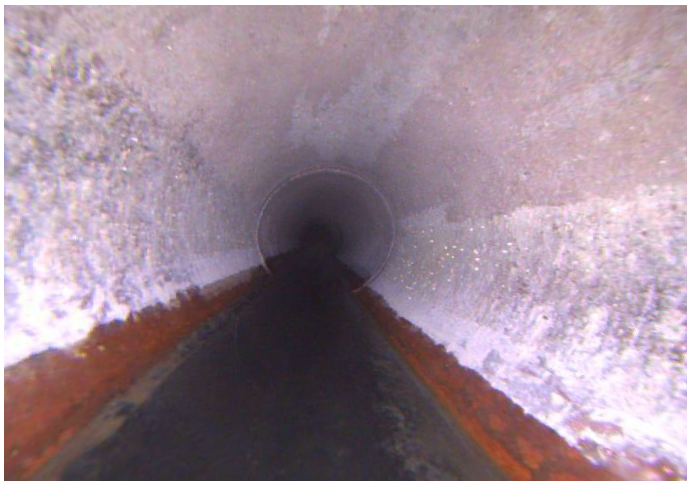
Code: **MSA**
Description: **Abandoned Survey**

Distance (ft): **4.3**
Structural Grade: **0**
O&M Grade: **0**
Clock Start/From:
Clock To:
1st Value:
2nd Value:
Value Percent:
Continuous Index:
Within 8" of Joint: **NO**
Remarks: **Unknown**
