Profile/Photo Observation Report

Street:	ALLEY BETWEEN N LIBERTY ST & N J	Flow Control:	Not Controlled
City:	Hobart, IN	Year Renewed:	
Location:	Light Highway	Tape/Media #:	
Purpose:	Routine Assessment	Dia/Height:	12"
Use:	Sanitary	Material:	VCP
Drain Area:	NA	Lining:	
Category:	NA		
Comment:

Location Details:		Direction of Survey:	Upstream
US MH:	M-803-019	DS MH:	M-803-018
		Total Length Surveyed (ft):	291.5

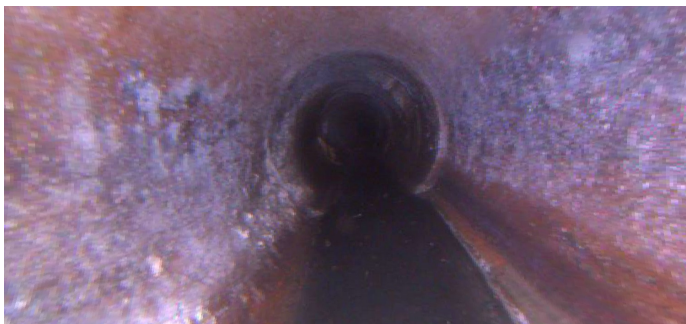
Code: **AMH**
Description: **Manhole**

Distance (ft): **.0**
Structural Grade: **0**
O&M Grade: **0**
Clock Start/From:
Clock To:
1st Value:
2nd Value:
Value Percent:
Continuous Index:
Within 8" of Joint: **NO**
Remarks: **M-803-018**

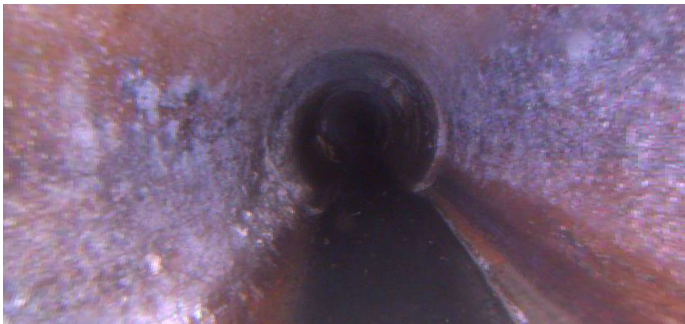
Code:	DAGS
Description:	Deposits Attached Grease

Distance (ft):	.0
Structural Grade:	0
O&M Grade:	2
Clock Start/From:	7
Clock To:	5
1st Value:	
2nd Value:	
Value Percent:	5.000
Continuous Index:	S01
Within 8" of Joint:	YES
Remarks:	WANDER

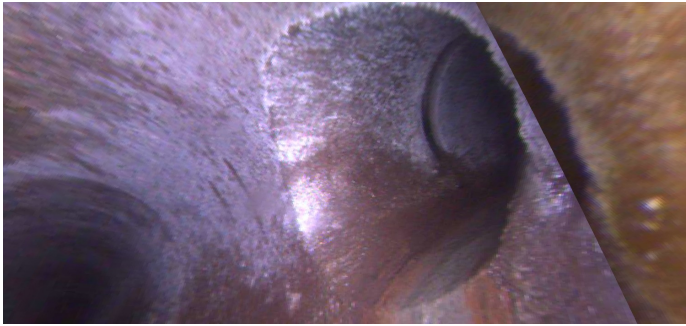
Code: **TF**
Description: **Tap Factory**

Distance (ft): **3.3**
Structural Grade: **0**
O&M Grade: **0**
Clock Start/From: **2**
Clock To:
1st Value: **4.000**
2nd Value:
Value Percent:
Continuous Index:
Within 8" of Joint:
Remarks:

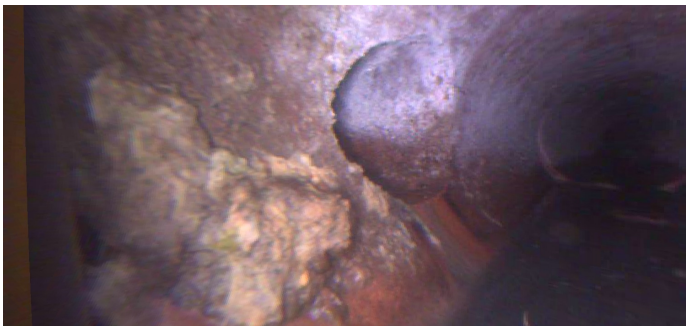
Code: **DAE**
Description: **Deposits Attached Encrustation**

Distance (ft): **5.0**
Structural Grade: **0**
O&M Grade: **2**
Clock Start/From: **7**
Clock To: **9**
1st Value:
2nd Value:
Value Percent: **5.000**
Continuous Index:
Within 8" of Joint: **YES**
Remarks:

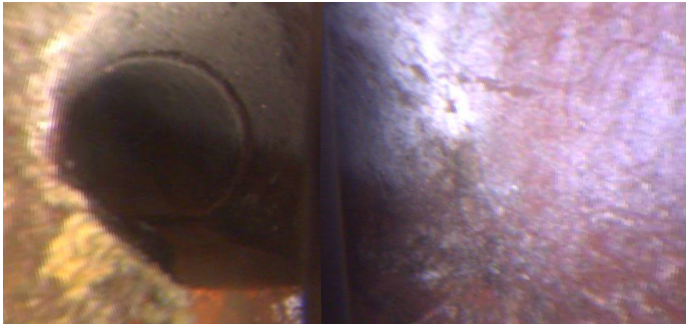
Code: **TF**
Description: **Tap Factory**

Distance (ft): **5.8**
Structural Grade: **0**
O&M Grade: **0**
Clock Start/From: **9**
Clock To:
1st Value: **4.000**
2nd Value:
Value Percent:
Continuous Index:
Within 8" of Joint:
Remarks:

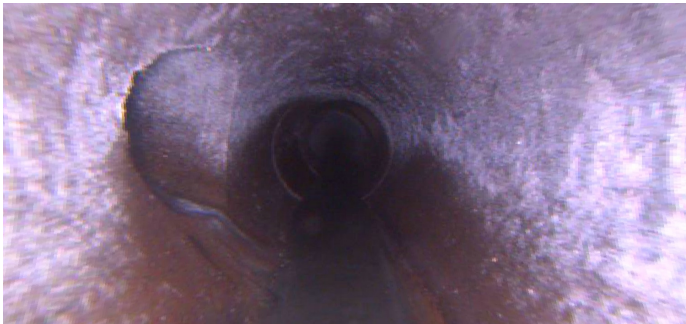
Code: **TF**
Description: **Tap Factory**

Distance (ft): **44.2**
Structural Grade: **0**
O&M Grade: **0**
Clock Start/From: **9**
Clock To:
1st Value: **4.000**
2nd Value:
Value Percent:
Continuous Index:
Within 8" of Joint:
Remarks:

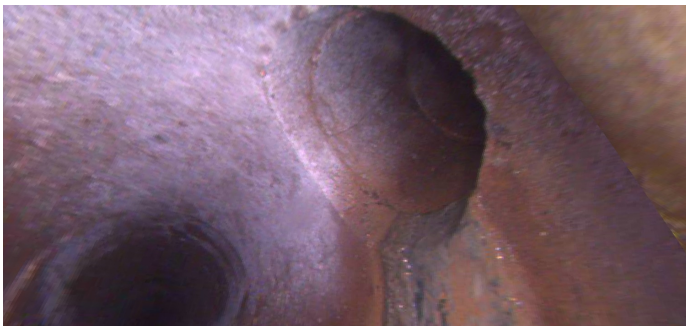
Code: **TF**
Description: **Tap Factory**

Distance (ft): **113.9**
Structural Grade: **0**
O&M Grade: **0**
Clock Start/From: **2**
Clock To:
1st Value: **4.000**
2nd Value:
Value Percent:
Continuous Index:
Within 8" of Joint:
Remarks:

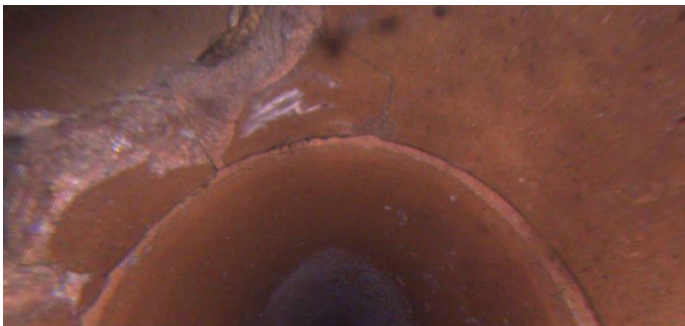
Code: **CM**
Description: **Crack Multiple**

Distance (ft): **185.4**
Structural Grade: **3**
O&M Grade: **0**
Clock Start/From: **10**
Clock To: **12**
1st Value:
2nd Value:
Value Percent:
Continuous Index:
Within 8" of Joint: **YES**
Remarks:

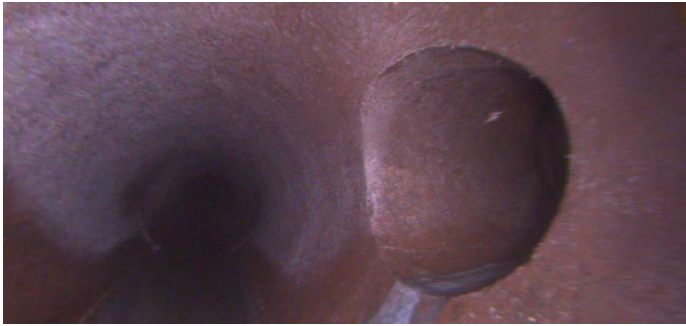
Code: **TF**
Description: **Tap Factory**

Distance (ft): **246.8**
Structural Grade: **0**
O&M Grade: **0**
Clock Start/From: **3**
Clock To:
1st Value: **4.000**
2nd Value:
Value Percent:
Continuous Index:
Within 8" of Joint:
Remarks:

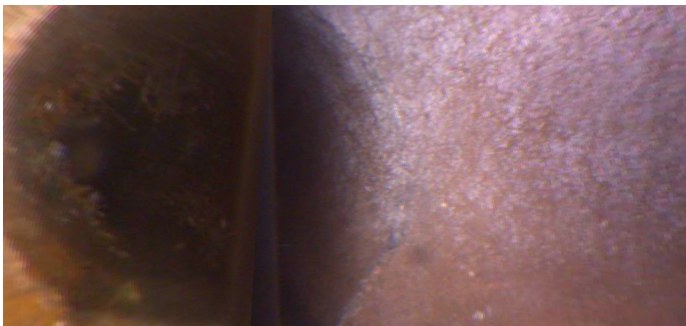
Code: **TF**
Description: **Tap Factory**

Distance (ft): **250.4**
Structural Grade: **0**
O&M Grade: **0**
Clock Start/From: **9**
Clock To:
1st Value: **4.000**
2nd Value:
Value Percent:
Continuous Index:
Within 8" of Joint:
Remarks:

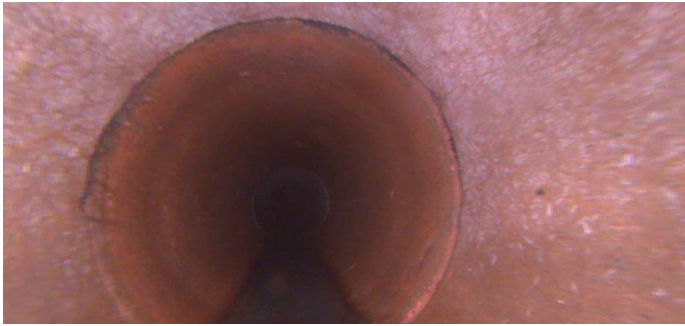
Code: **RFJ**
Description: **Roots Fine Joint**

Distance (ft): **251.9**
Structural Grade: **0**
O&M Grade: **1**
Clock Start/From: **9**
Clock To: **2**
1st Value:
2nd Value:
Value Percent:
Continuous Index:
Within 8" of Joint: **YES**
Remarks:

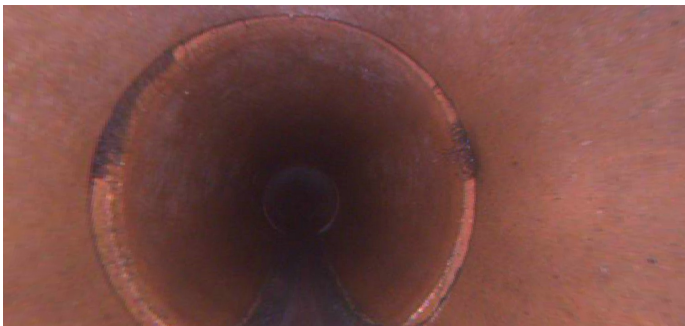
Code: **RFJ**
Description: **Roots Fine Joint**

Distance (ft): **257.9**
Structural Grade: **0**
O&M Grade: **1**
Clock Start/From: **9**
Clock To: **3**
1st Value:
2nd Value:
Value Percent:
Continuous Index:
Within 8" of Joint: **YES**
Remarks:

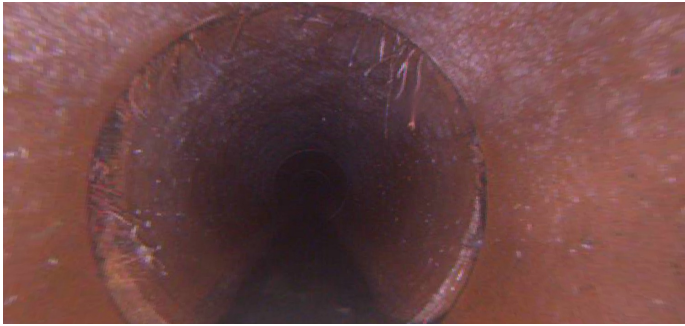
Code: **RFJ**
Description: **Roots Fine Joint**

Distance (ft): **264.0**
Structural Grade: **0**
O&M Grade: **1**
Clock Start/From: **8**
Clock To: **4**
1st Value:
2nd Value:
Value Percent:
Continuous Index: **S02**
Within 8" of Joint: **YES**
Remarks: **WANDER**

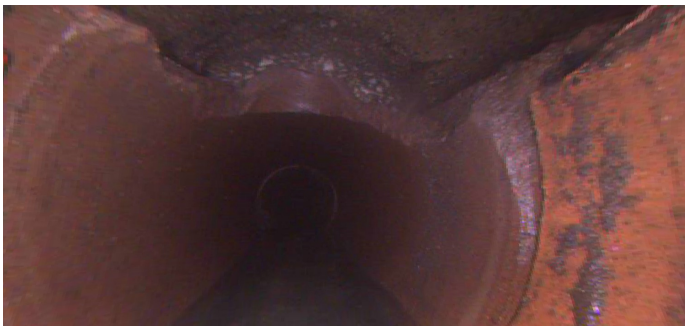
Code: **AMH**
Description: **Manhole**

Distance (ft): **291.5**
Structural Grade: **0**
O&M Grade: **0**
Clock Start/From:
Clock To:
1st Value:
2nd Value:
Value Percent:
Continuous Index:
Within 8" of Joint: **NO**
Remarks: **M-803-019**

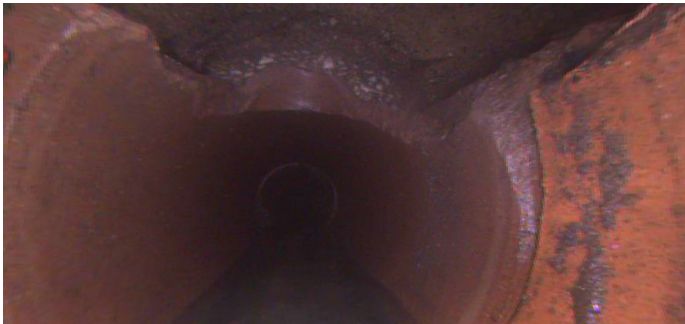
Code: **DAGS**
Description: **Deposits Attached Grease**

Distance (ft): **291.5**
Structural Grade: **0**
O&M Grade: **2**
Clock Start/From: **7**
Clock To: **5**
1st Value:
2nd Value:
Value Percent: **5.000**
Continuous Index: **F01**
Within 8" of Joint: **YES**
Remarks: **WANDER**
