Profile/Photo Observation Report

Street:	E 40TH AVE & N JOLIET ST	Flow Control:	Not Controlled
City:	Hobart, IN	Year Renewed:	
Location:	Other	Tape/Media #:	
Purpose:	Not Known	Dia/Height:	10"
Use:	Sanitary	Material:	VCP
Drain Area:	NA	Lining:	
Category:	NA		
Comment:

Location Details:		Direction of Survey:	Downstream
US MH:	M-803-021	DS MH:	M-803-020
		Total Length Surveyed (ft):	100.5

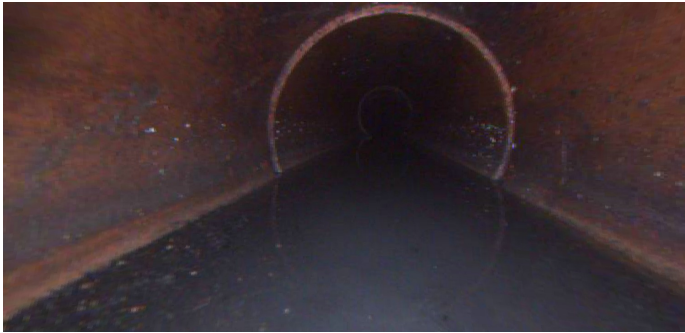
Code:	MWL
Description:	Water Level

Distance (ft):	.0
Structural Grade:	0
O&M Grade:	0
Clock Start/From:	
Clock To:	
1st Value:	
2nd Value:	
Value Percent:	5.000
Continuous Index:	
Within 8" of Joint:	NO
Remarks:

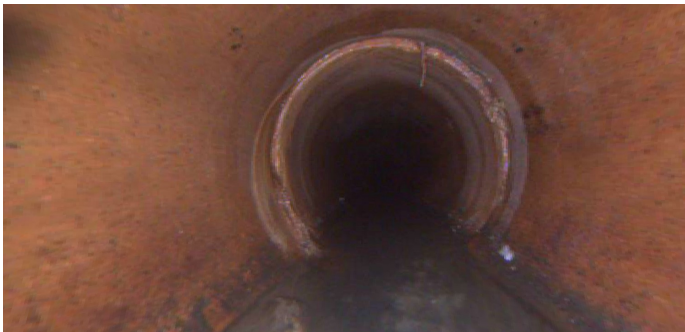
Code:	RFJ
Description:	Roots Fine Joint

Distance (ft):	5.1
Structural Grade:	0
O&M Grade:	1
Clock Start/From:	7
Clock To:	2
1st Value:	
2nd Value:	
Value Percent:	
Continuous Index:	
Within 8" of Joint:	YES
Remarks:

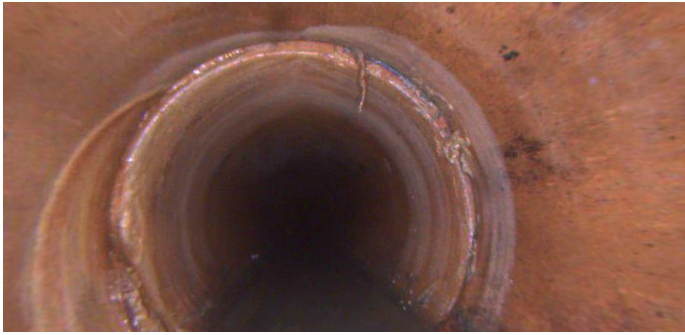
Code: **IW**
Description: **Infil Weeper**

Distance (ft): **5.5**
Structural Grade: **0**
O&M Grade: **2**
Clock Start/From: **8**
Clock To: **4**
1st Value:
2nd Value:
Value Percent:
Continuous Index:
Within 8" of Joint: **YES**
Remarks:

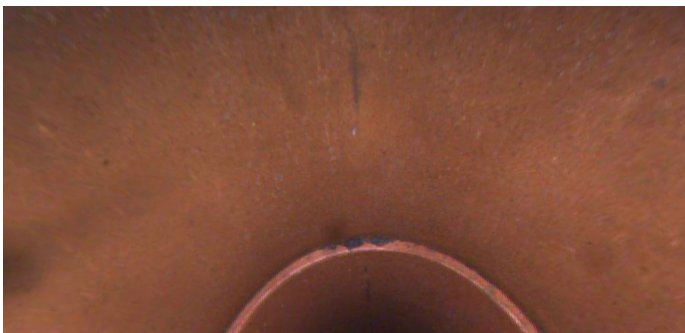
Code: **RFJ**
Description: **Roots Fine Joint**

Distance (ft): **84.9**
Structural Grade: **0**
O&M Grade: **1**
Clock Start/From: **12**
Clock To:
1st Value:
2nd Value:
Value Percent:
Continuous Index:
Within 8" of Joint: **YES**
Remarks:

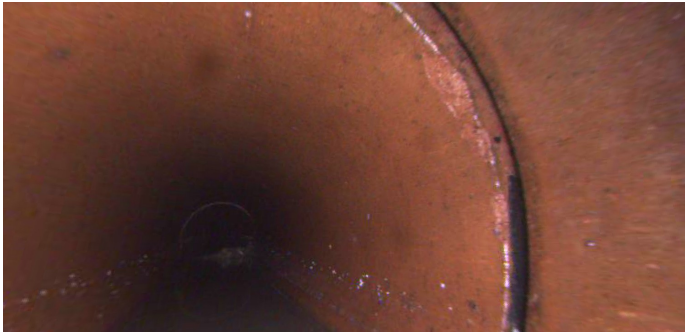
Code: **SSS**
Description: **Surface Spalling**

Distance (ft): **89.6**
Structural Grade: **2**
O&M Grade: **0**
Clock Start/From: **2**
Clock To: **3**
1st Value:
2nd Value:
Value Percent:
Continuous Index:
Within 8" of Joint: **YES**
Remarks:

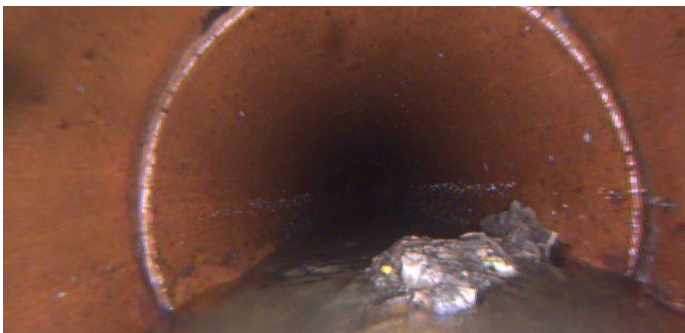
Code: **DSZ**
Description: **Deposits Settled Other**

Distance (ft): **93.4**
Structural Grade: **0**
O&M Grade: **3**
Clock Start/From: **4**
Clock To: **6**
1st Value:
2nd Value:
Value Percent: **15.000**
Continuous Index:
Within 8" of Joint: **YES**
Remarks: **mixed material**

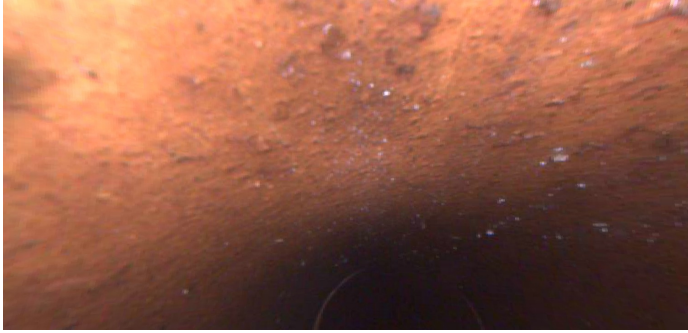
Code:	MSA
Description:	Abandoned Survey
Distance (ft):	100.5
Structural Grade:	0
O&M Grade:	0
Clock Start/From:	
Clock To:	
1st Value:	
2nd Value:	
Value Percent:	
Continuous Index:	
Within 8" of Joint:	NO
Remarks:	camera stopped
