Profile/Photo Observation Report

Street:	E 40TH AV	Flow Control:	Not Controlled
City:	Hobart, IN	Year Renewed:	
Location:	Other	Tape/Media #:	
Purpose:	Not Known	Dia/Height:	10"
Use:	Sanitary	Material:	VCP
Drain Area:	NA	Lining:	
Category:	NA		
Comment:

Location Details:		Direction of Survey:	Downstream
US MH:	M-803-021	DS MH:	M-803-020
		Total Length Surveyed (ft):	100.5

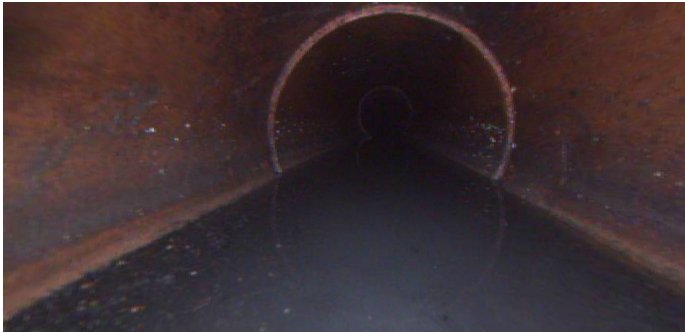
Code:	MWL
Description:	Water Level

Distance (ft):	.0
Structural Grade:	0
O&M Grade:	0
Clock Start/From:	
Clock To:	
1st Value:	
2nd Value:	
Value Percent:	5.000
Continuous Index:	
Within 8" of Joint:	NO
Remarks:

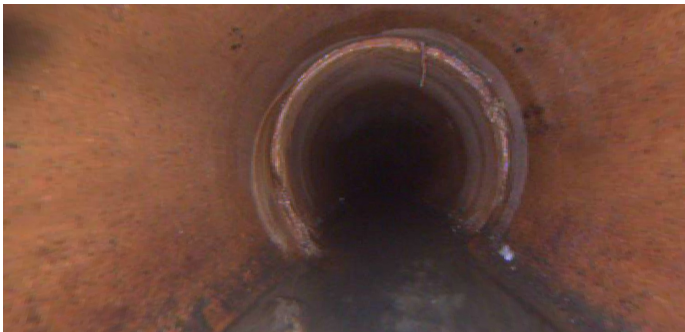
Code:	RFJ
Description:	Roots Fine Joint

Distance (ft):	5.1
Structural Grade:	0
O&M Grade:	1
Clock Start/From:	7
Clock To:	2
1st Value:	
2nd Value:	
Value Percent:	
Continuous Index:	
Within 8" of Joint:	YES
Remarks:

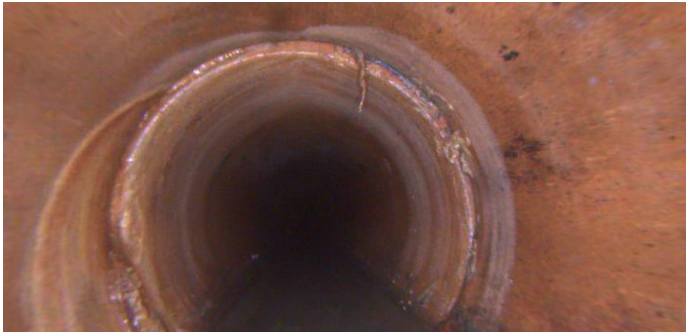
Code: **IW**
Description: **Infil Weeper**

Distance (ft): **5.5**
Structural Grade: **0**
O&M Grade: **2**
Clock Start/From: **8**
Clock To: **4**
1st Value:
2nd Value:
Value Percent:
Continuous Index:
Within 8" of Joint: **YES**
Remarks:

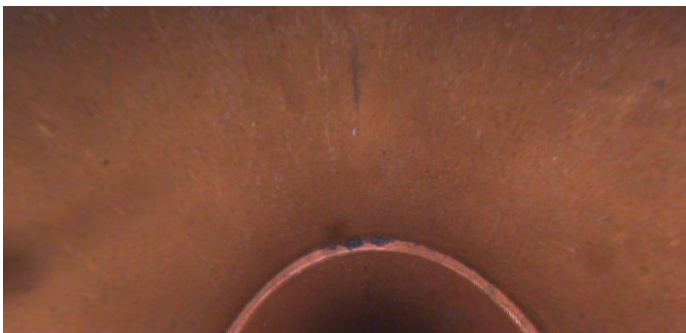
Code: **RFJ**
Description: **Roots Fine Joint**

Distance (ft): **84.9**
Structural Grade: **0**
O&M Grade: **1**
Clock Start/From: **12**
Clock To:
1st Value:
2nd Value:
Value Percent:
Continuous Index:
Within 8" of Joint: **YES**
Remarks:

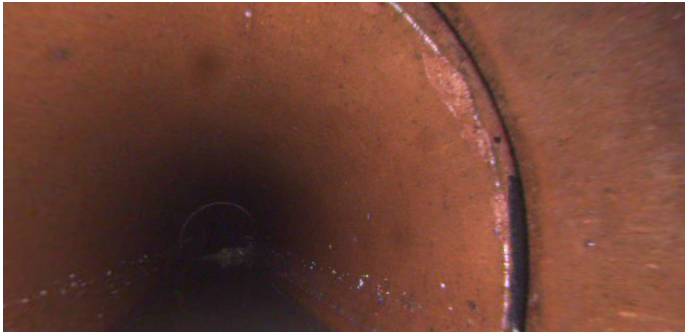
Code: **SSS**
Description: **Surface Spalling**

Distance (ft): **89.6**
Structural Grade: **2**
O&M Grade: **0**
Clock Start/From: **2**
Clock To: **3**
1st Value:
2nd Value:
Value Percent:
Continuous Index:
Within 8" of Joint: **YES**
Remarks:

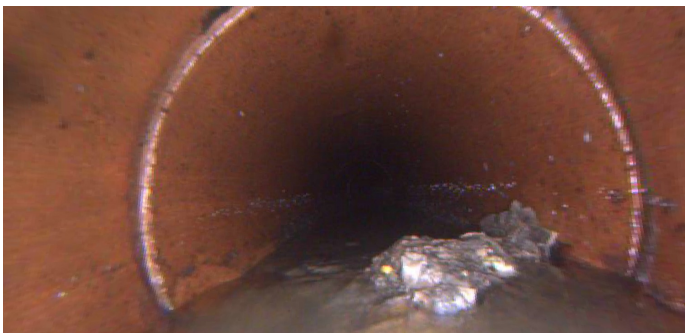
Code: **DSZ**
Description: **Deposits Settled Other**

Distance (ft): **93.4**
Structural Grade: **0**
O&M Grade: **3**
Clock Start/From: **4**
Clock To: **6**
1st Value:
2nd Value:
Value Percent: **15.000**
Continuous Index:
Within 8" of Joint: **YES**
Remarks: **mixed material**

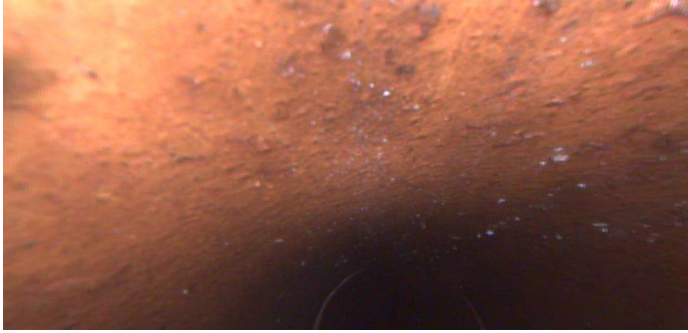
Code:	MSA
Description:	Abandoned Survey
Distance (ft):	100.5
Structural Grade:	0
O&M Grade:	0
Clock Start/From:	
Clock To:	
1st Value:	
2nd Value:	
Value Percent:	
Continuous Index:	
Within 8" of Joint:	NO
Remarks:	camera stopped
