Profile/Photo Observation Report

Street:	E 40TH AVE & N JOLIET ST	Flow Control:	Not Controlled
City:	Hobart, IN	Year Renewed:	
Location:	Other	Tape/Media #:	
Purpose:	Not Known	Dia/Height:	10"
Use:	Sanitary	Material:	VCP
Drain Area:	NA	Lining:	
Category:	NA		
Comment:

Location Details:		Direction of Survey:	Upstream
US MH:	M-803-021	DS MH:	M-803-020
		Total Length Surveyed (ft):	57.2

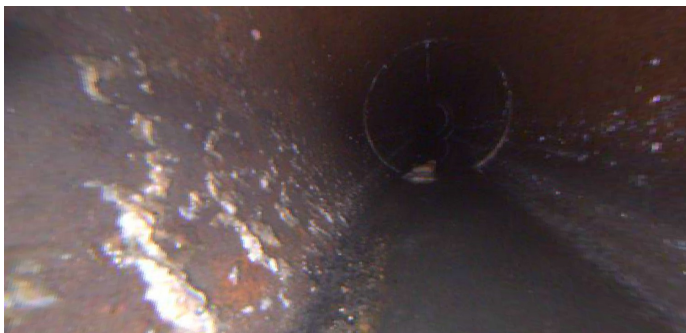
Code: **AMH**
Description: **Manhole**

Distance (ft): **.0**
Structural Grade: **0**
O&M Grade: **0**
Clock Start/From:
Clock To:
1st Value:
2nd Value:
Value Percent:
Continuous Index:
Within 8" of Joint: **NO**
Remarks: **M-803-020**

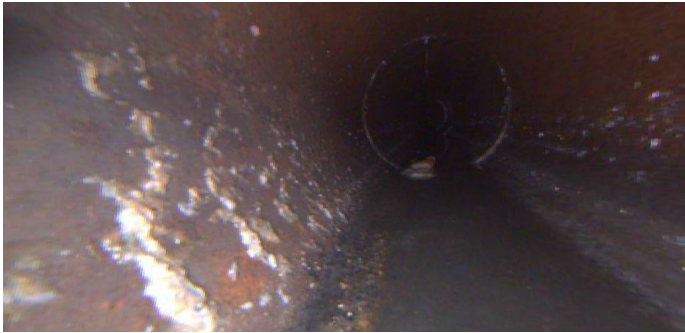
Code:	MWL
Description:	Water Level

Distance (ft):	.0
Structural Grade:	0
O&M Grade:	0
Clock Start/From:	
Clock To:	
1st Value:	
2nd Value:	
Value Percent:	5.000
Continuous Index:	
Within 8" of Joint:	NO
Remarks:

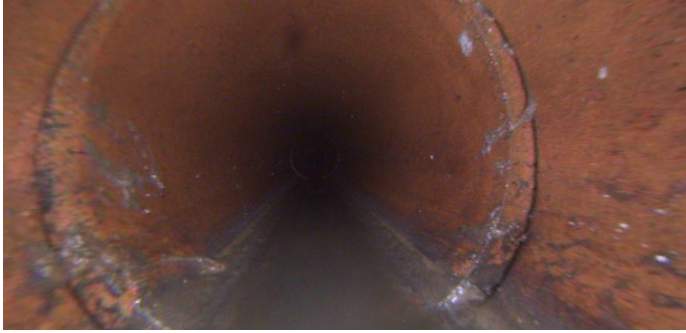
Code: **RFJ**
Description: **Roots Fine Joint**

Distance (ft): **12.9**
Structural Grade: **0**
O&M Grade: **1**
Clock Start/From: **8**
Clock To: **4**
1st Value:
2nd Value:
Value Percent:
Continuous Index: **S01**
Within 8" of Joint: **YES**
Remarks:

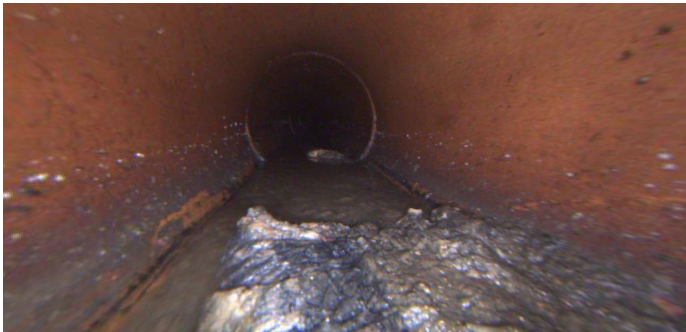
Code: **OBZ**
Description: **Obstacle Other**

Distance (ft): **55.5**
Structural Grade: **0**
O&M Grade: **3**
Clock Start/From: **4**
Clock To: **6**
1st Value:
2nd Value:
Value Percent: **20.000**
Continuous Index:
Within 8" of Joint: **NO**
Remarks: **MISC**

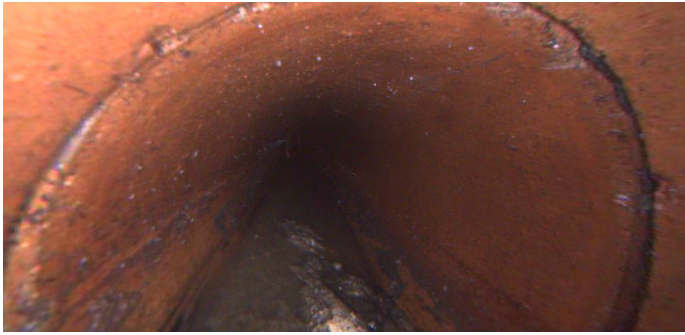
Code: **RFJ**
Description: **Roots Fine Joint**

Distance (ft): **57.2**
Structural Grade: **0**
O&M Grade: **1**
Clock Start/From: **8**
Clock To: **4**
1st Value:
2nd Value:
Value Percent:
Continuous Index: **F01**
Within 8" of Joint: **YES**
Remarks:

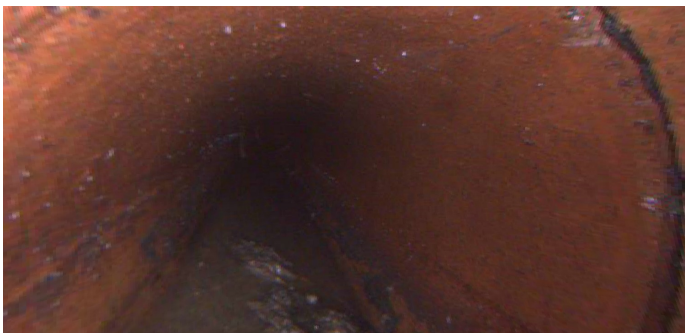
Code: **MSA**
Description: **Abandoned Survey**

Distance (ft): **57.2**
Structural Grade: **0**
O&M Grade: **0**
Clock Start/From:
Clock To:
1st Value:
2nd Value:
Value Percent:
Continuous Index:
Within 8" of Joint: **NO**
Remarks: **DEBRIS**
