Profile/Photo Observation Report

Date:	03/28/2018	Weather:		Coding:	PACP 6.0
Pipe Length (ft):	163.7	Owner:	NA	Pre Clean:	Not Known
P.O.#:		Surveyor:	Selasie Honu	PSR:	P-803-020-021
Customer:		Clean Date:	01/01/1900	Shape:	C

Street:	E 40TH AV	Flow Control:	Not Controlled
City:	Hobart, IN	Year Renewed:	
Location:	Other	Tape/Media #:	
Purpose:	Not Known	Dia/Height:	10"
Use:	Sanitary	Material:	VCP
Drain Area:	NA	Lining:	
Category:	NA		
Comment:

Location Details:		Direction of Survey:	Upstream
US MH:	M-803-021	DS MH:	M-803-020
		Total Length Surveyed (ft):	57.2

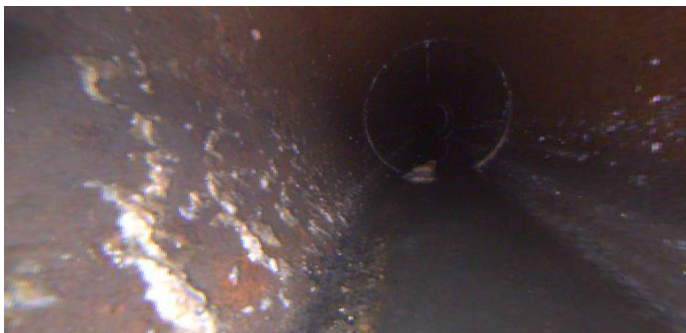
Code: **AMH**
Description: **Manhole**

Distance (ft): **.0**
Structural Grade: **0**
O&M Grade: **0**
Clock Start/From:
Clock To:
1st Value:
2nd Value:
Value Percent:
Continuous Index:
Within 8" of Joint: **NO**
Remarks: **M-803-020**

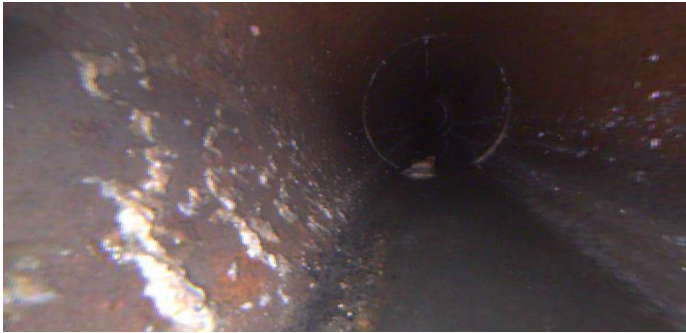
Code:	MWL
Description:	Water Level

Distance (ft):	.0
Structural Grade:	0
O&M Grade:	0
Clock Start/From:	
Clock To:	
1st Value:	
2nd Value:	
Value Percent:	5.000
Continuous Index:	
Within 8" of Joint:	NO
Remarks:

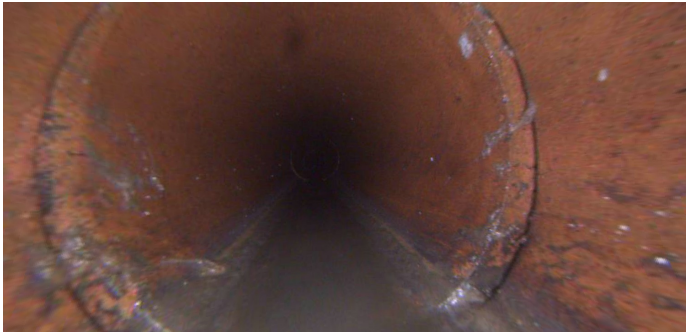
Code: **RFJ**
Description: **Roots Fine Joint**

Distance (ft): **12.9**
Structural Grade: **0**
O&M Grade: **1**
Clock Start/From: **8**
Clock To: **4**
1st Value:
2nd Value:
Value Percent:
Continuous Index: **S01**
Within 8" of Joint: **YES**
Remarks:

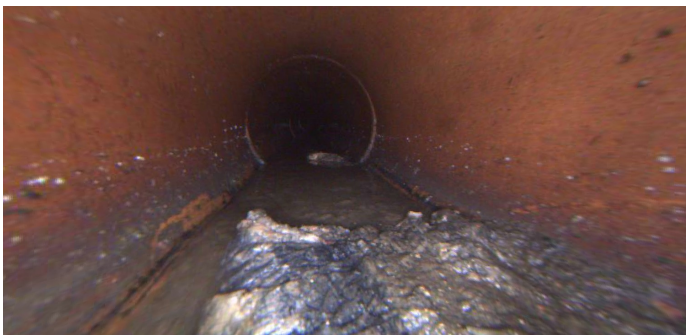
Code: **OBZ**
Description: **Obstacle Other**

Distance (ft): **55.5**
Structural Grade: **0**
O&M Grade: **3**
Clock Start/From: **4**
Clock To: **6**
1st Value:
2nd Value:
Value Percent: **20.000**
Continuous Index:
Within 8" of Joint: **NO**
Remarks: **MISC**

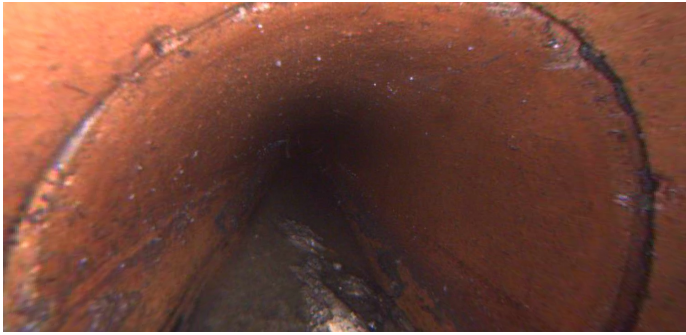
Code: **RFJ**
Description: **Roots Fine Joint**

Distance (ft): **57.2**
Structural Grade: **0**
O&M Grade: **1**
Clock Start/From: **8**
Clock To: **4**
1st Value:
2nd Value:
Value Percent:
Continuous Index: **F01**
Within 8" of Joint: **YES**
Remarks:

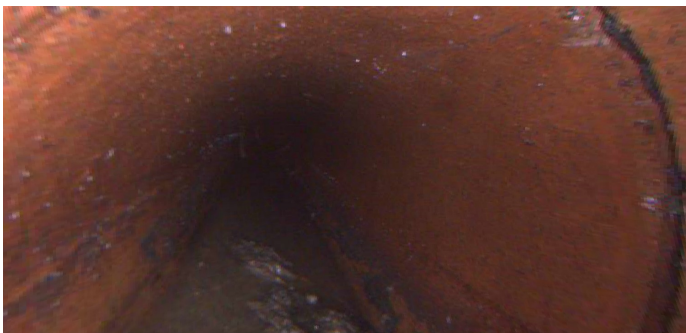
Code: **MSA**
Description: **Abandoned Survey**

Distance (ft): **57.2**
Structural Grade: **0**
O&M Grade: **0**
Clock Start/From:
Clock To:
1st Value:
2nd Value:
Value Percent:
Continuous Index:
Within 8" of Joint: **NO**
Remarks: **DEBRIS**
