Profile/Photo Observation Report

Date:	03/28/2018	Weather:		Coding:	PACP 6.0
Pipe Length (ft):	275.4	Owner:	NA	Pre Clean:	Not Known
P.O.#:		Surveyor:	Selasie Honu	PSR:	P-803-022-021
Customer:		Clean Date:	01/01/1900	Shape:	C

Street:	E 40TH AVE & N JOLIET ST	Flow Control:	Not Controlled
City:	Hobart, IN	Year Renewed:	
Location:	Other	Tape/Media #:	
Purpose:	Not Known	Dia/Height:	10"
Use:	Sanitary	Material:	VCP
Drain Area:	NA	Lining:	
Category:	NA		
Comment:

Location Details:		Direction of Survey:	Upstream
US MH:	M-803-022	DS MH:	M-803-021
		Total Length Surveyed (ft):	267.4

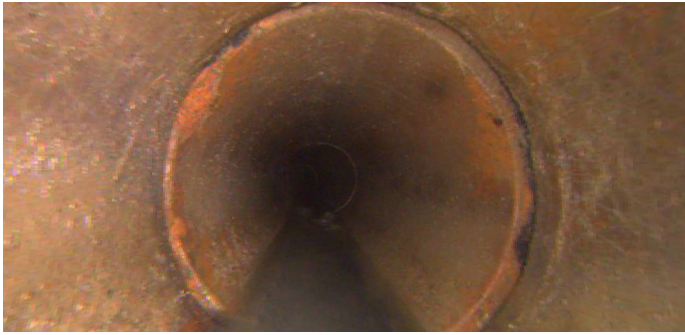
Code: **AMH**
Description: **Manhole**

Distance (ft): **.0**
Structural Grade: **0**
O&M Grade: **0**
Clock Start/From:
Clock To:
1st Value:
2nd Value:
Value Percent:
Continuous Index:
Within 8" of Joint: **NO**
Remarks: **M-803-021**

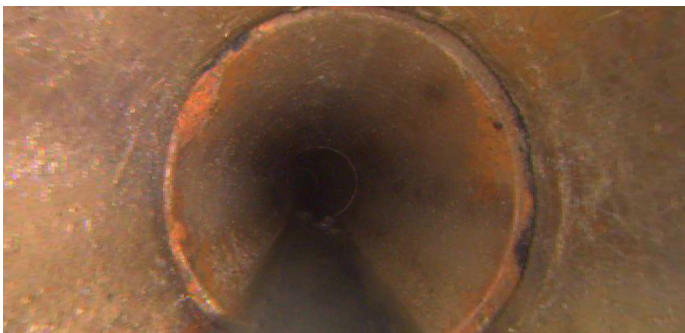
Code: **MWL**
Description: **Water Level**

Distance (ft): **.0**
Structural Grade: **0**
O&M Grade: **0**
Clock Start/From:
Clock To:
1st Value:
2nd Value:
Value Percent: **5.000**
Continuous Index:
Within 8" of Joint: **NO**
Remarks:

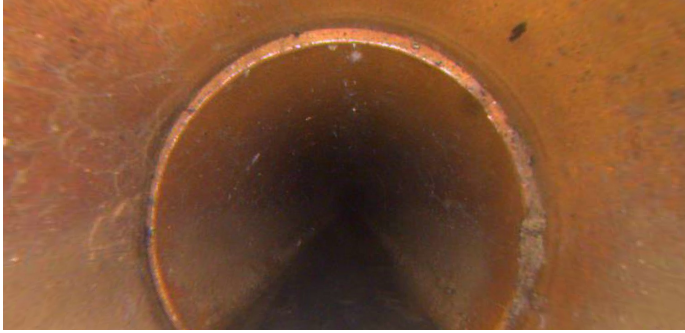
Code: **CM**
Description: **Crack Multiple**

Distance (ft): **9.9**
Structural Grade: **3**
O&M Grade: **0**
Clock Start/From: **9**
Clock To: **10**
1st Value:
2nd Value:
Value Percent:
Continuous Index:
Within 8" of Joint: **YES**
Remarks:

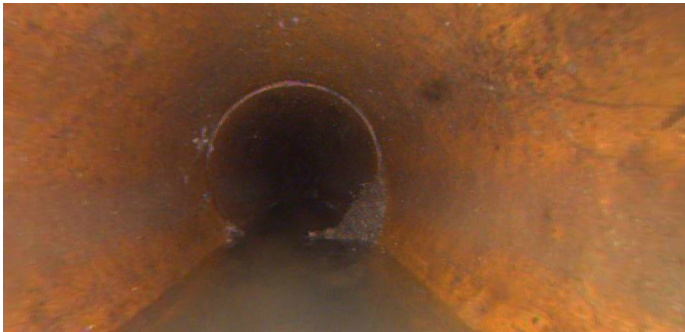
Code: **RMJ**
Description: **Roots Medium Joint**

Distance (ft): **20.7**
Structural Grade: **0**
O&M Grade: **3**
Clock Start/From: **7**
Clock To: **6**
1st Value:
2nd Value:
Value Percent: **15.000**
Continuous Index: **S01**
Within 8" of Joint: **YES**
Remarks:

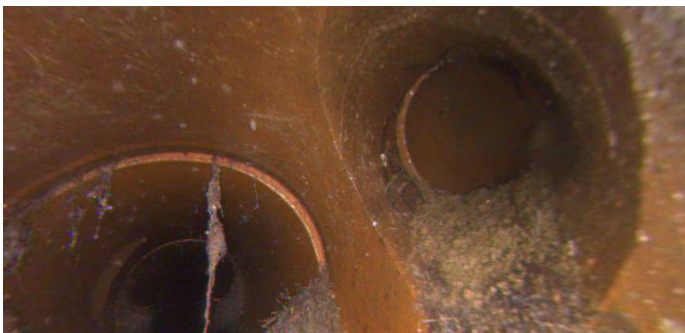
Code: **TFD**
Description: **Tap Factory Defective**

Distance (ft): **31.2**
Structural Grade: **0**
O&M Grade: **2**
Clock Start/From: **3**
Clock To:
1st Value: **4.000**
2nd Value:
Value Percent:
Continuous Index:
Within 8" of Joint:
Remarks: **roots**

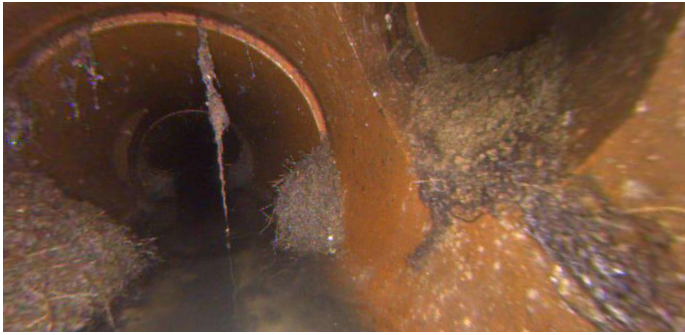
Code: **RFL**
Description: **Roots Fine Lateral**

Distance (ft): **31.2**
Structural Grade: **0**
O&M Grade: **1**
Clock Start/From: **3**
Clock To:
1st Value:
2nd Value:
Value Percent:
Continuous Index:
Within 8" of Joint: **NO**
Remarks:

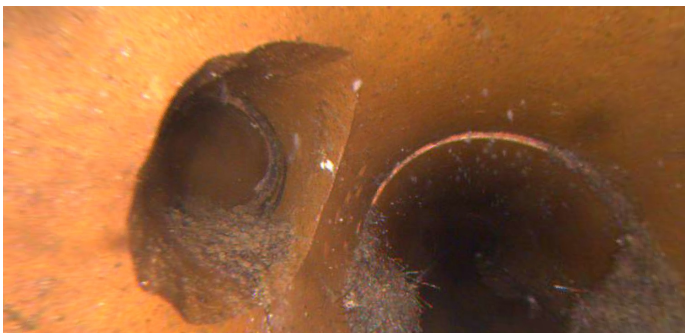
Code: **TFD**
Description: **Tap Factory Defective**

Distance (ft): **33.2**
Structural Grade: **0**
O&M Grade: **2**
Clock Start/From: **9**
Clock To:
1st Value: **4.000**
2nd Value:
Value Percent:
Continuous Index:
Within 8" of Joint:
Remarks: **roots**

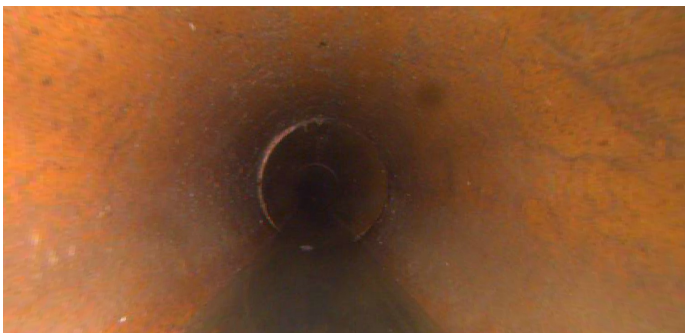
Code: **RMJ**
Description: **Roots Medium Joint**

Distance (ft): **76.2**
Structural Grade: **0**
O&M Grade: **3**
Clock Start/From: **7**
Clock To: **6**
1st Value:
2nd Value:
Value Percent: **15.000**
Continuous Index: **F01**
Within 8" of Joint: **YES**
Remarks:

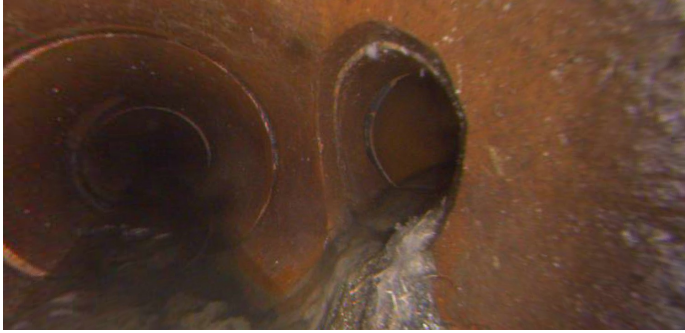
Code: **TFD**
Description: **Tap Factory Defective**

Distance (ft): **95.0**
Structural Grade: **0**
O&M Grade: **2**
Clock Start/From: **3**
Clock To:
1st Value: **4.000**
2nd Value:
Value Percent:
Continuous Index:
Within 8" of Joint:
Remarks: **roots**

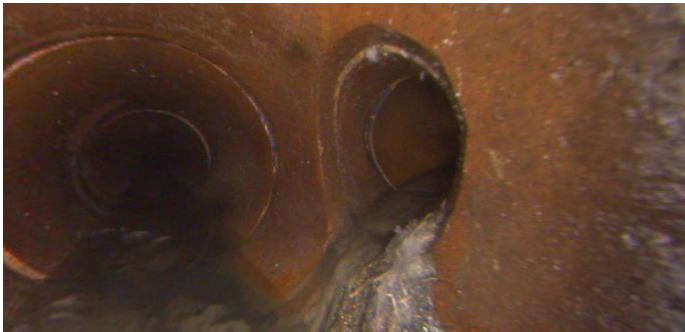
Code: **RML**
Description: **Roots Medium Lateral**

Distance (ft): **95.0**
Structural Grade: **0**
O&M Grade: **3**
Clock Start/From: **3**
Clock To:
1st Value:
2nd Value:
Value Percent: **5.000**
Continuous Index:
Within 8" of Joint: **NO**
Remarks:

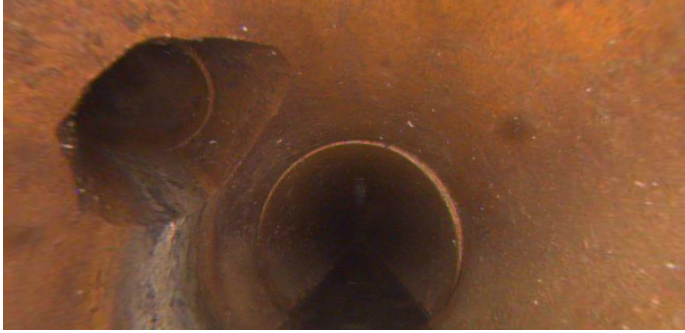
Code: **TF**
Description: **Tap Factory**

Distance (ft): **96.9**
Structural Grade: **0**
O&M Grade: **0**
Clock Start/From: **10**
Clock To:
1st Value: **4.000**
2nd Value:
Value Percent:
Continuous Index:
Within 8" of Joint:
Remarks:

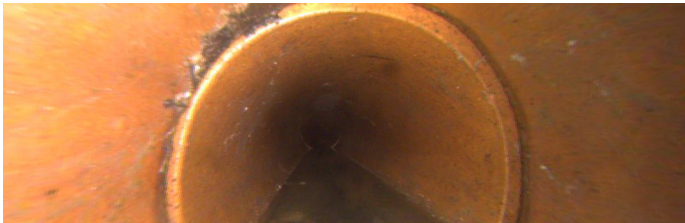
Code: **RFJ**
Description: **Roots Fine Joint**

Distance (ft): **113.9**
Structural Grade: **0**
O&M Grade: **1**
Clock Start/From: **7**
Clock To: **5**
1st Value:
2nd Value:
Value Percent:
Continuous Index: **S03**
Within 8" of Joint: **YES**
Remarks:

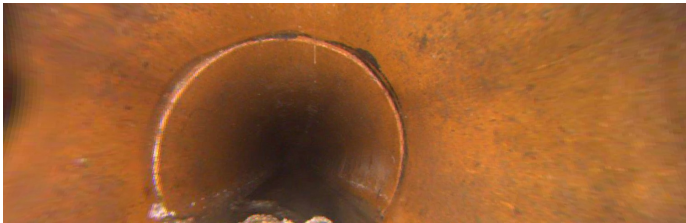
Code: **RFJ**
Description: **Roots Fine Joint**

Distance (ft): **133.4**
Structural Grade: **0**
O&M Grade: **1**
Clock Start/From: **7**
Clock To: **5**
1st Value:
2nd Value:
Value Percent:
Continuous Index: **F03**
Within 8" of Joint: **YES**
Remarks:

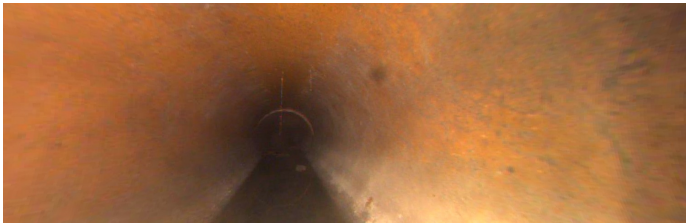
Code: **RFB**
Description: **Roots Fine Barrel**

Distance (ft): **158.8**
Structural Grade: **0**
O&M Grade: **2**
Clock Start/From: **12**
Clock To:
1st Value:
2nd Value:
Value Percent:
Continuous Index:
Within 8" of Joint: **NO**
Remarks:

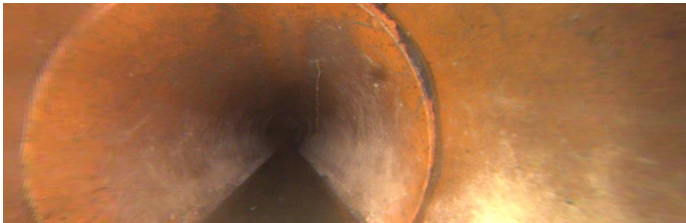
Code: **RFB**
Description: **Roots Fine Barrel**

Distance (ft): **169.8**
Structural Grade: **0**
O&M Grade: **2**
Clock Start/From: **1**
Clock To:
1st Value:
2nd Value:
Value Percent:
Continuous Index:
Within 8" of Joint: **NO**
Remarks:

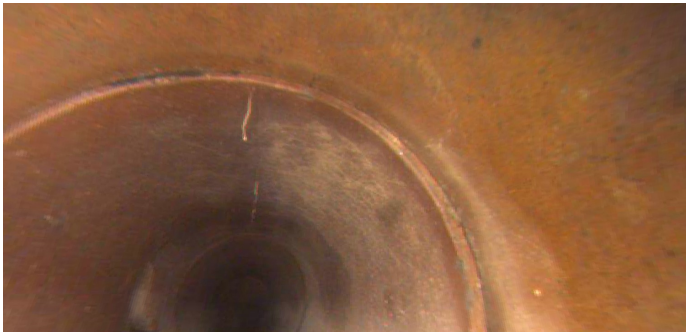
Code: **RFB**
Description: **Roots Fine Barrel**

Distance (ft): **175.8**
Structural Grade: **0**
O&M Grade: **2**
Clock Start/From: **12**
Clock To:
1st Value:
2nd Value:
Value Percent:
Continuous Index:
Within 8" of Joint: **NO**
Remarks:

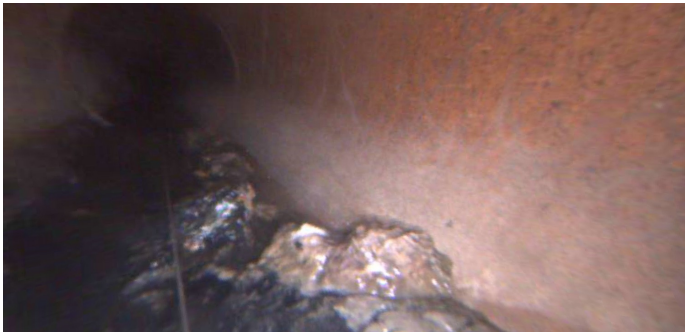
Code: **OBR**
Description: **Obstacle Rocks**

Distance (ft): **184.9**
Structural Grade: **0**
O&M Grade: **2**
Clock Start/From: **6**
Clock To: **7**
1st Value:
2nd Value:
Value Percent: **10.000**
Continuous Index:
Within 8" of Joint: **NO**
Remarks:

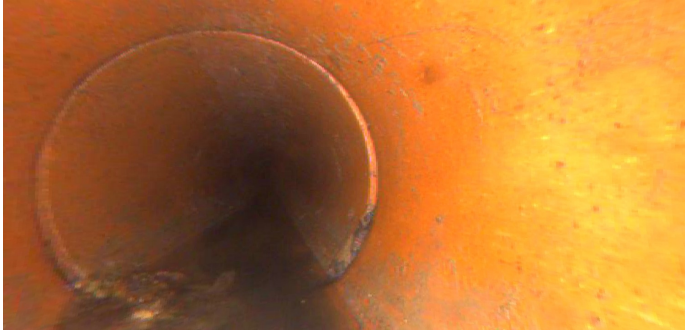
Code: **RFJ**
Description: **Roots Fine Joint**

Distance (ft): **193.5**
Structural Grade: **0**
O&M Grade: **1**
Clock Start/From: **4**
Clock To: **5**
1st Value:
2nd Value:
Value Percent:
Continuous Index:
Within 8" of Joint: **YES**
Remarks:

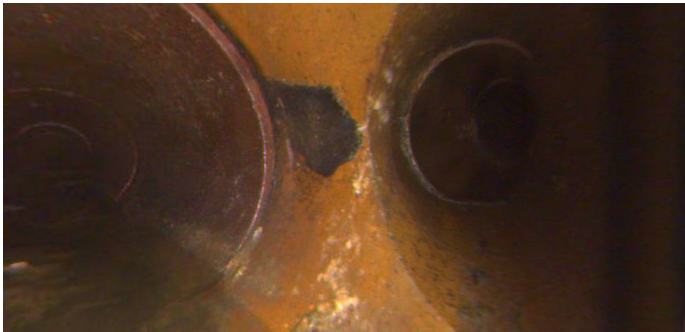
Code: **TF**
Description: **Tap Factory**

Distance (ft): **251.8**
Structural Grade: **0**
O&M Grade: **0**
Clock Start/From: **3**
Clock To:
1st Value: **4.000**
2nd Value:
Value Percent:
Continuous Index:
Within 8" of Joint:
Remarks:

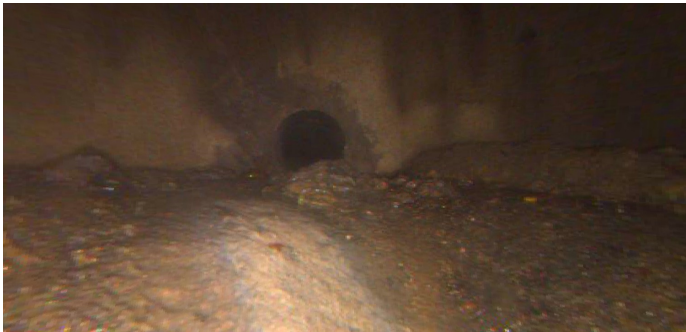
Code: **AMH**
Description: **Manhole**

Distance (ft): **267.4**
Structural Grade: **0**
O&M Grade: **0**
Clock Start/From:
Clock To:
1st Value:
2nd Value:
Value Percent:
Continuous Index:
Within 8" of Joint: **NO**
Remarks: **M-803-022**
