## Profile/Photo Observation Report

Street:	<b>E 40TH AV</b>	Flow Control:	<b>Not Controlled</b>
City:	<b>Hobart, IN</b>	Year Renewed:	
Location:	<b>Other</b>	Tape/Media #:	
Purpose:	<b>Not Known</b>	Dia/Height:	<b>10"</b>
Use:	<b>Sanitary</b>	Material:	<b>VCP</b>
Drain Area:	<b>NA</b>	Lining:	
Category:	<b>NA</b>		
Comment:

Location Details:		Direction of Survey:	<b>Upstream</b>
US MH:	<b>M-803-022</b>	DS MH:	<b>M-803-021</b>
		Total Length Surveyed (ft):	<b>267.4</b>

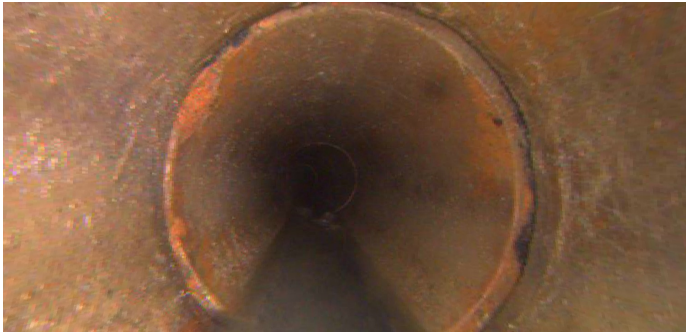
Code: **AMH**  
Description: **Manhole**

Distance (ft): **.0**  
Structural Grade: **0**  
O&M Grade: **0**  
Clock Start/From:  
Clock To:  
1st Value:  
2nd Value:  
Value Percent:  
Continuous Index:  
Within 8" of Joint: **NO**  
Remarks: **M-803-021**

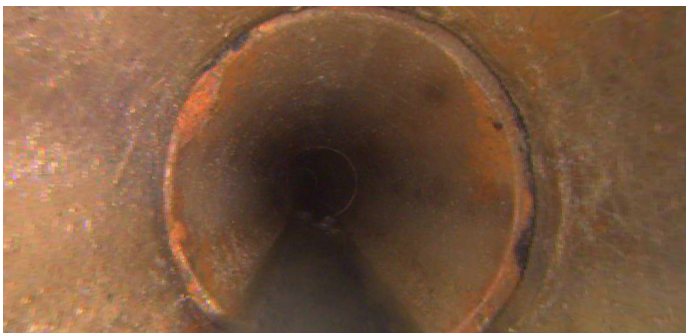
Code: **MWL**  
Description: **Water Level**

Distance (ft): **.0**  
Structural Grade: **0**  
O&M Grade: **0**  
Clock Start/From:  
Clock To:  
1st Value:  
2nd Value:  
Value Percent: **5.000**  
Continuous Index:  
Within 8" of Joint: **NO**  
Remarks:

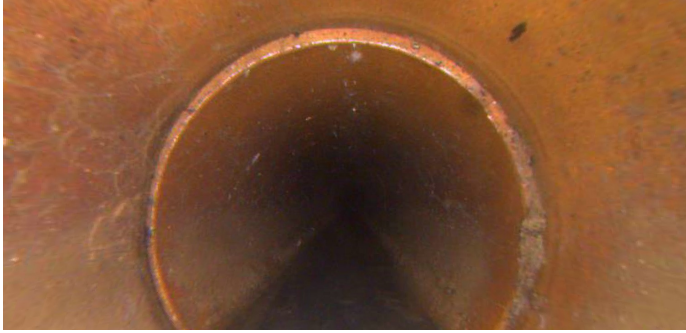
Code: **CM**  
Description: **Crack Multiple**

Distance (ft): **9.9**  
Structural Grade: **3**  
O&M Grade: **0**  
Clock Start/From: **9**  
Clock To: **10**  
1st Value:  
2nd Value:  
Value Percent:  
Continuous Index:  
Within 8" of Joint: **YES**  
Remarks:

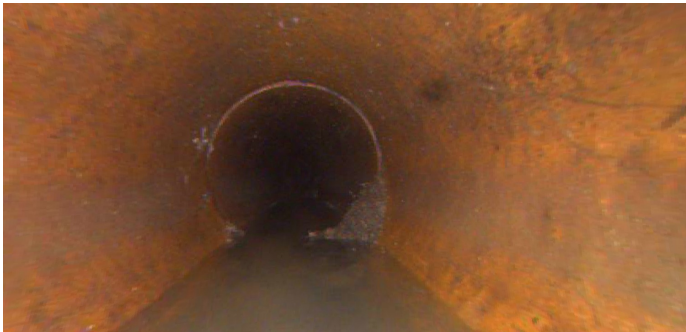
Code: **RMJ**  
Description: **Roots Medium Joint**

Distance (ft): **20.7**  
Structural Grade: **0**  
O&M Grade: **3**  
Clock Start/From: **7**  
Clock To: **6**  
1st Value:  
2nd Value:  
Value Percent: **15.000**  
Continuous Index: **S01**  
Within 8" of Joint: **YES**  
Remarks:

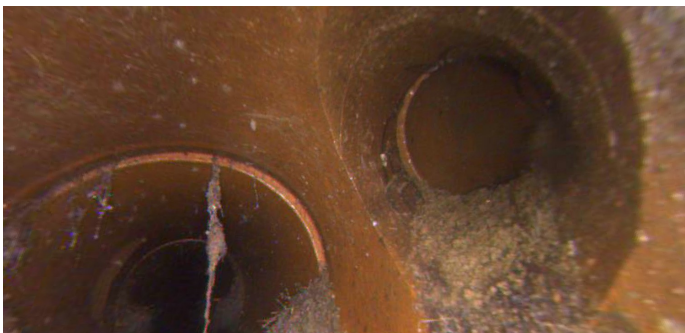
Code: **TFD**  
Description: **Tap Factory Defective**

Distance (ft): **31.2**  
Structural Grade: **0**  
O&M Grade: **2**  
Clock Start/From: **3**  
Clock To:  
1st Value: **4.000**  
2nd Value:  
Value Percent:  
Continuous Index:  
Within 8" of Joint:  
Remarks: **roots**

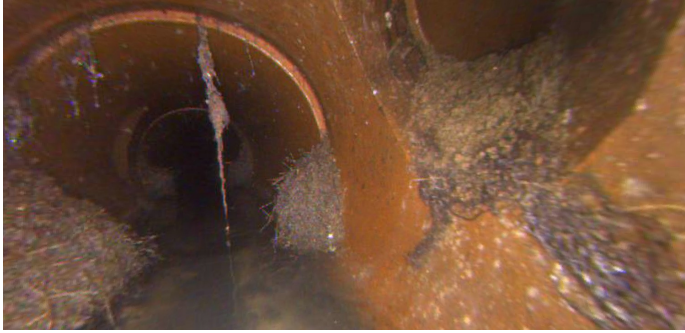
Code: **RFL**  
Description: **Roots Fine Lateral**

Distance (ft): **31.2**  
Structural Grade: **0**  
O&M Grade: **1**  
Clock Start/From: **3**  
Clock To:  
1st Value:  
2nd Value:  
Value Percent:  
Continuous Index:  
Within 8" of Joint: **NO**  
Remarks:

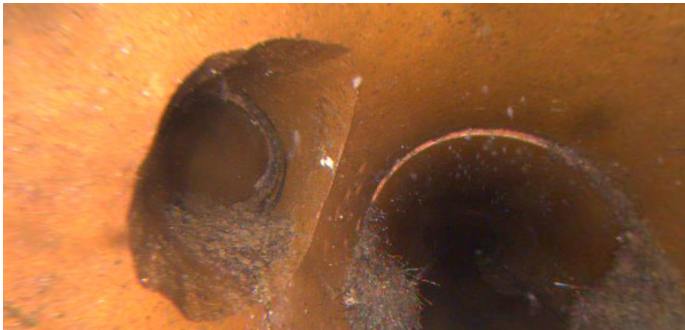
Code: **TFD**  
Description: **Tap Factory Defective**

Distance (ft): **33.2**  
Structural Grade: **0**  
O&M Grade: **2**  
Clock Start/From: **9**  
Clock To:  
1st Value: **4.000**  
2nd Value:  
Value Percent:  
Continuous Index:  
Within 8" of Joint:  
Remarks: **roots**

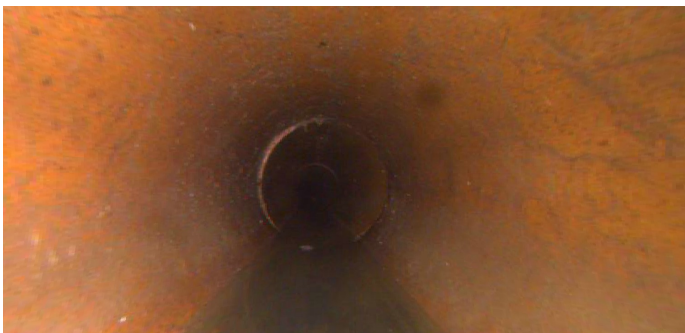
Code: **RMJ**  
Description: **Roots Medium Joint**

Distance (ft): **76.2**  
Structural Grade: **0**  
O&M Grade: **3**  
Clock Start/From: **7**  
Clock To: **6**  
1st Value:  
2nd Value:  
Value Percent: **15.000**  
Continuous Index: **F01**  
Within 8" of Joint: **YES**  
Remarks:

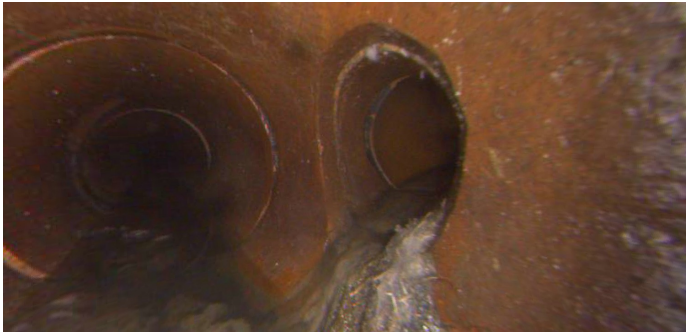
Code: **TFD**  
Description: **Tap Factory Defective**

Distance (ft): **95.0**  
Structural Grade: **0**  
O&M Grade: **2**  
Clock Start/From: **3**  
Clock To:  
1st Value: **4.000**  
2nd Value:  
Value Percent:  
Continuous Index:  
Within 8" of Joint:  
Remarks: **roots**

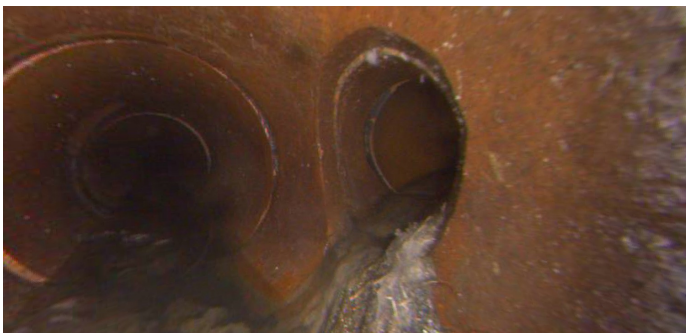
Code: **RML**  
Description: **Roots Medium Lateral**

Distance (ft): **95.0**  
Structural Grade: **0**  
O&M Grade: **3**  
Clock Start/From: **3**  
Clock To:  
1st Value:  
2nd Value:  
Value Percent: **5.000**  
Continuous Index:  
Within 8" of Joint: **NO**  
Remarks:

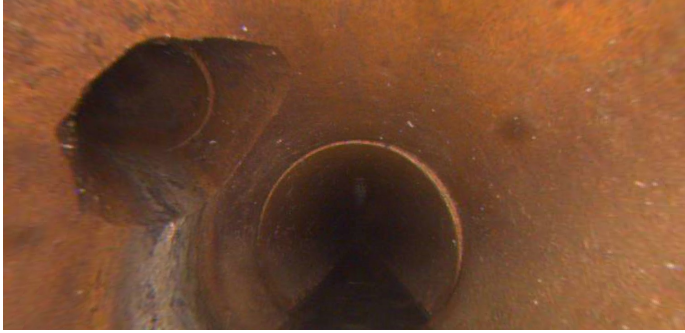
Code: **TF**  
Description: **Tap Factory**

Distance (ft): **96.9**  
Structural Grade: **0**  
O&M Grade: **0**  
Clock Start/From: **10**  
Clock To:  
1st Value: **4.000**  
2nd Value:  
Value Percent:  
Continuous Index:  
Within 8" of Joint:  
Remarks:

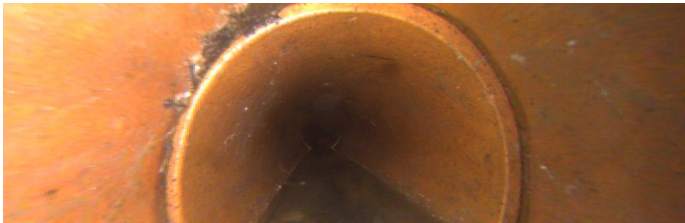
Code: **RFJ**  
Description: **Roots Fine Joint**

Distance (ft): **113.9**  
Structural Grade: **0**  
O&M Grade: **1**  
Clock Start/From: **7**  
Clock To: **5**  
1st Value:  
2nd Value:  
Value Percent:  
Continuous Index: **S03**  
Within 8" of Joint: **YES**  
Remarks:

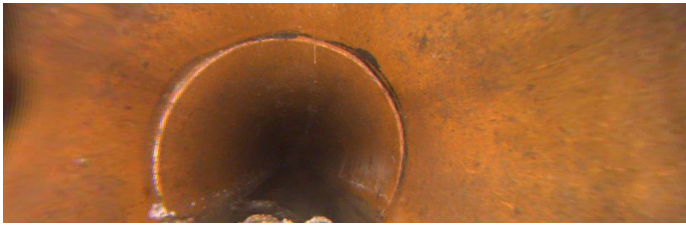
Code: **RFJ**  
Description: **Roots Fine Joint**

Distance (ft): **133.4**  
Structural Grade: **0**  
O&M Grade: **1**  
Clock Start/From: **7**  
Clock To: **5**  
1st Value:  
2nd Value:  
Value Percent:  
Continuous Index: **F03**  
Within 8" of Joint: **YES**  
Remarks:

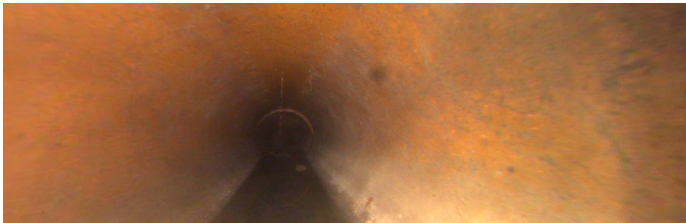
Code: **RFB**  
Description: **Roots Fine Barrel**

Distance (ft): **158.8**  
Structural Grade: **0**  
O&M Grade: **2**  
Clock Start/From: **12**  
Clock To:  
1st Value:  
2nd Value:  
Value Percent:  
Continuous Index:  
Within 8" of Joint: **NO**  
Remarks:

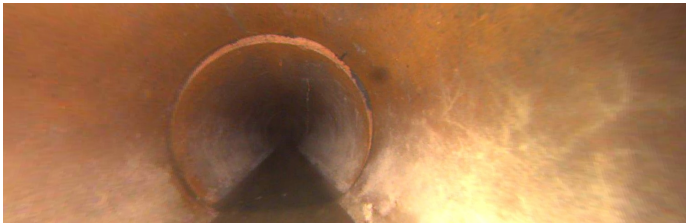
Code: **RFJ**  
Description: **Roots Fine Joint**

Distance (ft): **169.4**  
Structural Grade: **0**  
O&M Grade: **1**  
Clock Start/From: **11**  
Clock To: **3**  
1st Value:  
2nd Value:  
Value Percent:  
Continuous Index:  
Within 8" of Joint: **YES**  
Remarks:

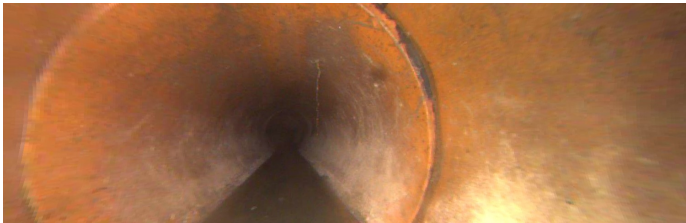
Code: **RFB**  
Description: **Roots Fine Barrel**

Distance (ft): **169.8**  
Structural Grade: **0**  
O&M Grade: **2**  
Clock Start/From: **1**  
Clock To:  
1st Value:  
2nd Value:  
Value Percent:  
Continuous Index:  
Within 8" of Joint: **NO**  
Remarks:

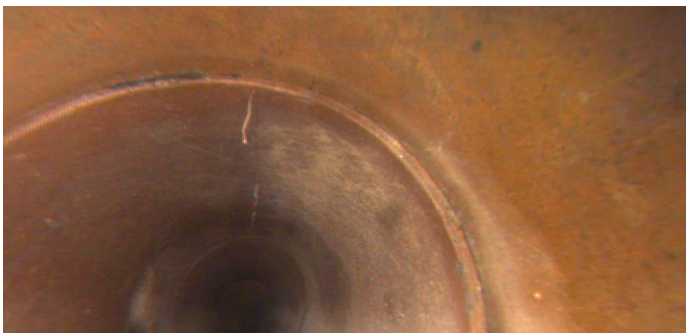
Code: **RFB**  
Description: **Roots Fine Barrel**

Distance (ft): **175.8**  
Structural Grade: **0**  
O&M Grade: **2**  
Clock Start/From: **12**  
Clock To:  
1st Value:  
2nd Value:  
Value Percent:  
Continuous Index:  
Within 8" of Joint: **NO**  
Remarks:

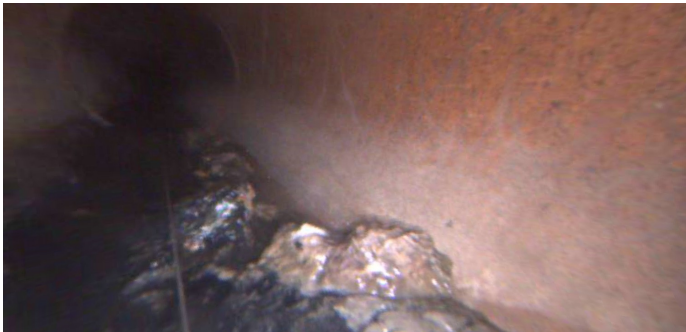
Code: **OBR**  
Description: **Obstacle Rocks**

Distance (ft): **184.9**  
Structural Grade: **0**  
O&M Grade: **2**  
Clock Start/From: **6**  
Clock To: **7**  
1st Value:  
2nd Value:  
Value Percent: **10.000**  
Continuous Index:  
Within 8" of Joint: **NO**  
Remarks:

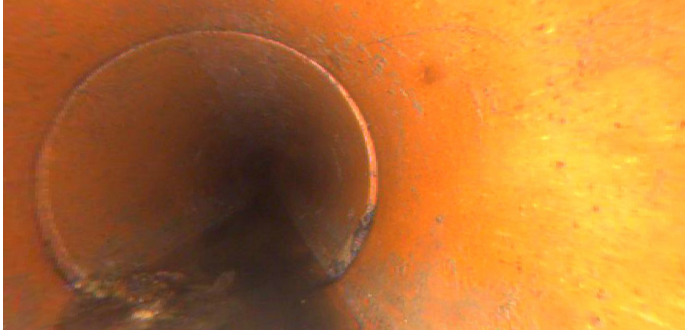
Code: **RFJ**  
Description: **Roots Fine Joint**

Distance (ft): **193.5**  
Structural Grade: **0**  
O&M Grade: **1**  
Clock Start/From: **4**  
Clock To: **5**  
1st Value:  
2nd Value:  
Value Percent:  
Continuous Index:  
Within 8" of Joint: **YES**  
Remarks:

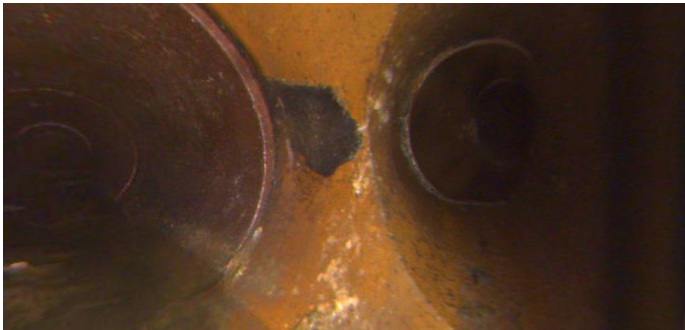
Code: **TF**  
Description: **Tap Factory**

Distance (ft): **251.8**  
Structural Grade: **0**  
O&M Grade: **0**  
Clock Start/From: **3**  
Clock To:  
1st Value: **4.000**  
2nd Value:  
Value Percent:  
Continuous Index:  
Within 8" of Joint:  
Remarks:

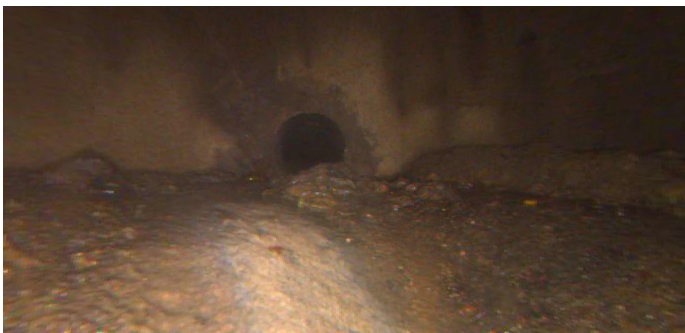
Code: **AMH**  
Description: **Manhole**

Distance (ft): **267.4**  
Structural Grade: **0**  
O&M Grade: **0**  
Clock Start/From:  
Clock To:  
1st Value:  
2nd Value:  
Value Percent:  
Continuous Index:  
Within 8" of Joint: **NO**  
Remarks: **M-803-022**
