Profile/Photo Observation Report

Street:	E 40TH AVE	Flow Control:	Not Controlled
City:	Hobart, IN	Year Renewed:	
Location:	Other	Tape/Media #:	
Purpose:	Not Known	Dia/Height:	10"
Use:	Sanitary	Material:	VCP
Drain Area:	NA	Lining:	
Category:	NA		
Comment:

Location Details:		Direction of Survey:	Downstream
US MH:	M-803-023	DS MH:	M-803-024
		Total Length Surveyed (ft):	293.6

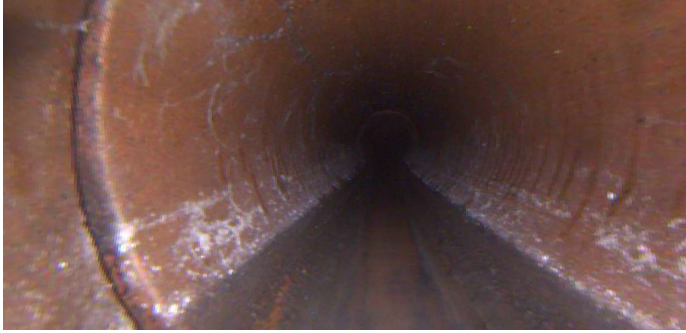
Code: **AMH**
Description: **Manhole**

Distance (ft): **.0**
Structural Grade: **0**
O&M Grade: **0**
Clock Start/From:
Clock To:
1st Value:
2nd Value:
Value Percent:
Continuous Index:
Within 8" of Joint: **NO**
Remarks: **M-803-023**

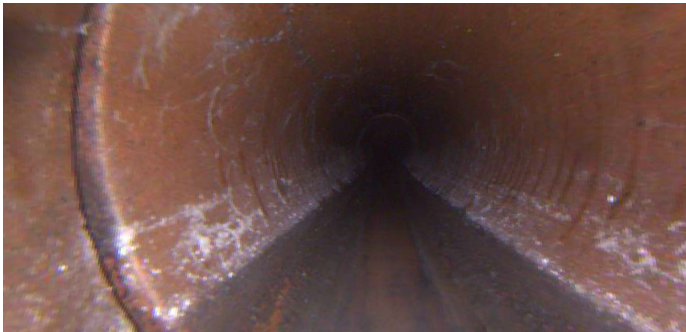
Code: **MWL**
Description: **Water Level**

Distance (ft): **.0**
Structural Grade: **0**
O&M Grade: **0**
Clock Start/From:
Clock To:
1st Value:
2nd Value:
Value Percent: **5.000**
Continuous Index:
Within 8" of Joint: **NO**
Remarks:

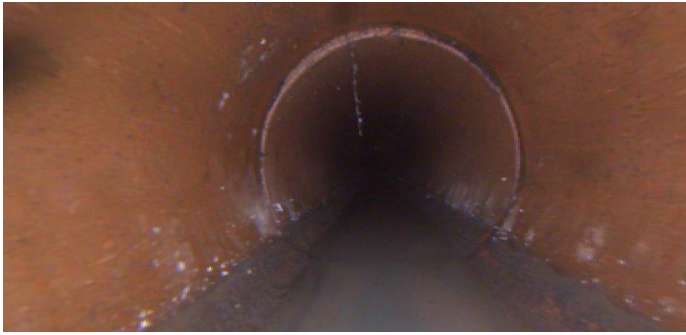
Code: **RFJ**
Description: **Roots Fine Joint**

Distance (ft): **8.7**
Structural Grade: **0**
O&M Grade: **1**
Clock Start/From: **7**
Clock To: **5**
1st Value:
2nd Value:
Value Percent:
Continuous Index:
Within 8" of Joint: **YES**
Remarks:

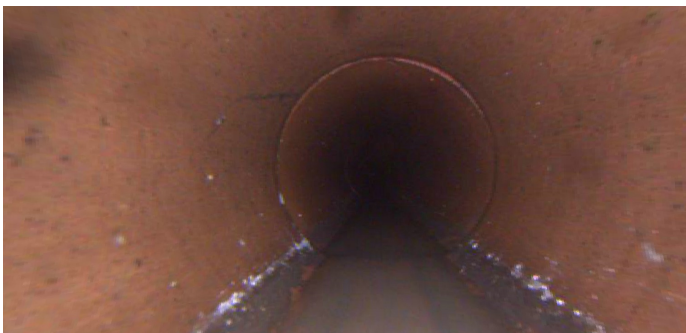
Code: **FL**
Description: **Fracture Longitudinal**

Distance (ft): **12.4**
Structural Grade: **3**
O&M Grade: **0**
Clock Start/From: **10**
Clock To:
1st Value:
2nd Value:
Value Percent:
Continuous Index:
Within 8" of Joint:
Remarks:

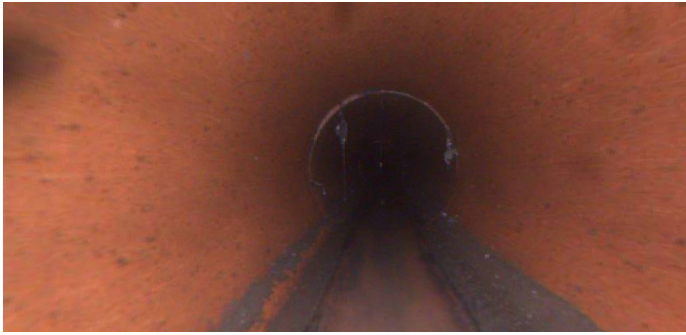
Code: **RFJ**
Description: **Roots Fine Joint**

Distance (ft): **18.7**
Structural Grade: **0**
O&M Grade: **1**
Clock Start/From: **7**
Clock To: **5**
1st Value:
2nd Value:
Value Percent:
Continuous Index:
Within 8" of Joint: **YES**
Remarks:

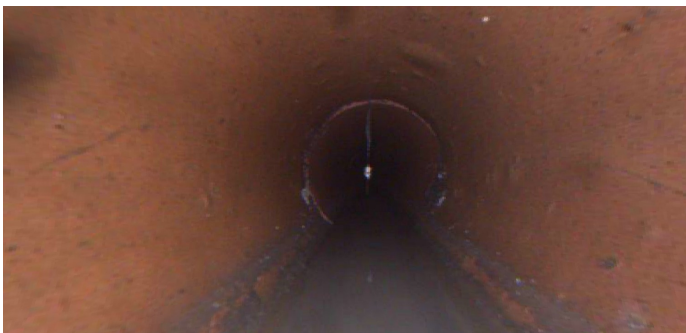
Code: **RFJ**
Description: **Roots Fine Joint**

Distance (ft): **22.6**
Structural Grade: **0**
O&M Grade: **1**
Clock Start/From: **7**
Clock To: **5**
1st Value:
2nd Value:
Value Percent:
Continuous Index:
Within 8" of Joint: **YES**
Remarks:

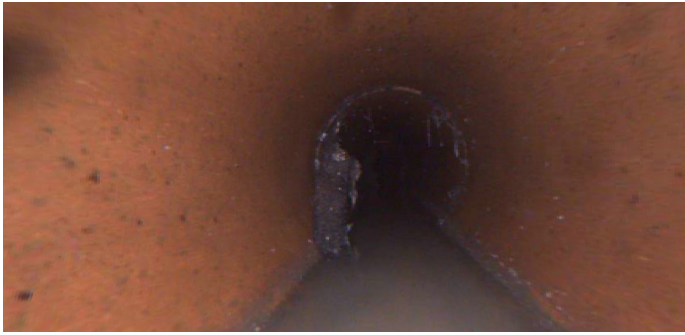
Code: **RMJ**
Description: **Roots Medium Joint**

Distance (ft): **33.8**
Structural Grade: **0**
O&M Grade: **3**
Clock Start/From: **7**
Clock To: **5**
1st Value:
2nd Value:
Value Percent: **30.000**
Continuous Index: **S01**
Within 8" of Joint: **YES**
Remarks:

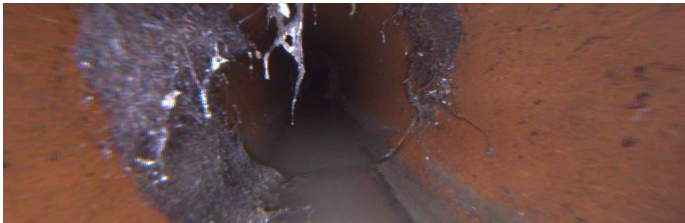
Code: **FL**
Description: **Fracture Longitudinal**

Distance (ft): **54.7**
Structural Grade: **3**
O&M Grade: **0**
Clock Start/From: **4**
Clock To:
1st Value:
2nd Value:
Value Percent:
Continuous Index:
Within 8" of Joint: **YES**
Remarks:

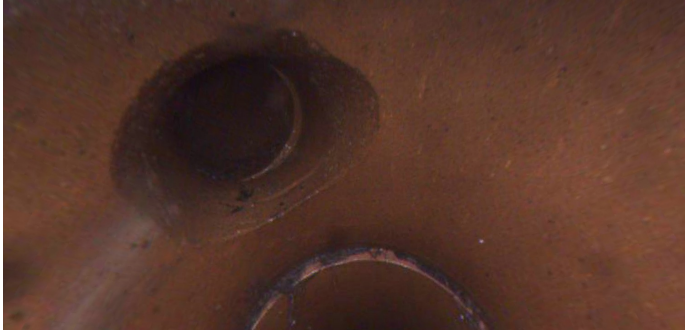
Code: **TF**
Description: **Tap Factory**

Distance (ft): **78.2**
Structural Grade: **0**
O&M Grade: **0**
Clock Start/From: **11**
Clock To:
1st Value: **4.000**
2nd Value:
Value Percent:
Continuous Index:
Within 8" of Joint:
Remarks:

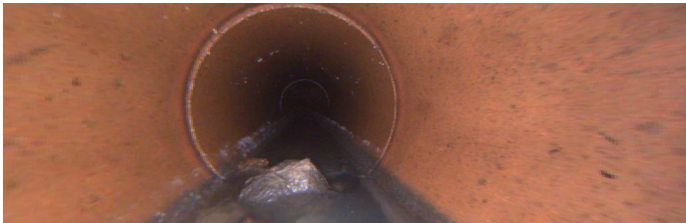
Code: **DSZ**
Description: **Deposits Settled Other**

Distance (ft): **105.3**
Structural Grade: **0**
O&M Grade: **2**
Clock Start/From: **6**
Clock To:
1st Value:
2nd Value:
Value Percent: **10.000**
Continuous Index:
Within 8" of Joint: **NO**
Remarks: **mixed material**

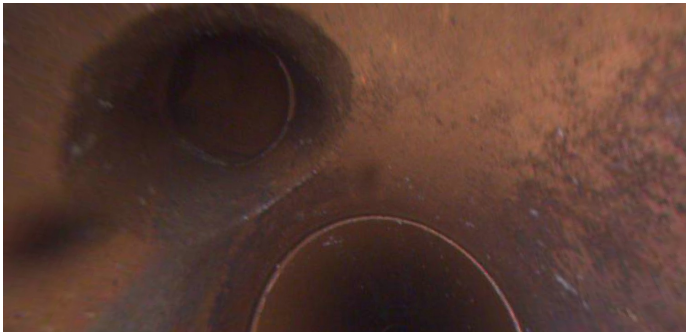
Code: **TF**
Description: **Tap Factory**

Distance (ft): **145.0**
Structural Grade: **0**
O&M Grade: **0**
Clock Start/From: **11**
Clock To:
1st Value: **4.000**
2nd Value:
Value Percent:
Continuous Index:
Within 8" of Joint:
Remarks:

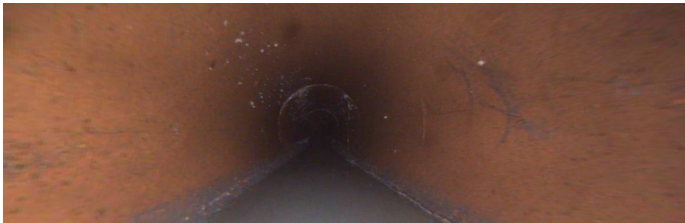
Code: **RFJ**
Description: **Roots Fine Joint**

Distance (ft): **191.7**
Structural Grade: **0**
O&M Grade: **1**
Clock Start/From: **1**
Clock To:
1st Value:
2nd Value:
Value Percent:
Continuous Index:
Within 8" of Joint: **YES**
Remarks:

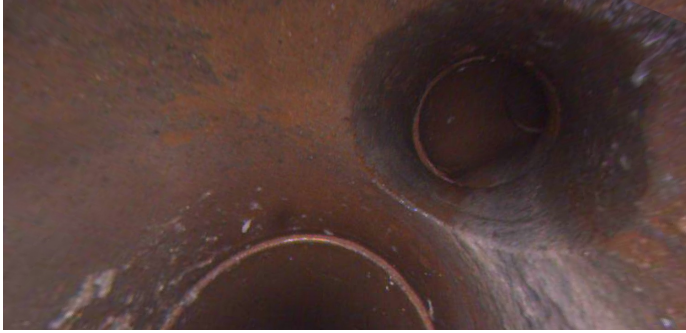
Code: **TF**
Description: **Tap Factory**

Distance (ft): **206.8**
Structural Grade: **0**
O&M Grade: **0**
Clock Start/From: **1**
Clock To:
1st Value: **4.000**
2nd Value:
Value Percent:
Continuous Index:
Within 8" of Joint:
Remarks:

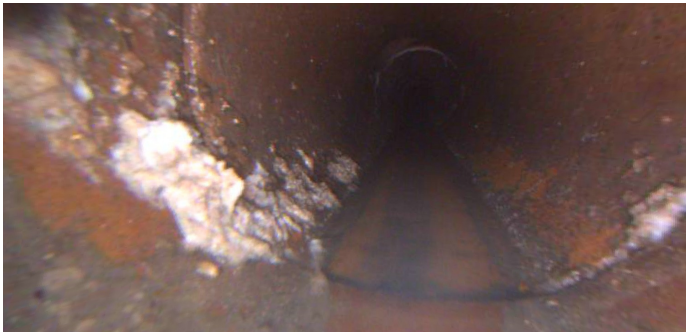
Code: **DAGS**
Description: **Deposits Attached Grease**

Distance (ft): **207.4**
Structural Grade: **0**
O&M Grade: **2**
Clock Start/From: **8**
Clock To: **9**
1st Value:
2nd Value:
Value Percent: **5.000**
Continuous Index:
Within 8" of Joint: **YES**
Remarks:

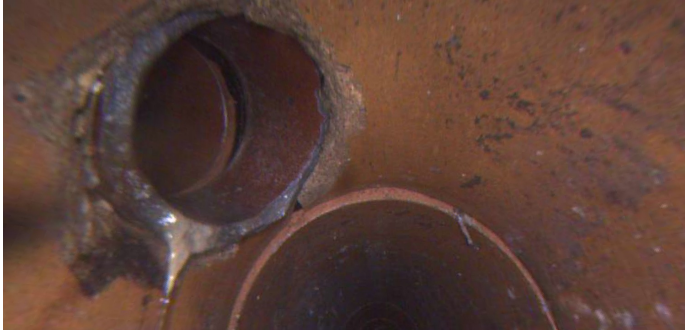
Code: **TBI**
Description: **Tap Break-in Intruding**

Distance (ft): **210.0**
Structural Grade: **0**
O&M Grade: **2**
Clock Start/From: **11**
Clock To:
1st Value: **4.000**
2nd Value: **1.000**
Value Percent:
Continuous Index:
Within 8" of Joint:
Remarks:

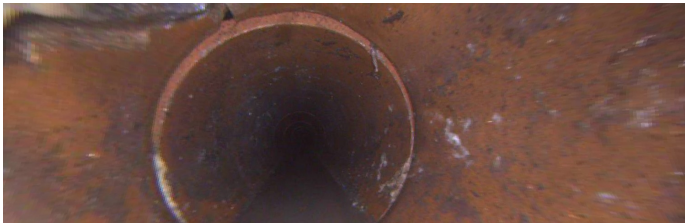
Code: **RFJ**
Description: **Roots Fine Joint**

Distance (ft): **210.2**
Structural Grade: **0**
O&M Grade: **1**
Clock Start/From: **2**
Clock To:
1st Value:
2nd Value:
Value Percent:
Continuous Index:
Within 8" of Joint: **YES**
Remarks:

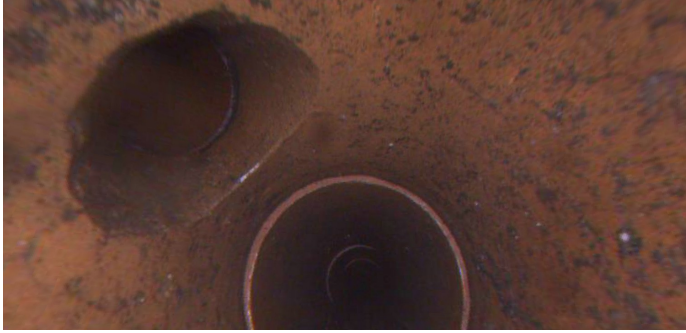
Code: **TF**
Description: **Tap Factory**

Distance (ft): **214.6**
Structural Grade: **0**
O&M Grade: **0**
Clock Start/From: **11**
Clock To:
1st Value: **4.000**
2nd Value:
Value Percent:
Continuous Index:
Within 8" of Joint:
Remarks:

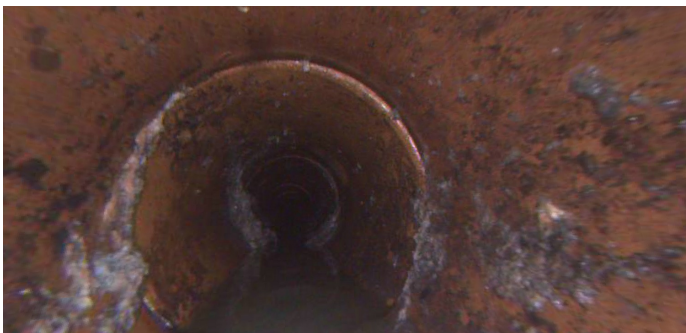
Code: **DAGS**
Description: **Deposits Attached Grease**

Distance (ft): **279.9**
Structural Grade: **0**
O&M Grade: **2**
Clock Start/From: **8**
Clock To: **4**
1st Value:
2nd Value:
Value Percent: **5.000**
Continuous Index:
Within 8" of Joint: **YES**
Remarks:

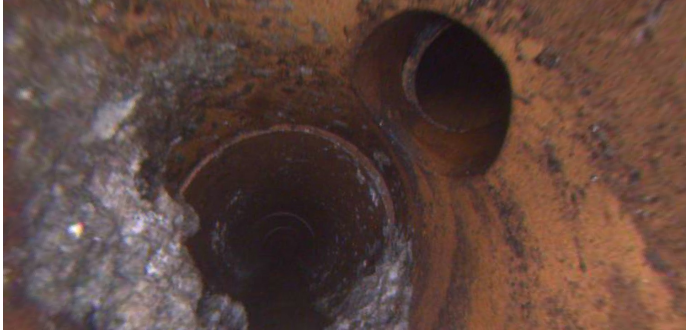
Code: **TF**
Description: **Tap Factory**

Distance (ft): **281.6**
Structural Grade: **0**
O&M Grade: **0**
Clock Start/From: **2**
Clock To:
1st Value: **4.000**
2nd Value:
Value Percent:
Continuous Index:
Within 8" of Joint:
Remarks:

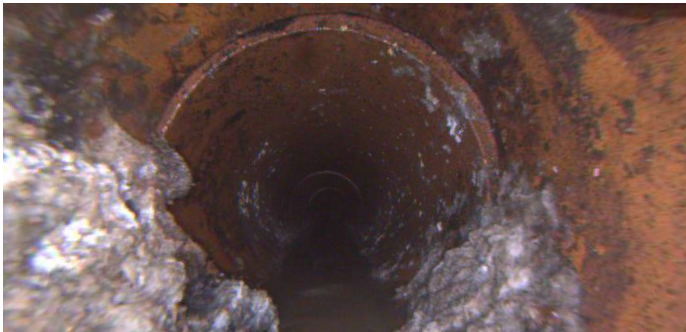
Code: **DAGS**
Description: **Deposits Attached Grease**

Distance (ft): **282.1**
Structural Grade: **0**
O&M Grade: **2**
Clock Start/From: **7**
Clock To: **5**
1st Value:
2nd Value:
Value Percent: **10.000**
Continuous Index:
Within 8" of Joint: **YES**
Remarks:

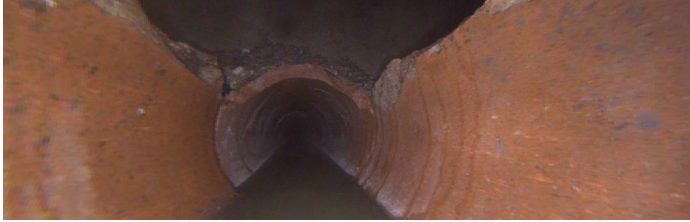
Code:	AMH
Description:	Manhole
Distance (ft):	293.6
Structural Grade:	0
O&M Grade:	0
Clock Start/From:	
Clock To:	
1st Value:	
2nd Value:	
Value Percent:	
Continuous Index:	
Within 8" of Joint:	NO
Remarks:	M-803-024
