## Profile/Photo Observation Report

Date:	<b>03/28/2018</b>	Weather:		Coding:	<b>PACP 6.0</b>
Pipe Length (ft):	<b>300.7</b>	Owner:	<b>NA</b>	Pre Clean:	<b>Not Known</b>
P.O.#:		Surveyor:	<b>Selasie Honu</b>	PSR:	<b>P-803-024-023</b>
Customer:		Clean Date:	<b>01/01/1900</b>	Shape:	<b>C</b>

Street:	<b>E 40TH AV</b>	Flow Control:	<b>Not Controlled</b>
City:	<b>Hobart, IN</b>	Year Renewed:	
Location:	<b>Other</b>	Tape/Media #:	
Purpose:	<b>Not Known</b>	Dia/Height:	<b>10"</b>
Use:	<b>Sanitary</b>	Material:	<b>VCP</b>
Drain Area:	<b>NA</b>	Lining:	
Category:	<b>NA</b>		
Comment:

Location Details:		Direction of Survey:	<b>Downstream</b>
US MH:	<b>M-803-023</b>	DS MH:	<b>M-803-024</b>
		Total Length Surveyed (ft):	<b>293.6</b>

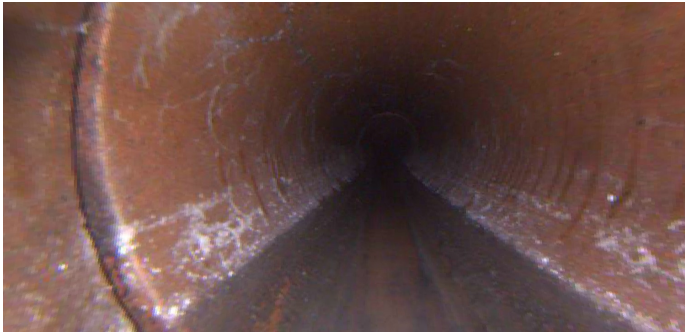
Code: **AMH**  
Description: **Manhole**

Distance (ft): **.0**  
Structural Grade: **0**  
O&M Grade: **0**  
Clock Start/From:  
Clock To:  
1st Value:  
2nd Value:  
Value Percent:  
Continuous Index:  
Within 8" of Joint: **NO**  
Remarks: **M-803-023**

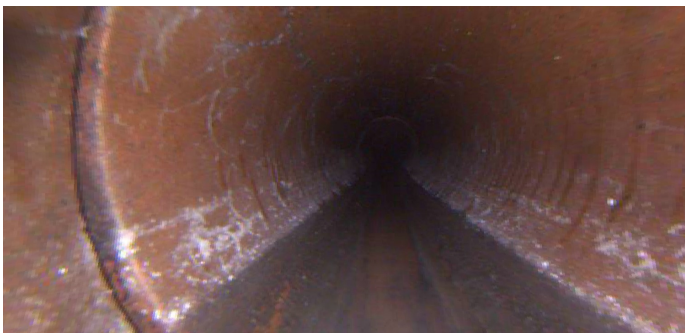
Code: **MWL**  
Description: **Water Level**

Distance (ft): **.0**  
Structural Grade: **0**  
O&M Grade: **0**  
Clock Start/From:  
Clock To:  
1st Value:  
2nd Value:  
Value Percent: **5.000**  
Continuous Index:  
Within 8" of Joint: **NO**  
Remarks:

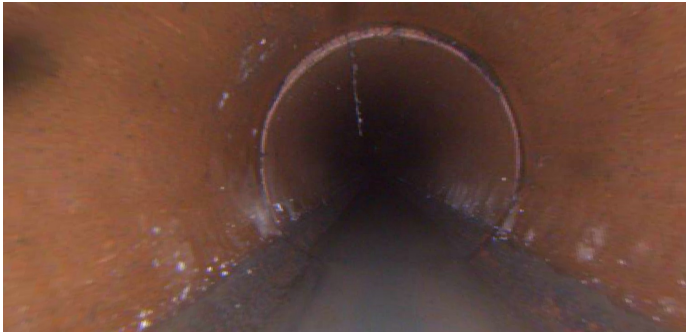
Code: **RFJ**  
Description: **Roots Fine Joint**

Distance (ft): **8.7**  
Structural Grade: **0**  
O&M Grade: **1**  
Clock Start/From: **7**  
Clock To: **5**  
1st Value:  
2nd Value:  
Value Percent:  
Continuous Index:  
Within 8" of Joint: **YES**  
Remarks:

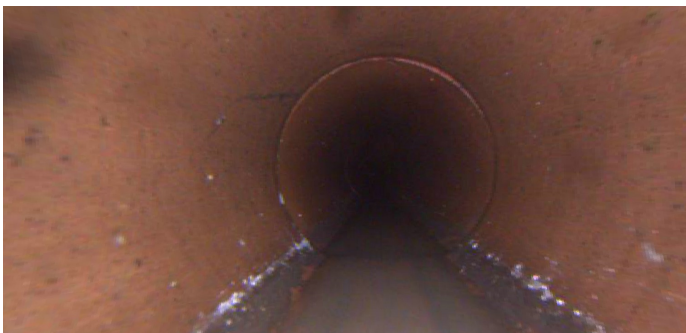
Code: **FL**  
Description: **Fracture Longitudinal**

Distance (ft): **12.4**  
Structural Grade: **3**  
O&M Grade: **0**  
Clock Start/From: **10**  
Clock To:  
1st Value:  
2nd Value:  
Value Percent:  
Continuous Index:  
Within 8" of Joint:  
Remarks:

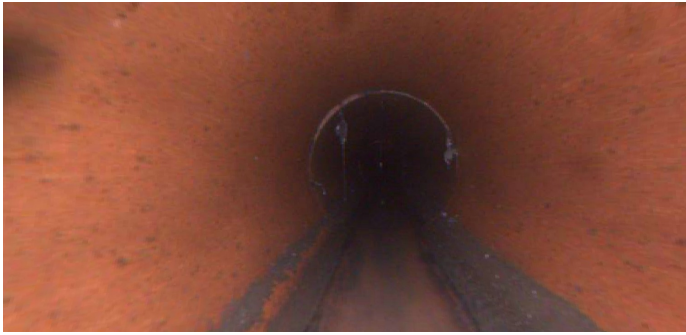
Code: **RFJ**  
Description: **Roots Fine Joint**

Distance (ft): **18.7**  
Structural Grade: **0**  
O&M Grade: **1**  
Clock Start/From: **7**  
Clock To: **5**  
1st Value:  
2nd Value:  
Value Percent:  
Continuous Index:  
Within 8" of Joint: **YES**  
Remarks:

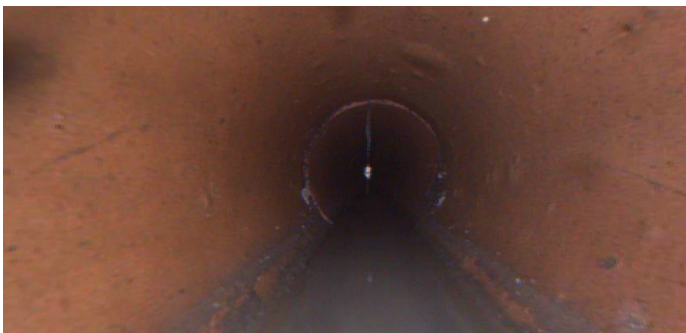
Code: **RFJ**  
Description: **Roots Fine Joint**

Distance (ft): **22.6**  
Structural Grade: **0**  
O&M Grade: **1**  
Clock Start/From: **7**  
Clock To: **5**  
1st Value:  
2nd Value:  
Value Percent:  
Continuous Index:  
Within 8" of Joint: **YES**  
Remarks:

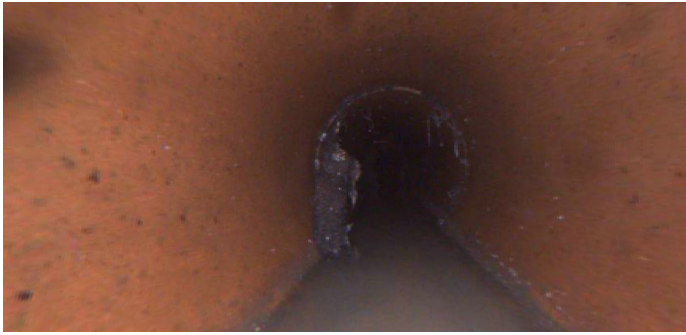
Code: **RMJ**  
Description: **Roots Medium Joint**

Distance (ft): **33.8**  
Structural Grade: **0**  
O&M Grade: **3**  
Clock Start/From: **7**  
Clock To: **5**  
1st Value:  
2nd Value:  
Value Percent: **30.000**  
Continuous Index: **S01**  
Within 8" of Joint: **YES**  
Remarks:

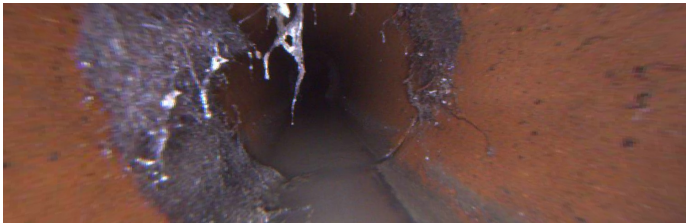
Code: **FL**  
Description: **Fracture Longitudinal**

Distance (ft): **54.7**  
Structural Grade: **3**  
O&M Grade: **0**  
Clock Start/From: **4**  
Clock To:  
1st Value:  
2nd Value:  
Value Percent:  
Continuous Index:  
Within 8" of Joint: **YES**  
Remarks:

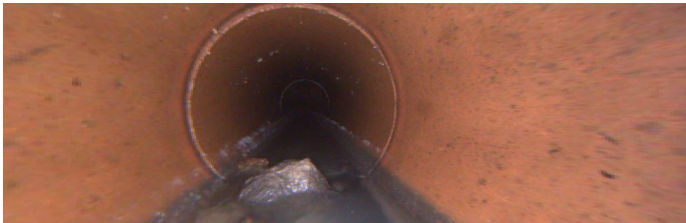
Code: **DSZ**  
Description: **Deposits Settled Other**

Distance (ft): **105.3**  
Structural Grade: **0**  
O&M Grade: **2**  
Clock Start/From: **6**  
Clock To:  
1st Value:  
2nd Value:  
Value Percent: **10.000**  
Continuous Index:  
Within 8" of Joint: **NO**  
Remarks: **mixed material**

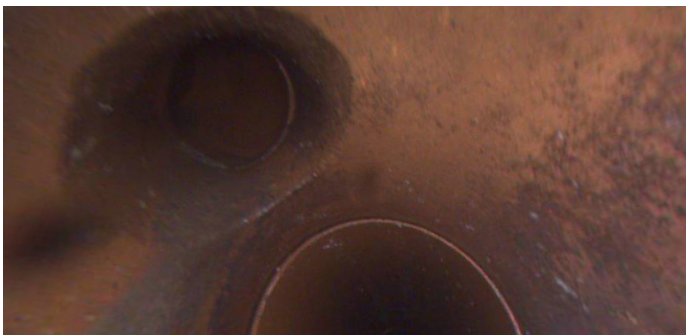
Code: **TF**  
Description: **Tap Factory**

Distance (ft): **145.0**  
Structural Grade: **0**  
O&M Grade: **0**  
Clock Start/From: **11**  
Clock To:  
1st Value: **4.000**  
2nd Value:  
Value Percent:  
Continuous Index:  
Within 8" of Joint:  
Remarks:

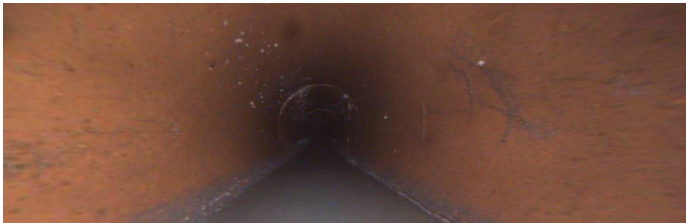
Code: **RFJ**  
Description: **Roots Fine Joint**

Distance (ft): **191.7**  
Structural Grade: **0**  
O&M Grade: **1**  
Clock Start/From: **1**  
Clock To:  
1st Value:  
2nd Value:  
Value Percent:  
Continuous Index:  
Within 8" of Joint: **YES**  
Remarks:

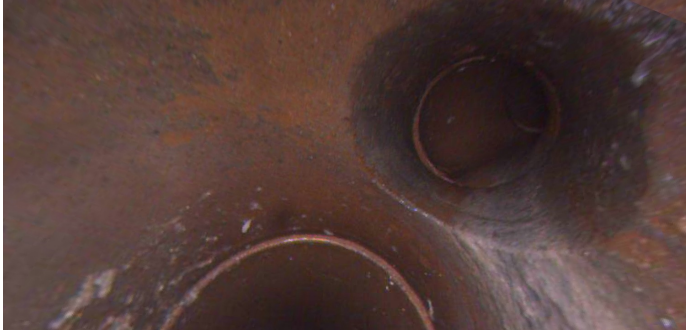
Code: **TF**  
Description: **Tap Factory**

Distance (ft): **206.8**  
Structural Grade: **0**  
O&M Grade: **0**  
Clock Start/From: **1**  
Clock To:  
1st Value: **4.000**  
2nd Value:  
Value Percent:  
Continuous Index:  
Within 8" of Joint:  
Remarks:

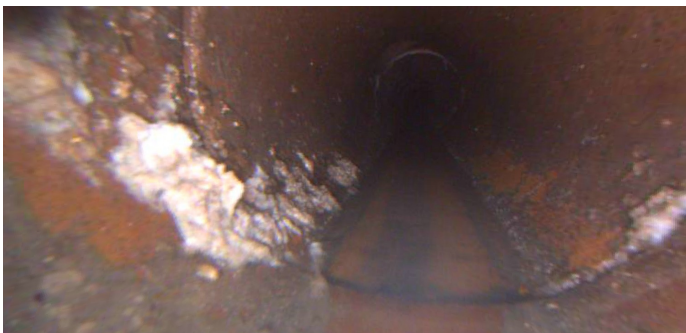
Code: **DAGS**  
Description: **Deposits Attached Grease**

Distance (ft): **207.4**  
Structural Grade: **0**  
O&M Grade: **2**  
Clock Start/From: **8**  
Clock To: **9**  
1st Value:  
2nd Value:  
Value Percent: **5.000**  
Continuous Index:  
Within 8" of Joint: **YES**  
Remarks:

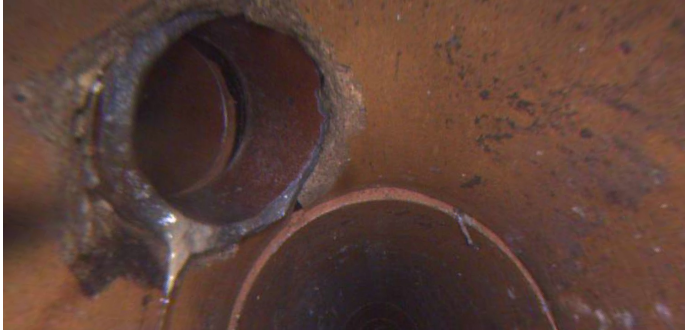
Code: **TBI**  
Description: **Tap Break-in Intruding**

Distance (ft): **210.0**  
Structural Grade: **0**  
O&M Grade: **2**  
Clock Start/From: **11**  
Clock To:  
1st Value: **4.000**  
2nd Value: **1.000**  
Value Percent:  
Continuous Index:  
Within 8" of Joint:  
Remarks:

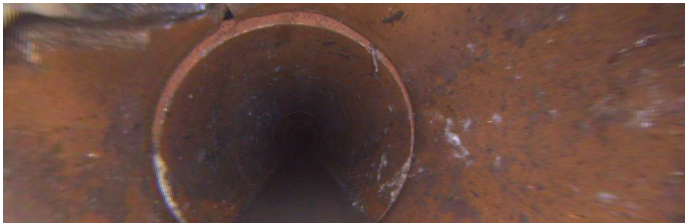
Code: **RFJ**  
Description: **Roots Fine Joint**

Distance (ft): **210.2**  
Structural Grade: **0**  
O&M Grade: **1**  
Clock Start/From: **2**  
Clock To:  
1st Value:  
2nd Value:  
Value Percent:  
Continuous Index:  
Within 8" of Joint: **YES**  
Remarks:

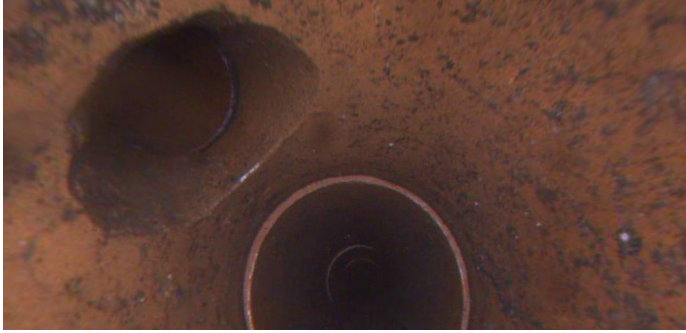
Code: **TF**  
Description: **Tap Factory**

Distance (ft): **214.6**  
Structural Grade: **0**  
O&M Grade: **0**  
Clock Start/From: **11**  
Clock To:  
1st Value: **4.000**  
2nd Value:  
Value Percent:  
Continuous Index:  
Within 8" of Joint:  
Remarks:

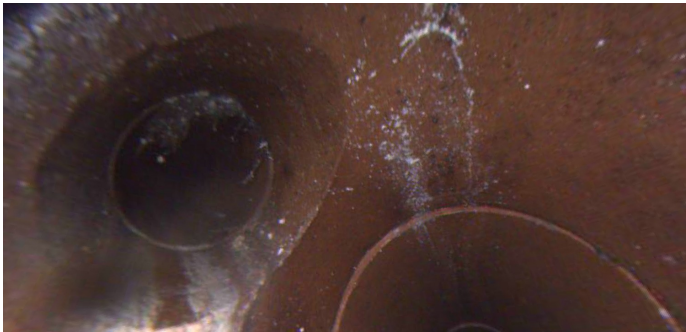
Code: **TF**  
Description: **Tap Factory**

Distance (ft): **270.8**  
Structural Grade: **0**  
O&M Grade: **0**  
Clock Start/From: **10**  
Clock To:  
1st Value: **4.000**  
2nd Value:  
Value Percent:  
Continuous Index:  
Within 8" of Joint:  
Remarks:

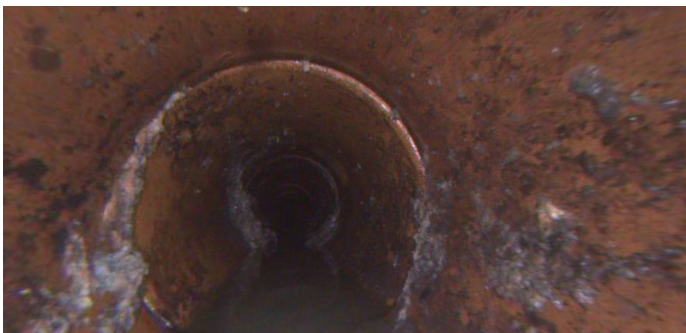
Code: **DAGS**  
Description: **Deposits Attached Grease**

Distance (ft): **279.9**  
Structural Grade: **0**  
O&M Grade: **2**  
Clock Start/From: **8**  
Clock To: **4**  
1st Value:  
2nd Value:  
Value Percent: **5.000**  
Continuous Index:  
Within 8" of Joint: **YES**  
Remarks:

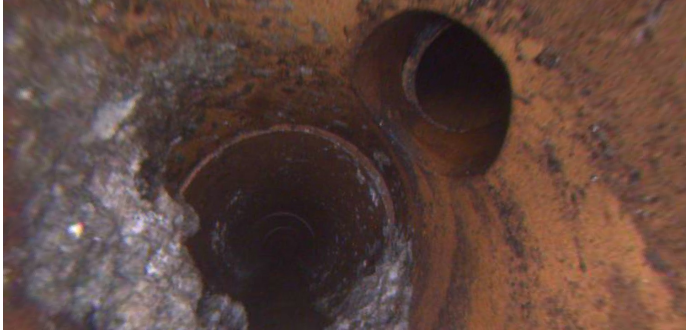
Code: **TF**  
Description: **Tap Factory**

Distance (ft): **281.6**  
Structural Grade: **0**  
O&M Grade: **0**  
Clock Start/From: **2**  
Clock To:  
1st Value: **4.000**  
2nd Value:  
Value Percent:  
Continuous Index:  
Within 8" of Joint:  
Remarks:

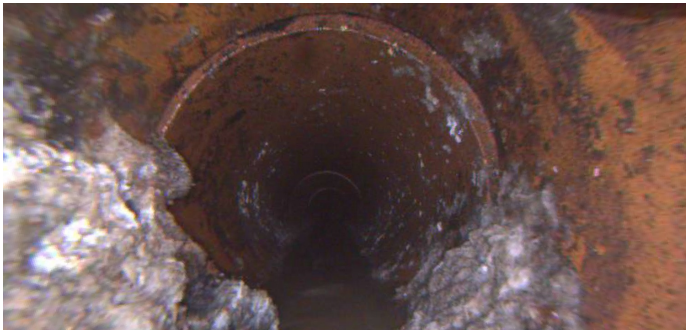
Code: **DAGS**  
Description: **Deposits Attached Grease**

Distance (ft): **282.1**  
Structural Grade: **0**  
O&M Grade: **2**  
Clock Start/From: **7**  
Clock To: **5**  
1st Value:  
2nd Value:  
Value Percent: **10.000**  
Continuous Index:  
Within 8" of Joint: **YES**  
Remarks:

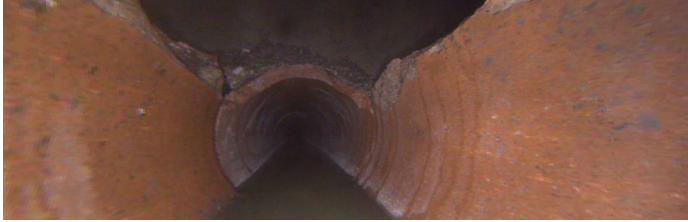
Code:	<b>AMH</b>
Description:	<b>Manhole</b>
Distance (ft):	<b>293.6</b>
Structural Grade:	<b>0</b>
O&M Grade:	<b>0</b>
Clock Start/From:	
Clock To:	
1st Value:	
2nd Value:	
Value Percent:	
Continuous Index:	
Within 8" of Joint:	<b>NO</b>
Remarks:	<b>M-803-024</b>
