## Profile/Photo Observation Report

Street:	<b>E 40TH AVE &amp; N OHIO ST</b>	Flow Control:	<b>Not Controlled</b>
City:	<b>Hobart, IN</b>	Year Renewed:	
Location:	<b>Other</b>	Tape/Media #:	
Purpose:	<b>Not Known</b>	Dia/Height:	<b>10"</b>
Use:	<b>Sanitary</b>	Material:	<b>VCP</b>
Drain Area:	<b>NA</b>	Lining:	
Category:	<b>NA</b>		
Comment:

Location Details:		Direction of Survey:	<b>Downstream</b>
US MH:	<b>M-803-023</b>	DS MH:	<b>M-803-026</b>
		Total Length Surveyed (ft):	<b>165.7</b>

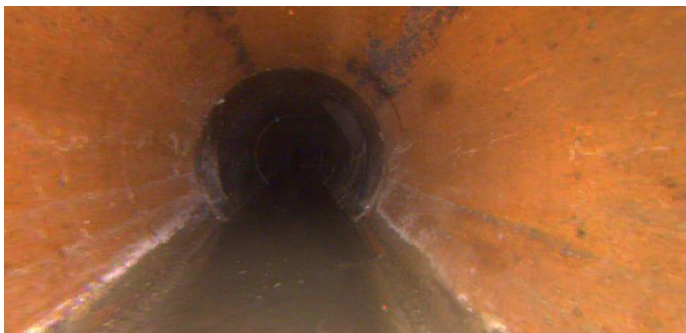
Code: **AMH**  
Description: **Manhole**

Distance (ft): **.0**  
Structural Grade: **0**  
O&M Grade: **0**  
Clock Start/From:  
Clock To:  
1st Value:  
2nd Value:  
Value Percent:  
Continuous Index:  
Within 8" of Joint: **NO**  
Remarks: **M-803-023**

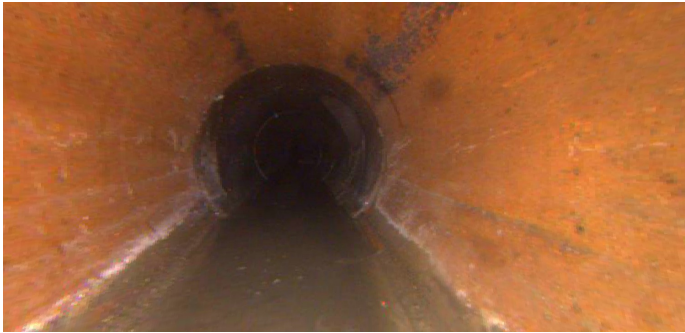
Code:	<b>MWL</b>
Description:	<b>Water Level</b>

Distance (ft):	<b>.0</b>
Structural Grade:	<b>0</b>
O&M Grade:	<b>0</b>
Clock Start/From:	
Clock To:	
1st Value:	
2nd Value:	
Value Percent:	<b>5.000</b>
Continuous Index:	
Within 8" of Joint:	<b>NO</b>
Remarks:

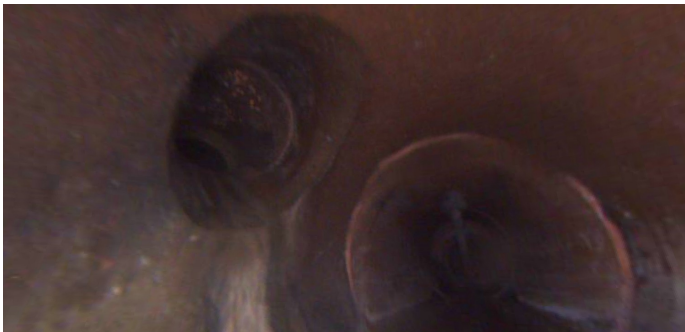
Code:	<b>TF</b>
Description:	<b>Tap Factory</b>

Distance (ft):	<b>4.1</b>
Structural Grade:	<b>0</b>
O&M Grade:	<b>0</b>
Clock Start/From:	<b>2</b>
Clock To:	
1st Value:	<b>4.000</b>
2nd Value:	
Value Percent:	
Continuous Index:	
Within 8" of Joint:	
Remarks:

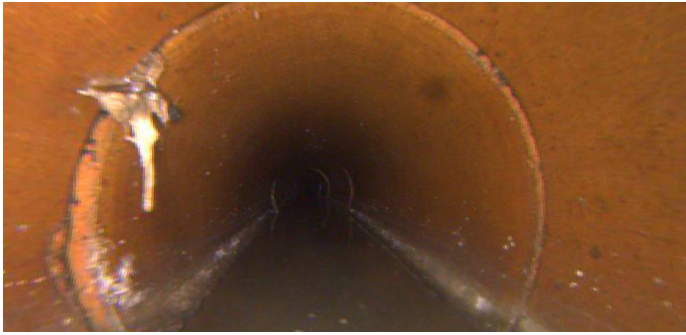
Code: **RFJ**  
Description: **Roots Fine Joint**

Distance (ft): **13.0**  
Structural Grade: **0**  
O&M Grade: **1**  
Clock Start/From: **10**  
Clock To:  
1st Value:  
2nd Value:  
Value Percent:  
Continuous Index:  
Within 8" of Joint: **YES**  
Remarks:

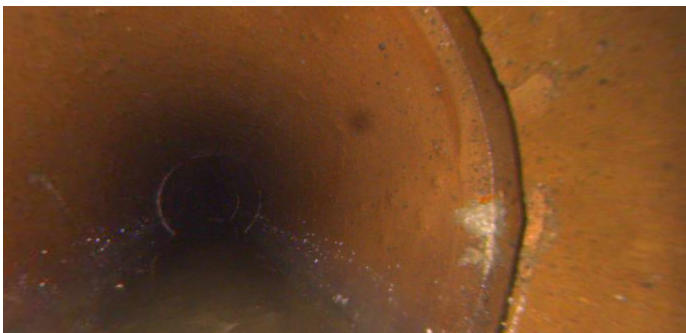
Code: **SSS**  
Description: **Surface Spalling**

Distance (ft): **126.3**  
Structural Grade: **2**  
O&M Grade: **0**  
Clock Start/From: **2**  
Clock To: **3**  
1st Value:  
2nd Value:  
Value Percent:  
Continuous Index:  
Within 8" of Joint: **YES**  
Remarks:

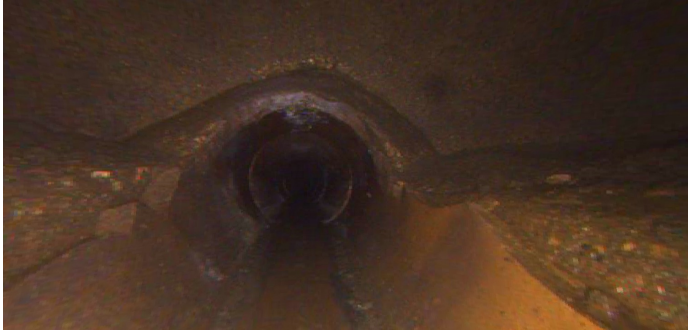
Code:	AMH
Description:	Manhole
Distance (ft):	165.7
Structural Grade:	0
O&M Grade:	0
Clock Start/From:	
Clock To:	
1st Value:	
2nd Value:	
Value Percent:	
Continuous Index:	
Within 8" of Joint:	NO
Remarks:	M-803-026
