Profile/Photo Observation Report

Street:	E RAND ST	Flow Control:	Not Controlled
City:	Hobart, IN	Year Renewed:	
Location:	Other	Tape/Media #:	
Purpose:	Not Known	Dia/Height:	10"
Use:	Sanitary	Material:	VCP
Drain Area:	NA	Lining:	
Category:	NA		
Comment:

Location Details:		Direction of Survey:	Downstream
US MH:	M-803-028	DS MH:	M-803-027
		Total Length Surveyed (ft):	3.5

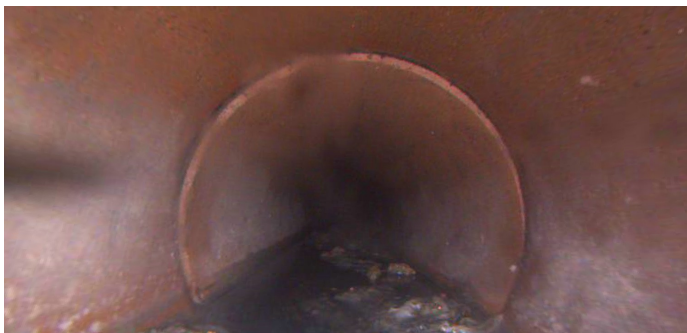
Code: **AMH**
Description: **Manhole**

Distance (ft): **.0**
Structural Grade: **0**
O&M Grade: **0**
Clock Start/From:
Clock To:
1st Value:
2nd Value:
Value Percent:
Continuous Index:
Within 8" of Joint: **NO**
Remarks: **M-803-028**

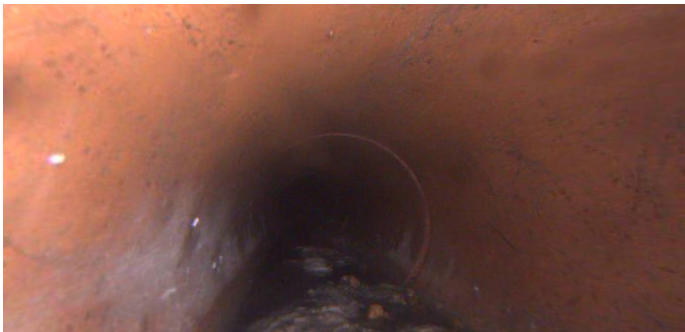
Code:	MSA
Description:	Abandoned Survey

Distance (ft):	3.5
Structural Grade:	0
O&M Grade:	0
Clock Start/From:	
Clock To:	
1st Value:	
2nd Value:	
Value Percent:	
Continuous Index:	
Within 8" of Joint:	NO
Remarks:	debris under water
