## Profile/Photo Observation Report

Street:	<b>E RAND ST &amp; N LIBERTY ST</b>	Flow Control:	<b>Not Controlled</b>
City:	<b>Hobart, IN</b>	Year Renewed:	
Location:	<b>Light Highway</b>	Tape/Media #:	
Purpose:	<b>Routine Assessment</b>	Dia/Height:	<b>12"</b>
Use:	<b>Sanitary</b>	Material:	<b>VCP</b>
Drain Area:	<b>NA</b>	Lining:	
Category:	<b>NA</b>		
Comment:

Location Details:		Direction of Survey:	<b>Upstream</b>
US MH:	<b>M-803-028</b>	DS MH:	<b>M-803-027</b>
		Total Length Surveyed (ft):	<b>18.9</b>

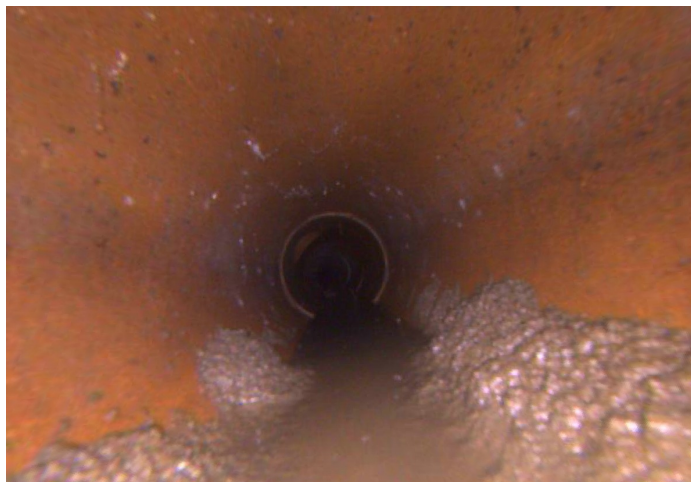
Code: **AMH**  
Description: **Manhole**

Distance (ft): **.0**  
Structural Grade: **0**  
O&M Grade: **0**  
Clock Start/From:  
Clock To:  
1st Value:  
2nd Value:  
Value Percent:  
Continuous Index:  
Within 8" of Joint: **NO**  
Remarks: **M-803-027**

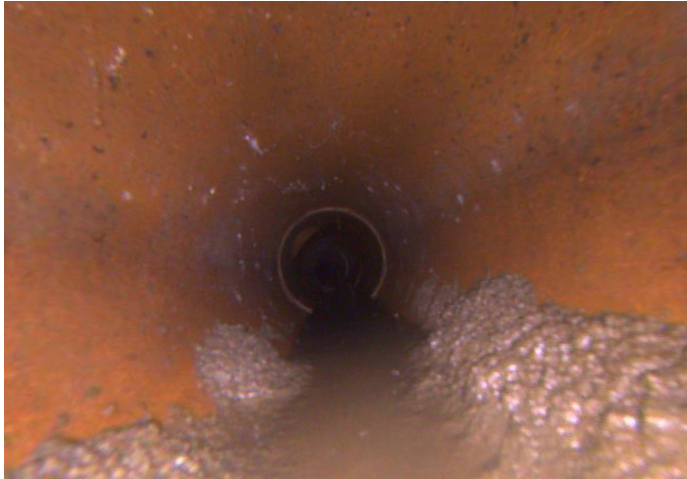
Code: **MWL**  
Description: **Water Level**

Distance (ft): **.0**  
Structural Grade: **0**  
O&M Grade: **0**  
Clock Start/From:  
Clock To:  
1st Value:  
2nd Value:  
Value Percent: **5.000**  
Continuous Index:  
Within 8" of Joint: **NO**  
Remarks:

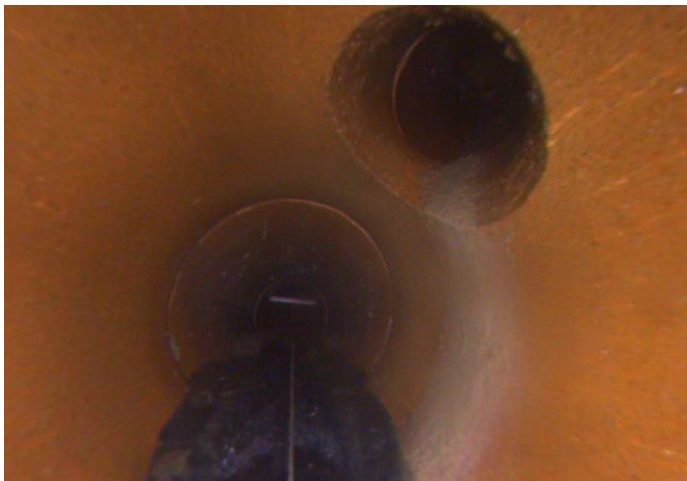
Code: **TF**  
Description: **Tap Factory**

Distance (ft): **5.5**  
Structural Grade: **0**  
O&M Grade: **0**  
Clock Start/From: **1**  
Clock To:  
1st Value: **6.000**  
2nd Value:  
Value Percent:  
Continuous Index:  
Within 8" of Joint:  
Remarks:

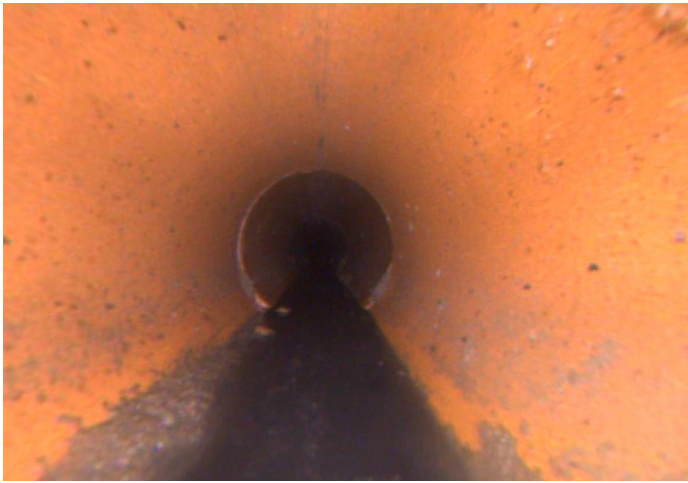
Code:	<b>MSA</b>
Description:	<b>Abandoned Survey</b>
Distance (ft):	<b>18.9</b>
Structural Grade:	<b>0</b>
O&M Grade:	<b>0</b>
Clock Start/From:	
Clock To:	
1st Value:	
2nd Value:	
Value Percent:	
Continuous Index:	
Within 8" of Joint:	<b>NO</b>
Remarks:	<b>Unknown</b>
