## Profile/Photo Observation Report

Street:	<b>E RAND ST</b>	Flow Control:	<b>Not Controlled</b>
City:	<b>Hobart, IN</b>	Year Renewed:	
Location:	<b>Other</b>	Tape/Media #:	
Purpose:	<b>Not Known</b>	Dia/Height:	<b>10"</b>
Use:	<b>Sanitary</b>	Material:	<b>VCP</b>
Drain Area:	<b>NA</b>	Lining:	
Category:	<b>NA</b>		
Comment:

Location Details:		Direction of Survey:	<b>Downstream</b>
US MH:	<b>M-803-029</b>	DS MH:	<b>M-803-030</b>
		Total Length Surveyed (ft):	<b>8.1</b>

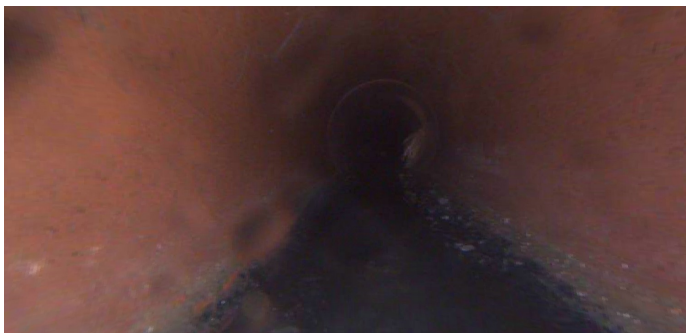
Code: **AMH**  
Description: **Manhole**

Distance (ft): **.0**  
Structural Grade: **0**  
O&M Grade: **0**  
Clock Start/From:  
Clock To:  
1st Value:  
2nd Value:  
Value Percent:  
Continuous Index:  
Within 8" of Joint: **NO**  
Remarks: **M-803-029**

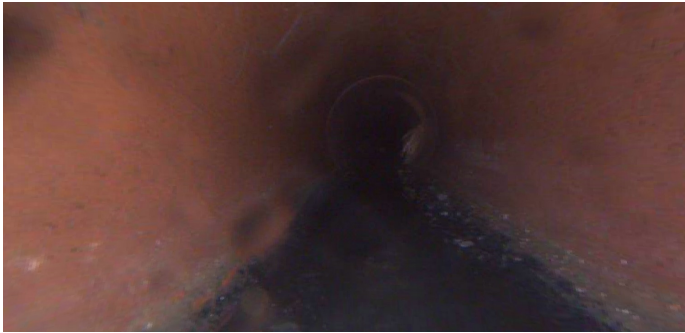
Code:	<b>MWL</b>
Description:	<b>Water Level</b>

Distance (ft):	<b>.0</b>
Structural Grade:	<b>0</b>
O&M Grade:	<b>0</b>
Clock Start/From:	
Clock To:	
1st Value:	
2nd Value:	
Value Percent:	<b>5.000</b>
Continuous Index:	
Within 8" of Joint:	<b>NO</b>
Remarks:

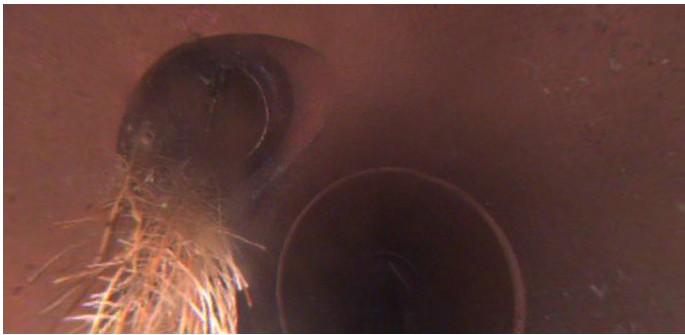
Code:	<b>TFD</b>
Description:	<b>Tap Factory Defective</b>

Distance (ft):	<b>4.9</b>
Structural Grade:	<b>0</b>
O&M Grade:	<b>2</b>
Clock Start/From:	<b>2</b>
Clock To:	
1st Value:	<b>4.000</b>
2nd Value:	
Value Percent:	
Continuous Index:	
Within 8" of Joint:	
Remarks:	<b>roots</b>

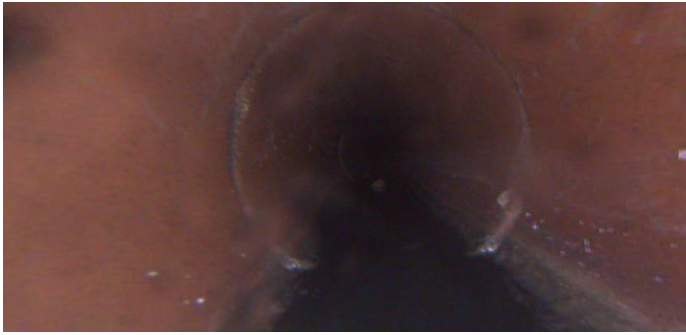
Code: **RFJ**  
Description: **Roots Fine Joint**

Distance (ft): **5.6**  
Structural Grade: **0**  
O&M Grade: **1**  
Clock Start/From: **10**  
Clock To: **4**  
1st Value:  
2nd Value:  
Value Percent:  
Continuous Index:  
Within 8" of Joint: **YES**  
Remarks:

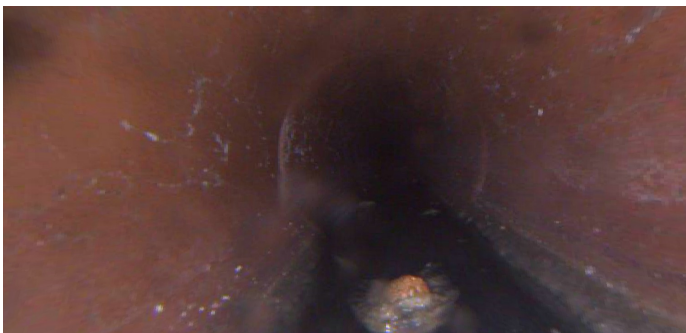
Code: **MSA**  
Description: **Abandoned Survey**

Distance (ft): **8.1**  
Structural Grade: **0**  
O&M Grade: **0**  
Clock Start/From:  
Clock To:  
1st Value:  
2nd Value:  
Value Percent:  
Continuous Index:  
Within 8" of Joint: **NO**  
Remarks: **camera stopped**
