Profile/Photo Observation Report

Street:	E RAND ST	Flow Control:	Not Controlled
City:	Hobart, IN	Year Renewed:	
Location:	Other	Tape/Media #:	
Purpose:	Not Known	Dia/Height:	10"
Use:	Sanitary	Material:	VCP
Drain Area:	NA	Lining:	
Category:	NA		
Comment:

Location Details:		Direction of Survey:	Downstream
US MH:	M-803-030	DS MH:	M-803-037
		Total Length Surveyed (ft):	72.0

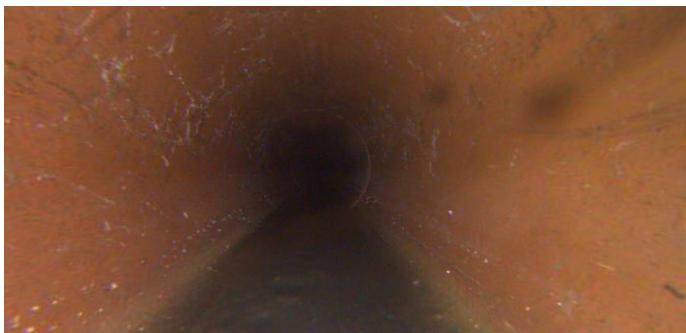
Code: **AMH**
Description: **Manhole**

Distance (ft): **.0**
Structural Grade: **0**
O&M Grade: **0**
Clock Start/From:
Clock To:
1st Value:
2nd Value:
Value Percent:
Continuous Index:
Within 8" of Joint: **NO**
Remarks: **M-803-030**

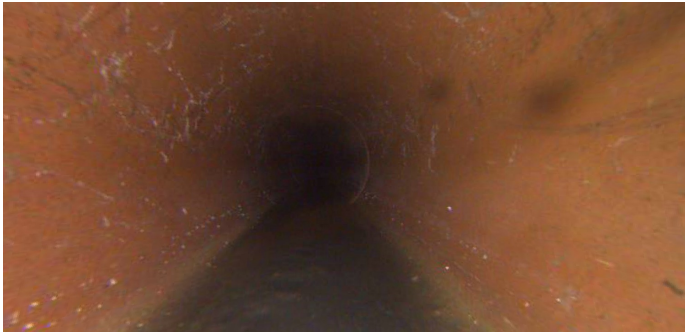
Code:	MWL
Description:	Water Level

Distance (ft):	.0
Structural Grade:	0
O&M Grade:	0
Clock Start/From:	
Clock To:	
1st Value:	
2nd Value:	
Value Percent:	10.000
Continuous Index:	
Within 8" of Joint:	NO
Remarks:

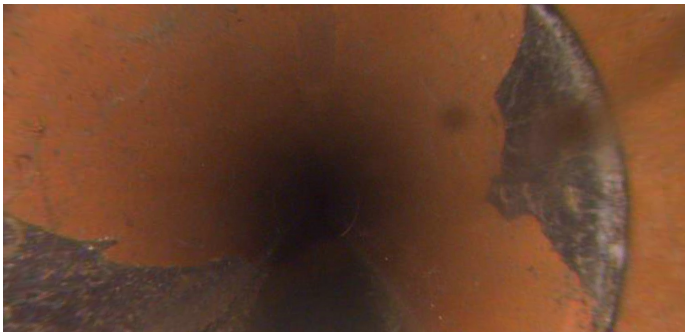
Code:	DAZ
Description:	Deposits Attached Other

Distance (ft):	29.5
Structural Grade:	0
O&M Grade:	2
Clock Start/From:	8
Clock To:	4
1st Value:	
2nd Value:	
Value Percent:	5.000
Continuous Index:	
Within 8" of Joint:	YES
Remarks:	SEALANT

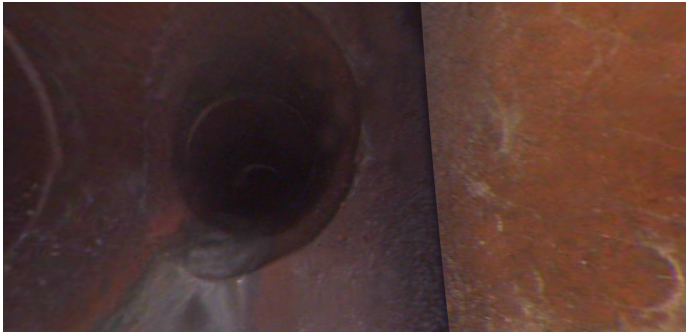
Code: **TFA**
Description: **Tap Factory Active**

Distance (ft): **49.0**
Structural Grade: **0**
O&M Grade: **0**
Clock Start/From: **9**
Clock To:
1st Value: **4.000**
2nd Value:
Value Percent:
Continuous Index:
Within 8" of Joint:
Remarks:

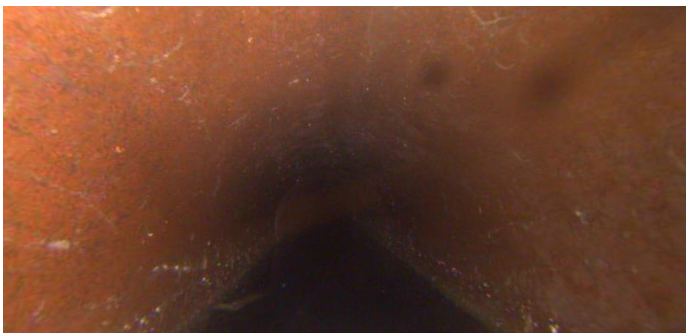
Code: **MSA**
Description: **Abandoned Survey**

Distance (ft): **72.0**
Structural Grade: **0**
O&M Grade: **0**
Clock Start/From:
Clock To:
1st Value:
2nd Value:
Value Percent:
Continuous Index:
Within 8" of Joint: **NO**
Remarks: **DEBRIS UNDER WATER**
