Profile/Photo Observation Report

Street:	E RAND ST & N OHIO ST	Flow Control:	Not Controlled
City:	Hobart, IN	Year Renewed:	
Location:	Other	Tape/Media #:	
Purpose:	Not Known	Dia/Height:	10"
Use:	Sanitary	Material:	VCP
Drain Area:	NA	Lining:	
Category:	NA		
Comment:

Location Details:		Direction of Survey:	Upstream
US MH:	M-803-030	DS MH:	M-803-037
		Total Length Surveyed (ft):	68.5

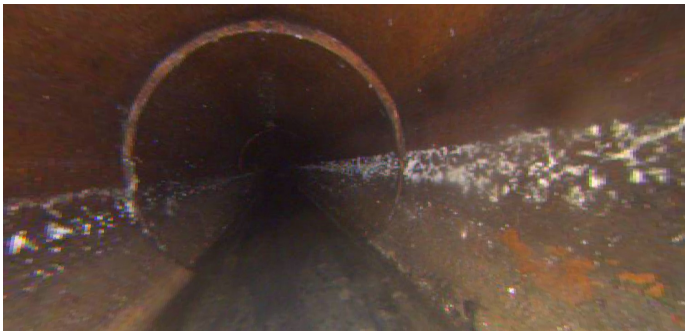
Code: **AMH**
Description: **Manhole**

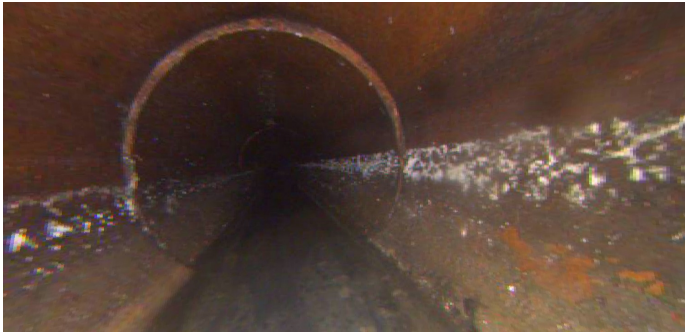
Code:	MWL
Description:	Water Level

Distance (ft):	.0
Structural Grade:	0
O&M Grade:	0
Clock Start/From:	
Clock To:	
1st Value:	
2nd Value:	
Value Percent:	5.000
Continuous Index:	
Within 8" of Joint:	NO
Remarks:

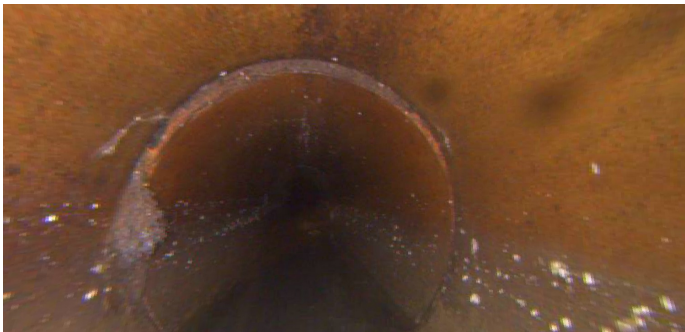
Code:	RFJ
Description:	Roots Fine Joint

Distance (ft):	7.5
Structural Grade:	0
O&M Grade:	1
Clock Start/From:	7
Clock To:	4
1st Value:	
2nd Value:	
Value Percent:	
Continuous Index:	S01
Within 8" of Joint:	YES
Remarks:

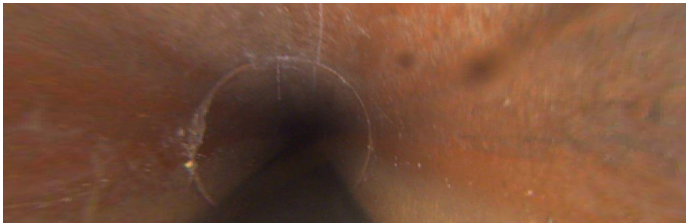
Code: **RFJ**
Description: **Roots Fine Joint**

Distance (ft): **37.0**
Structural Grade: **0**
O&M Grade: **1**
Clock Start/From: **7**
Clock To: **4**
1st Value:
2nd Value:
Value Percent:
Continuous Index: **F01**
Within 8" of Joint: **YES**
Remarks:

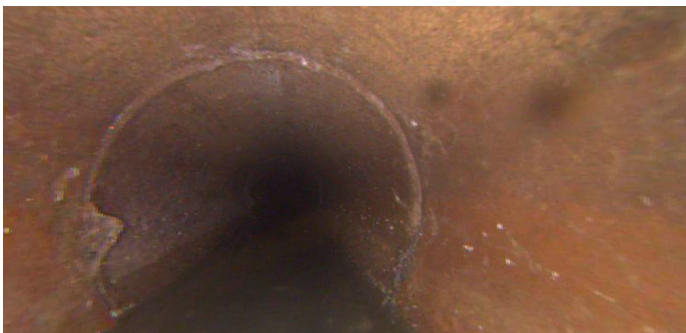
Code: **RFJ**
Description: **Roots Fine Joint**

Distance (ft): **58.1**
Structural Grade: **0**
O&M Grade: **1**
Clock Start/From: **7**
Clock To: **5**
1st Value:
2nd Value:
Value Percent:
Continuous Index:
Within 8" of Joint: **YES**
Remarks:

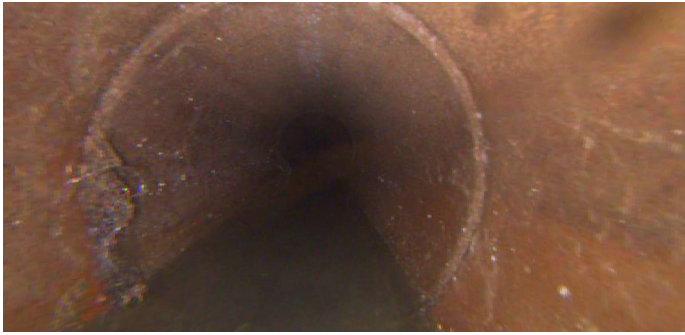
Code: **RFJ**
Description: **Roots Fine Joint**

Distance (ft): **61.3**
Structural Grade: **0**
O&M Grade: **1**
Clock Start/From: **7**
Clock To: **9**
1st Value:
2nd Value:
Value Percent:
Continuous Index:
Within 8" of Joint: **YES**
Remarks:

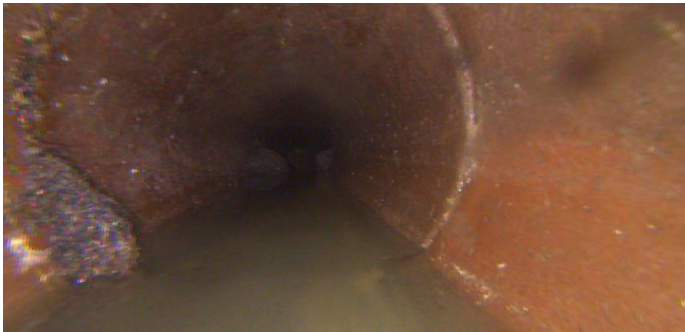
Code: **RMJ**
Description: **Roots Medium Joint**

Distance (ft): **64.3**
Structural Grade: **0**
O&M Grade: **3**
Clock Start/From: **7**
Clock To: **5**
1st Value:
2nd Value:
Value Percent: **30.000**
Continuous Index: **S02**
Within 8" of Joint: **YES**
Remarks:

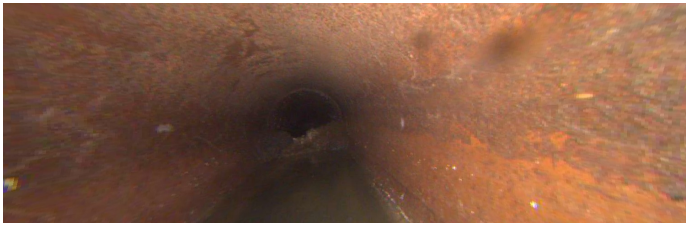
Code: **RMJ**
Description: **Roots Medium Joint**

Distance (ft): **68.5**
Structural Grade: **0**
O&M Grade: **3**
Clock Start/From: **7**
Clock To: **5**
1st Value:
2nd Value:
Value Percent: **30.000**
Continuous Index: **F02**
Within 8" of Joint: **YES**
Remarks:

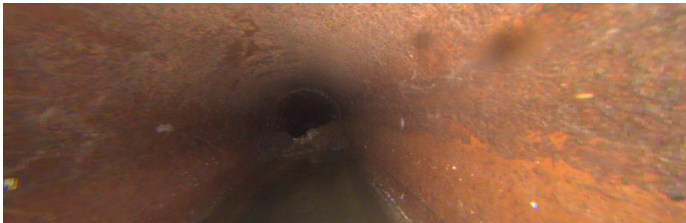
Code: **MSA**
Description: **Abandoned Survey**

Distance (ft): **68.5**
Structural Grade: **0**
O&M Grade: **0**
Clock Start/From:
Clock To:
1st Value:
2nd Value:
Value Percent:
Continuous Index:
Within 8" of Joint: **NO**
Remarks: **camera stopped**
