Profile/Photo Observation Report

Street:	E RAND ST	Flow Control:	Not Controlled
City:	Hobart, IN	Year Renewed:	
Location:	Other	Tape/Media #:	
Purpose:	Not Known	Dia/Height:	10"
Use:	Sanitary	Material:	VCP
Drain Area:	NA	Lining:	
Category:	NA		
Comment:

Location Details:		Direction of Survey:	Upstream
US MH:	M-803-030	DS MH:	M-803-037
		Total Length Surveyed (ft):	68.5

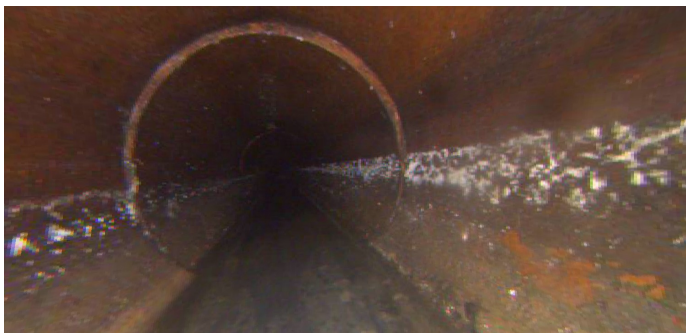
Code: **AMH**
Description: **Manhole**

Distance (ft): **.0**
Structural Grade: **0**
O&M Grade: **0**
Clock Start/From:
Clock To:
1st Value:
2nd Value:
Value Percent:
Continuous Index:
Within 8" of Joint: **NO**
Remarks: **M-803-037**

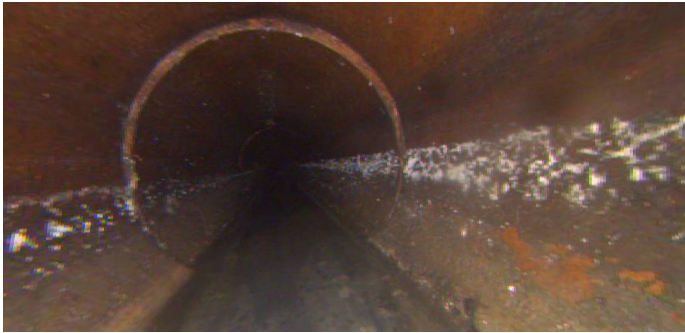
Code:	MWL
Description:	Water Level

Distance (ft):	.0
Structural Grade:	0
O&M Grade:	0
Clock Start/From:	
Clock To:	
1st Value:	
2nd Value:	
Value Percent:	5.000
Continuous Index:	
Within 8" of Joint:	NO
Remarks:

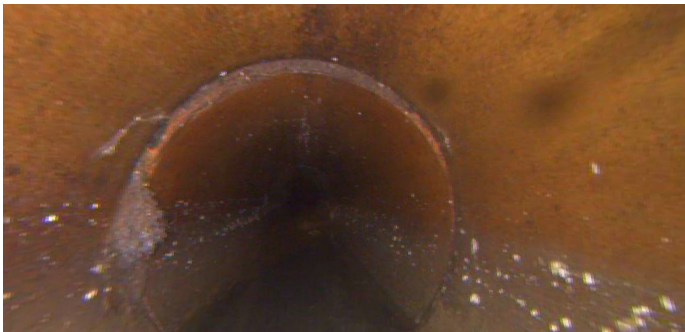
Code:	RFJ
Description:	Roots Fine Joint

Distance (ft):	7.5
Structural Grade:	0
O&M Grade:	1
Clock Start/From:	7
Clock To:	4
1st Value:	
2nd Value:	
Value Percent:	
Continuous Index:	S01
Within 8" of Joint:	YES
Remarks:

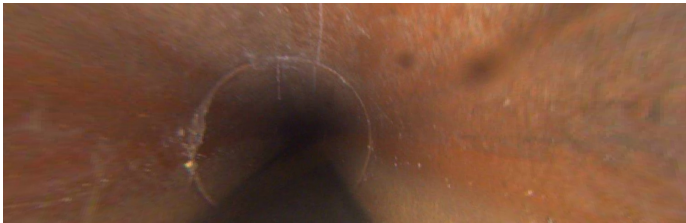
Code: **RFJ**
Description: **Roots Fine Joint**

Distance (ft): **37.0**
Structural Grade: **0**
O&M Grade: **1**
Clock Start/From: **7**
Clock To: **4**
1st Value:
2nd Value:
Value Percent:
Continuous Index: **F01**
Within 8" of Joint: **YES**
Remarks:

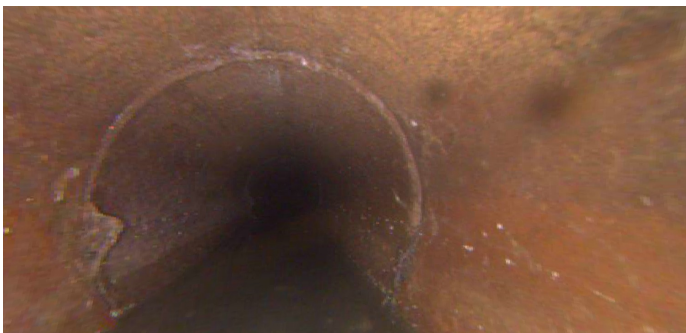
Code: **RFJ**
Description: **Roots Fine Joint**

Distance (ft): **58.1**
Structural Grade: **0**
O&M Grade: **1**
Clock Start/From: **7**
Clock To: **5**
1st Value:
2nd Value:
Value Percent:
Continuous Index:
Within 8" of Joint: **YES**
Remarks:

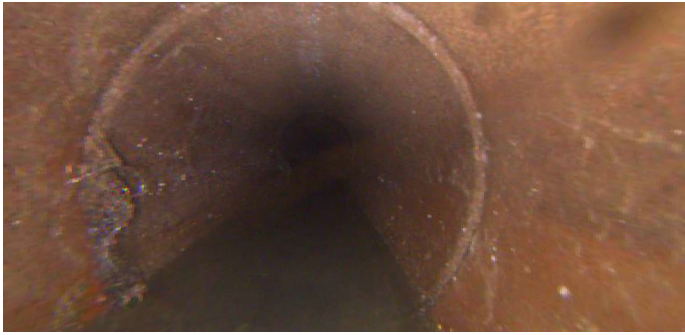
Code: **RFJ**
Description: **Roots Fine Joint**

Distance (ft): **61.3**
Structural Grade: **0**
O&M Grade: **1**
Clock Start/From: **7**
Clock To: **9**
1st Value:
2nd Value:
Value Percent:
Continuous Index:
Within 8" of Joint: **YES**
Remarks:

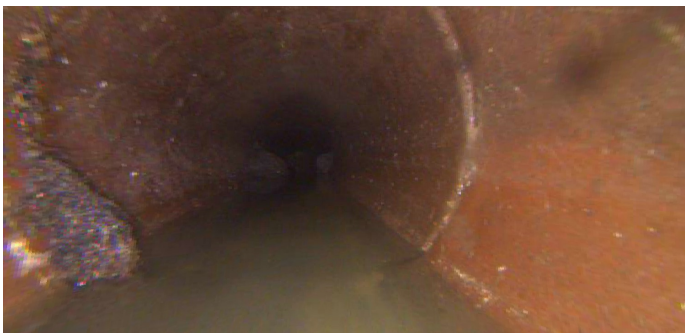
Code: **RMJ**
Description: **Roots Medium Joint**

Distance (ft): **64.3**
Structural Grade: **0**
O&M Grade: **3**
Clock Start/From: **7**
Clock To: **5**
1st Value:
2nd Value:
Value Percent: **30.000**
Continuous Index: **S02**
Within 8" of Joint: **YES**
Remarks:

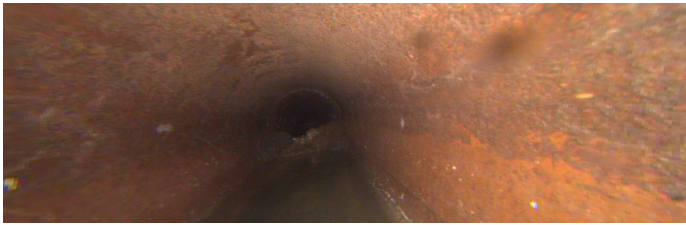
Code: **RMJ**
Description: **Roots Medium Joint**

Distance (ft): **68.5**
Structural Grade: **0**
O&M Grade: **3**
Clock Start/From: **7**
Clock To: **5**
1st Value:
2nd Value:
Value Percent: **30.000**
Continuous Index: **F02**
Within 8" of Joint: **YES**
Remarks:

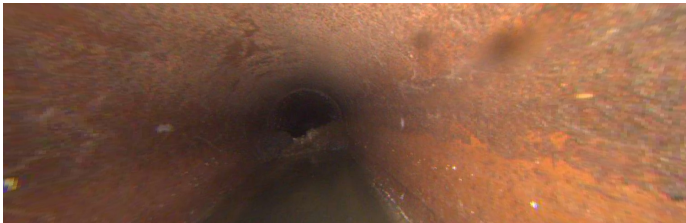
Code: **MSA**
Description: **Abandoned Survey**

Distance (ft): **68.5**
Structural Grade: **0**
O&M Grade: **0**
Clock Start/From:
Clock To:
1st Value:
2nd Value:
Value Percent:
Continuous Index:
Within 8" of Joint: **NO**
Remarks: **camera stopped**
