## Profile/Photo Observation Report

| Street: | <b>E RAND ST &amp; N OHIO ST</b> | Flow Control: | <b>Not Controlled</b> |
| City: | <b>Hobart, IN</b> | Year Renewed: | |

| US MH: | <b>M-803-030</b> | DS MH: | <b>M-803-037</b> |

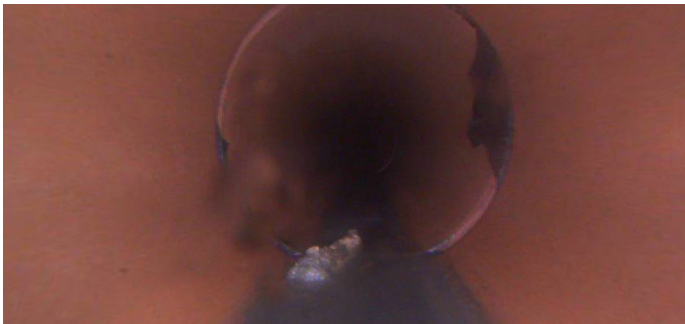
| Description: | <b>Intruding Sealing Ring</b> |

| Distance (ft): | <b>29.5</b> |
| O&M Grade: | <b>2</b> |
| Clock Start/From: | <b>7</b> |
| Clock To: | <b>4</b> |
| Value Percent: | <b>5.000</b> |

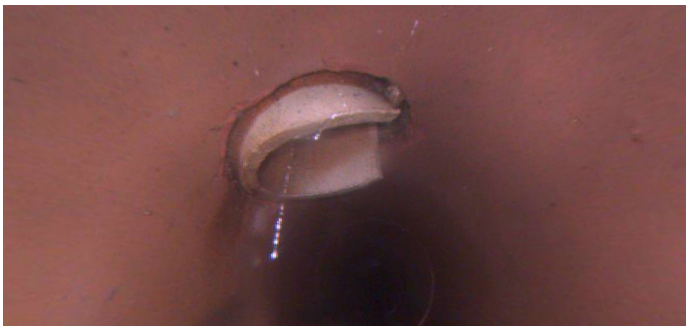
Code: **TBI**  
Description: **Tap Break-in Intruding**

Distance (ft): **88.0**  
Structural Grade: **0**  
O&M Grade: **2**  
Clock Start/From: **11**  
Clock To:  
1st Value: **4.000**  
2nd Value: **0.500**  
Value Percent:  
Continuous Index:  
Within 8" of Joint:  
Remarks:

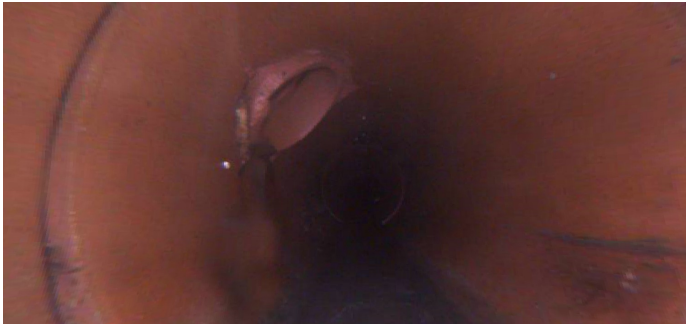
Code: **TBI**  
Description: **Tap Break-in Intruding**

Distance (ft): **149.8**  
Structural Grade: **0**  
O&M Grade: **2**  
Clock Start/From: **10**  
Clock To:  
1st Value: **4.000**  
2nd Value: **0.500**  
Value Percent:  
Continuous Index:  
Within 8" of Joint:  
Remarks:

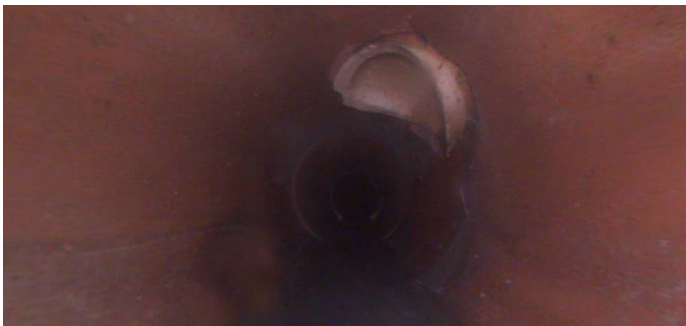
Code: **TB**  
Description: **Tap Break-in**

Distance (ft): **171.8**  
Structural Grade: **0**  
O&M Grade: **0**  
Clock Start/From: **1**  
Clock To:  
1st Value: **4.000**  
2nd Value:  
Value Percent:  
Continuous Index:  
Within 8" of Joint:  
Remarks:

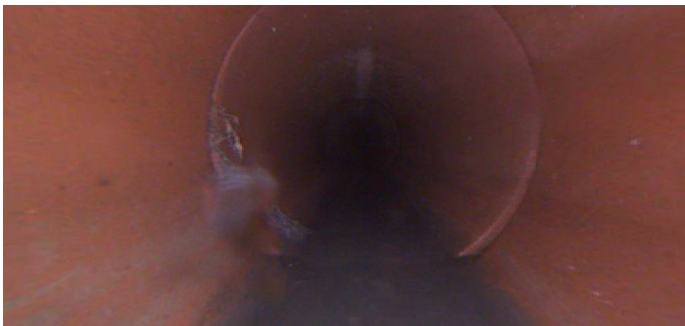
Code: **RFJ**  
Description: **Roots Fine Joint**

Distance (ft): **184.5**  
Structural Grade: **0**  
O&M Grade: **1**  
Clock Start/From: **9**  
Clock To:  
1st Value:  
2nd Value:  
Value Percent:  
Continuous Index:  
Within 8" of Joint: **YES**  
Remarks:

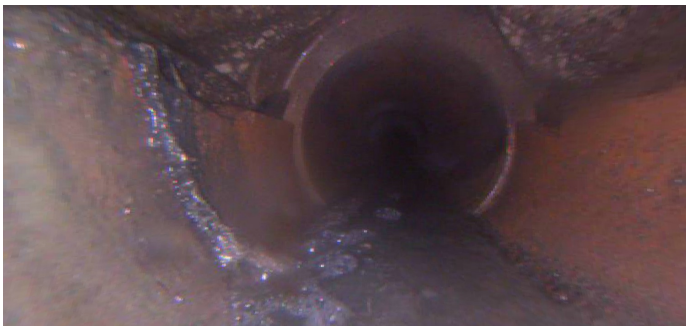
Code: **AMH**  
Description: **Manhole**

Distance (ft): **268.7**  
Structural Grade: **0**  
O&M Grade: **0**  
Clock Start/From:  
Clock To:  
1st Value:  
2nd Value:  
Value Percent:  
Continuous Index:  
Within 8" of Joint: **NO**  
Remarks: **M-803-037**
