## Profile/Photo Observation Report

Street:	<b>Rand St.</b>	Flow Control:	<b>Not Controlled</b>
City:	<b>Hobart, IN</b>	Year Renewed:	
Location:	<b>Light Highway</b>	Tape/Media #:	
Purpose:	<b>Routine Assessment</b>	Dia/Height:	<b>12"</b>
Use:	<b>Sanitary</b>	Material:	<b>VCP</b>
Drain Area:	<b>NA</b>	Lining:	
Category:	<b>NA</b>		
Comment:

Location Details:		Direction of Survey:	<b>Downstream</b>
US MH:	<b>M-803-030</b>	DS MH:	<b>M-803-037</b>
		Total Length Surveyed (ft):	<b>268.7</b>

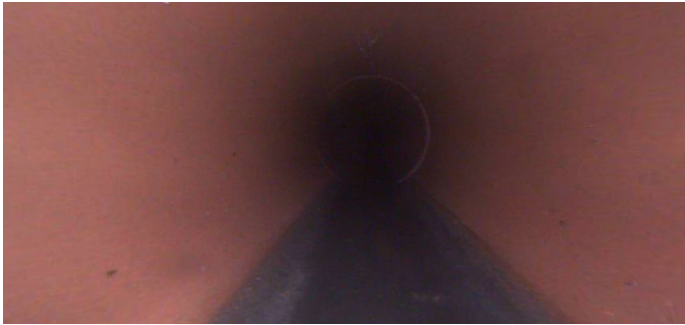
Code:	<b>MWL</b>
Description:	<b>Water Level</b>

Distance (ft):	<b>.0</b>
Structural Grade:	<b>0</b>
O&M Grade:	<b>0</b>
Clock Start/From:	
Clock To:	
1st Value:	
2nd Value:	
Value Percent:	<b>10.000</b>
Continuous Index:	
Within 8" of Joint:	<b>NO</b>
Remarks:

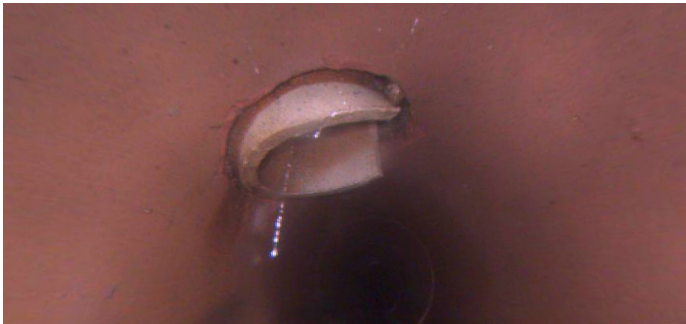
Code: **TBI**  
Description: **Tap Break-in Intruding**

Distance (ft): **88.0**  
Structural Grade: **0**  
O&M Grade: **2**  
Clock Start/From: **11**  
Clock To:  
1st Value: **4.000**  
2nd Value: **0.500**  
Value Percent:  
Continuous Index:  
Within 8" of Joint:  
Remarks:

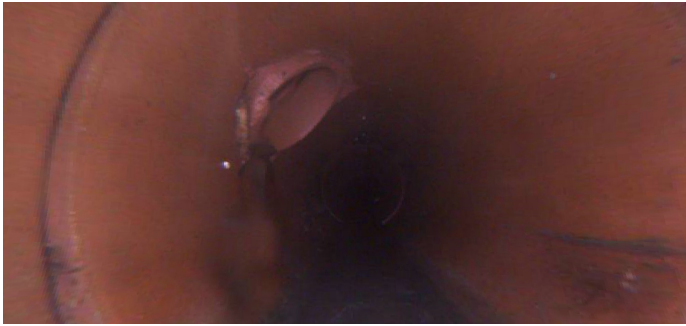
Code: **TBI**  
Description: **Tap Break-in Intruding**

Distance (ft): **149.8**  
Structural Grade: **0**  
O&M Grade: **2**  
Clock Start/From: **10**  
Clock To:  
1st Value: **4.000**  
2nd Value: **0.500**  
Value Percent:  
Continuous Index:  
Within 8" of Joint:  
Remarks:

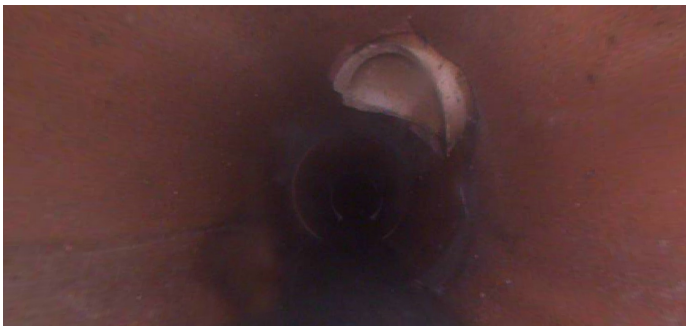
Code: **TB**  
Description: **Tap Break-in**

Distance (ft): **171.8**  
Structural Grade: **0**  
O&M Grade: **0**  
Clock Start/From: **1**  
Clock To:  
1st Value: **4.000**  
2nd Value:  
Value Percent:  
Continuous Index:  
Within 8" of Joint:  
Remarks:

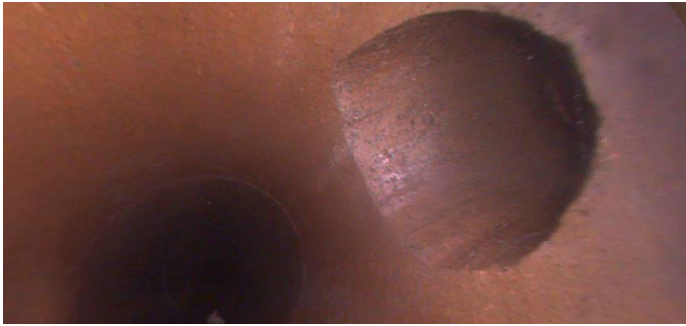
Code: **TF**  
Description: **Tap Factory**

Distance (ft): **177.7**  
Structural Grade: **0**  
O&M Grade: **0**  
Clock Start/From: **2**  
Clock To:  
1st Value: **4.000**  
2nd Value:  
Value Percent:  
Continuous Index:  
Within 8" of Joint:  
Remarks:

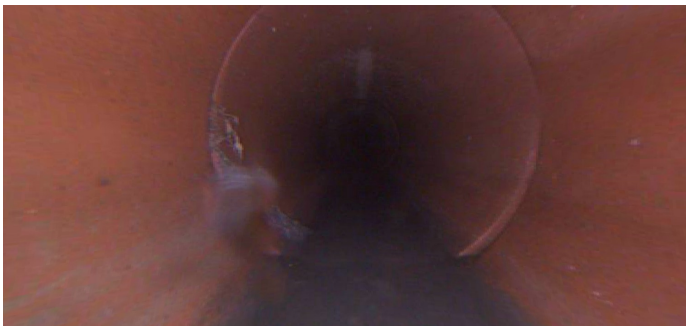
Code: **RFJ**  
Description: **Roots Fine Joint**

Distance (ft): **184.5**  
Structural Grade: **0**  
O&M Grade: **1**  
Clock Start/From: **9**  
Clock To:  
1st Value:  
2nd Value:  
Value Percent:  
Continuous Index:  
Within 8" of Joint: **YES**  
Remarks:

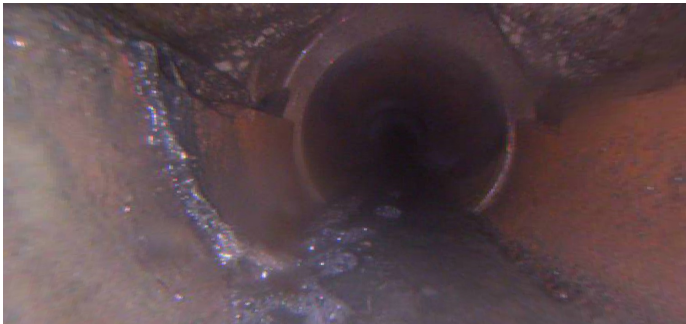
Code: **AMH**  
Description: **Manhole**

Distance (ft): **268.7**  
Structural Grade: **0**  
O&M Grade: **0**  
Clock Start/From:  
Clock To:  
1st Value:  
2nd Value:  
Value Percent:  
Continuous Index:  
Within 8" of Joint: **NO**  
Remarks: **M-803-037**
