## Profile/Photo Observation Report

Street:	<b>ALLEY BETWEEN N INDIANA ST &amp; N</b>	Flow Control:	<b>Not Controlled</b>
City:	<b>Hobart, IN</b>	Year Renewed:	
Location:	<b>Other</b>	Tape/Media #:	
Purpose:	<b>Not Known</b>	Dia/Height:	<b>10"</b>
Use:	<b>Sanitary</b>	Material:	<b>VCP</b>
Drain Area:	<b>NA</b>	Lining:	
Category:	<b>NA</b>		
Comment:

Location Details:		Direction of Survey:	<b>Downstream</b>
US MH:	<b>M-803-033</b>	DS MH:	<b>M-803-032</b>
		Total Length Surveyed (ft):	<b>159.6</b>

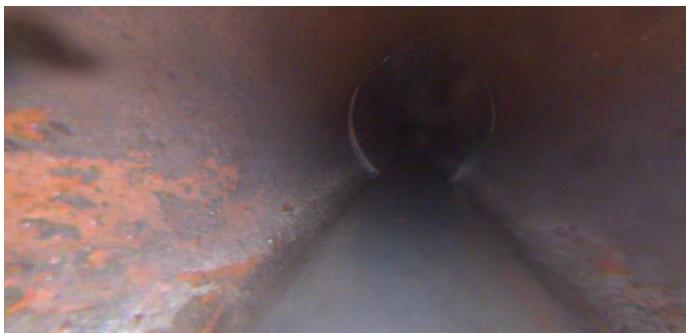
Code: **AMH**  
Description: **Manhole**

Distance (ft): **.0**  
Structural Grade: **0**  
O&M Grade: **0**  
Clock Start/From:  
Clock To:  
1st Value:  
2nd Value:  
Value Percent:  
Continuous Index:  
Within 8" of Joint: **NO**  
Remarks: **M-803-033**

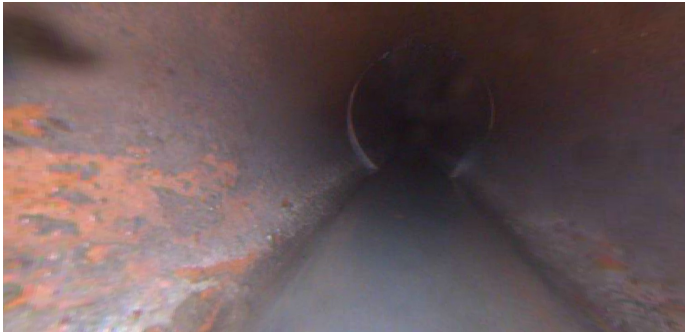
Code:	<b>MWL</b>
Description:	<b>Water Level</b>

Distance (ft):	<b>.0</b>
Structural Grade:	<b>0</b>
O&M Grade:	<b>0</b>
Clock Start/From:	
Clock To:	
1st Value:	
2nd Value:	
Value Percent:	<b>5.000</b>
Continuous Index:	
Within 8" of Joint:	<b>NO</b>
Remarks:

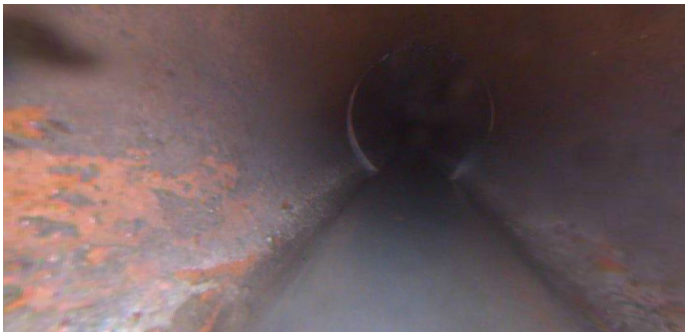
Code:	<b>RFJ</b>
Description:	<b>Roots Fine Joint</b>

Distance (ft):	<b>.0</b>
Structural Grade:	<b>0</b>
O&M Grade:	<b>1</b>
Clock Start/From:	<b>4</b>
Clock To:	<b>5</b>
1st Value:	
2nd Value:	
Value Percent:	
Continuous Index:	
Within 8" of Joint:	<b>YES</b>
Remarks:

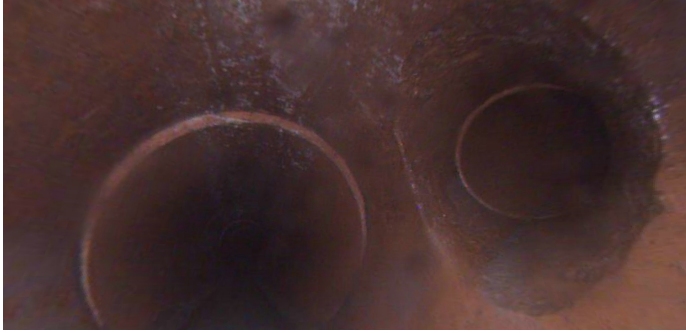
Code: **TF**  
Description: **Tap Factory**

Distance (ft): **10.0**  
Structural Grade: **0**  
O&M Grade: **0**  
Clock Start/From: **3**  
Clock To:  
1st Value: **4.000**  
2nd Value:  
Value Percent:  
Continuous Index:  
Within 8" of Joint:  
Remarks:

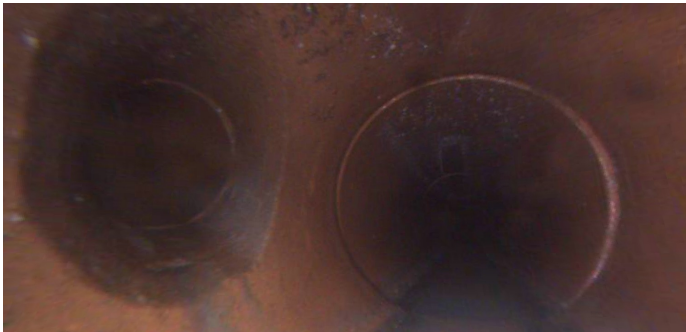
Code: **TF**  
Description: **Tap Factory**

Distance (ft): **20.9**  
Structural Grade: **0**  
O&M Grade: **0**  
Clock Start/From: **9**  
Clock To:  
1st Value: **4.000**  
2nd Value:  
Value Percent:  
Continuous Index:  
Within 8" of Joint:  
Remarks:

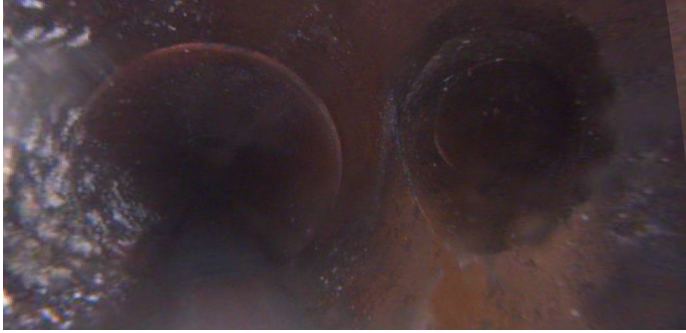
Code: **TF**  
Description: **Tap Factory**

Distance (ft): **61.7**  
Structural Grade: **0**  
O&M Grade: **0**  
Clock Start/From: **3**  
Clock To:  
1st Value: **4.000**  
2nd Value:  
Value Percent:  
Continuous Index:  
Within 8" of Joint:  
Remarks:

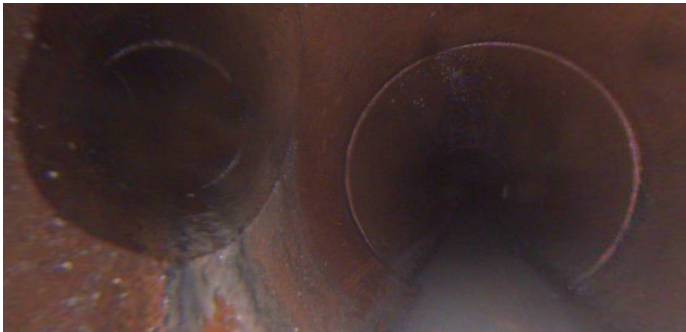
Code: **TF**  
Description: **Tap Factory**

Distance (ft): **78.7**  
Structural Grade: **0**  
O&M Grade: **0**  
Clock Start/From: **9**  
Clock To:  
1st Value: **4.000**  
2nd Value:  
Value Percent:  
Continuous Index:  
Within 8" of Joint:  
Remarks:

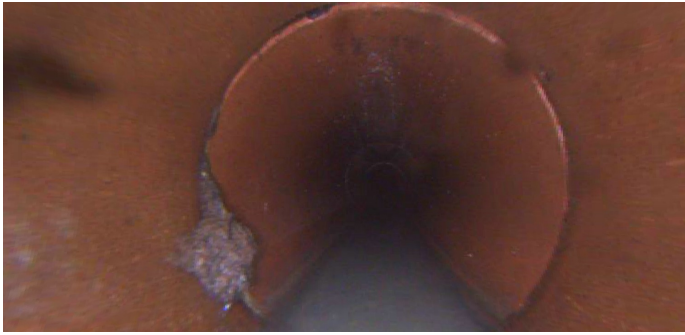
Code: **RFJ**  
Description: **Roots Fine Joint**

Distance (ft): **85.1**  
Structural Grade: **0**  
O&M Grade: **1**  
Clock Start/From: **7**  
Clock To: **9**  
1st Value:  
2nd Value:  
Value Percent:  
Continuous Index:  
Within 8" of Joint: **YES**  
Remarks:

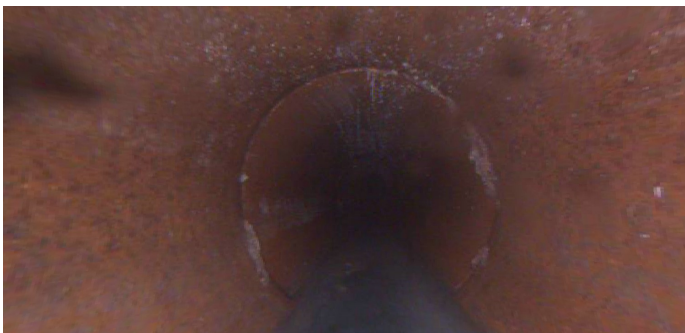
Code: **RFJ**  
Description: **Roots Fine Joint**

Distance (ft): **96.5**  
Structural Grade: **0**  
O&M Grade: **1**  
Clock Start/From: **7**  
Clock To: **5**  
1st Value:  
2nd Value:  
Value Percent:  
Continuous Index:  
Within 8" of Joint: **YES**  
Remarks:

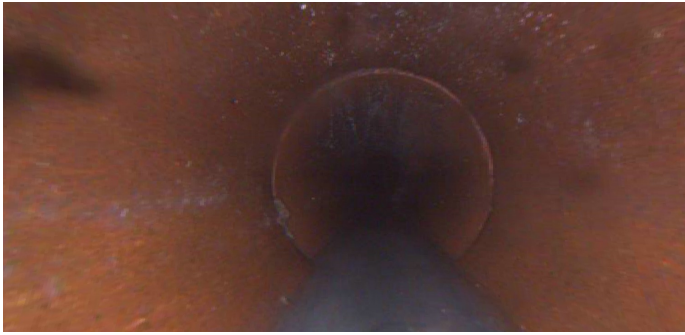
Code: **RFJ**  
Description: **Roots Fine Joint**

Distance (ft): **99.3**  
Structural Grade: **0**  
O&M Grade: **1**  
Clock Start/From: **7**  
Clock To: **5**  
1st Value:  
2nd Value:  
Value Percent:  
Continuous Index:  
Within 8" of Joint: **YES**  
Remarks:

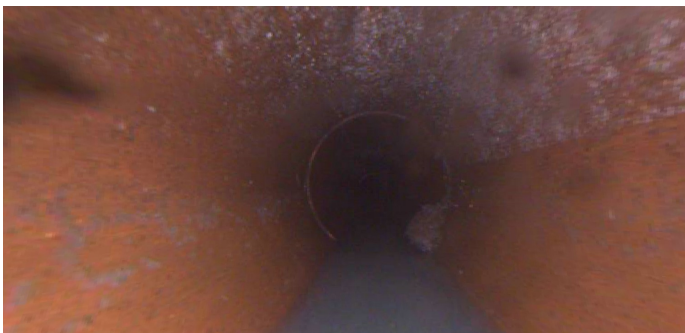
Code: **RMJ**  
Description: **Roots Medium Joint**

Distance (ft): **102.7**  
Structural Grade: **0**  
O&M Grade: **3**  
Clock Start/From: **2**  
Clock To: **5**  
1st Value:  
2nd Value:  
Value Percent: **10.000**  
Continuous Index:  
Within 8" of Joint: **YES**  
Remarks:

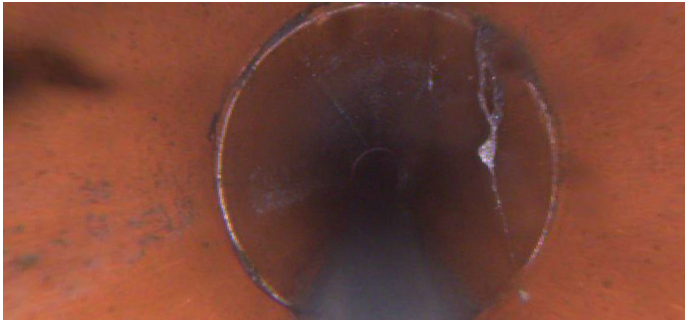
Code: **RFJ**  
Description: **Roots Fine Joint**

Distance (ft): **107.9**  
Structural Grade: **0**  
O&M Grade: **1**  
Clock Start/From: **7**  
Clock To: **5**  
1st Value:  
2nd Value:  
Value Percent:  
Continuous Index:  
Within 8" of Joint: **YES**  
Remarks:

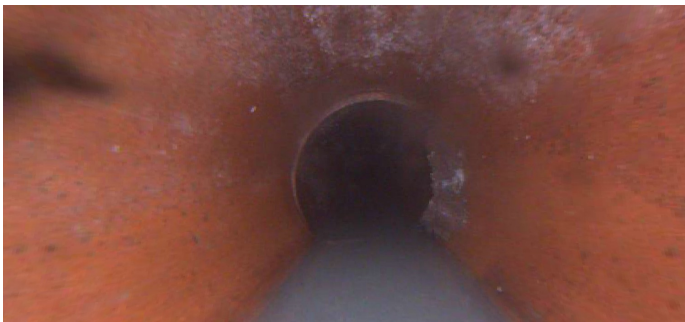
Code: **RMJ**  
Description: **Roots Medium Joint**

Distance (ft): **111.1**  
Structural Grade: **0**  
O&M Grade: **3**  
Clock Start/From: **12**  
Clock To: **5**  
1st Value:  
2nd Value:  
Value Percent: **10.000**  
Continuous Index:  
Within 8" of Joint: **YES**  
Remarks:

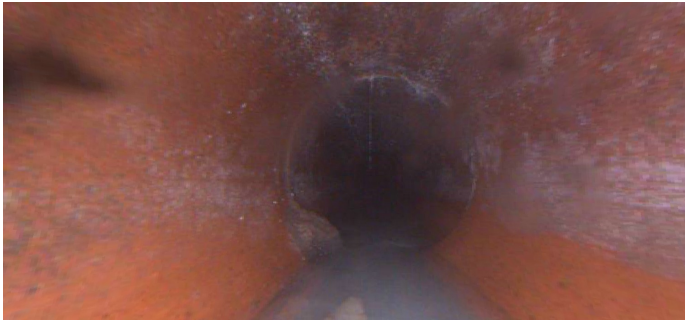
Code: **RMJ**  
Description: **Roots Medium Joint**

Distance (ft): **115.4**  
Structural Grade: **0**  
O&M Grade: **3**  
Clock Start/From: **7**  
Clock To: **5**  
1st Value:  
2nd Value:  
Value Percent: **10.000**  
Continuous Index:  
Within 8" of Joint: **YES**  
Remarks:

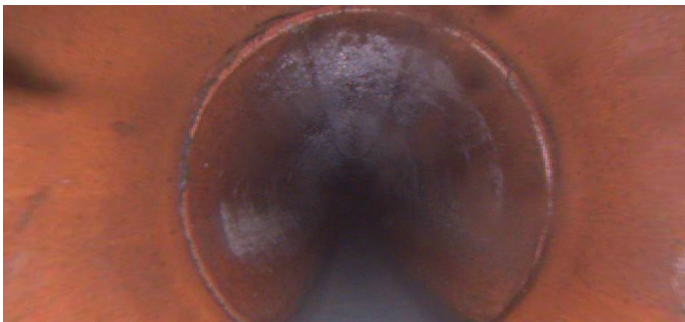
Code: **RFJ**  
Description: **Roots Fine Joint**

Distance (ft): **123.2**  
Structural Grade: **0**  
O&M Grade: **1**  
Clock Start/From: **7**  
Clock To: **5**  
1st Value:  
2nd Value:  
Value Percent:  
Continuous Index:  
Within 8" of Joint: **YES**  
Remarks:

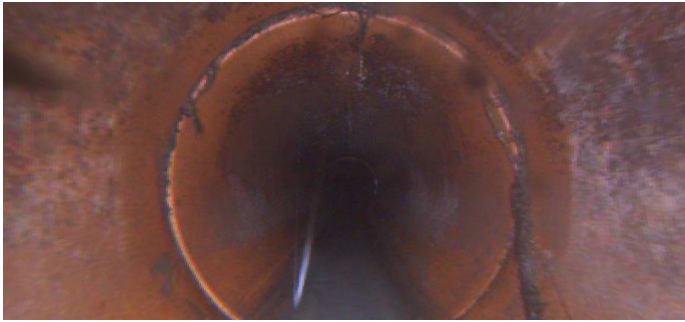
Code: **RFJ**  
Description: **Roots Fine Joint**

Distance (ft): **140.3**  
Structural Grade: **0**  
O&M Grade: **1**  
Clock Start/From: **9**  
Clock To: **5**  
1st Value:  
2nd Value:  
Value Percent:  
Continuous Index:  
Within 8" of Joint: **YES**  
Remarks:

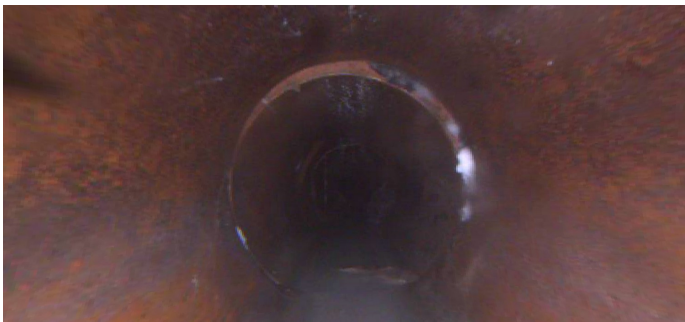
Code: **RFJ**  
Description: **Roots Fine Joint**

Distance (ft): **143.9**  
Structural Grade: **0**  
O&M Grade: **1**  
Clock Start/From: **7**  
Clock To: **5**  
1st Value:  
2nd Value:  
Value Percent:  
Continuous Index:  
Within 8" of Joint: **YES**  
Remarks:

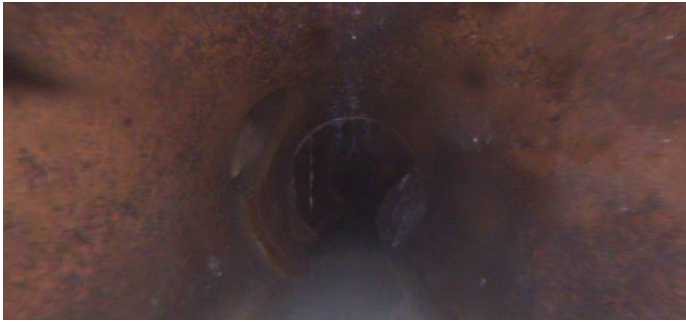
Code: **RMJ**  
Description: **Roots Medium Joint**

Distance (ft): **145.0**  
Structural Grade: **0**  
O&M Grade: **3**  
Clock Start/From: **7**  
Clock To: **5**  
1st Value:  
2nd Value:  
Value Percent: **10.000**  
Continuous Index:  
Within 8" of Joint: **YES**  
Remarks:

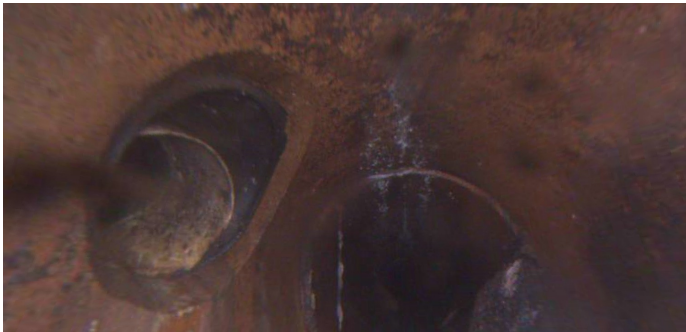
Code: **TB**  
Description: **Tap Break-in**

Distance (ft): **145.7**  
Structural Grade: **0**  
O&M Grade: **0**  
Clock Start/From: **10**  
Clock To:  
1st Value: **4.000**  
2nd Value:  
Value Percent:  
Continuous Index:  
Within 8" of Joint:  
Remarks:

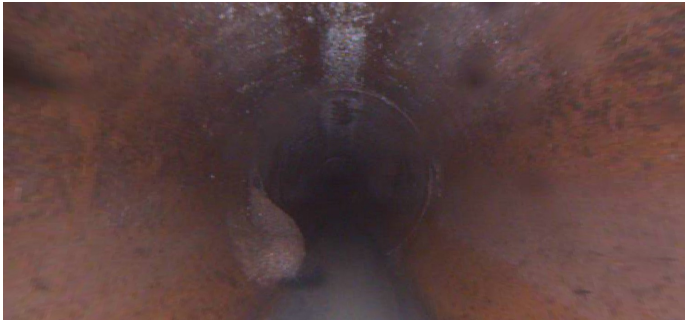
Code: **RMJ**  
Description: **Roots Medium Joint**

Distance (ft): **148.2**  
Structural Grade: **0**  
O&M Grade: **3**  
Clock Start/From: **7**  
Clock To: **9**  
1st Value:  
2nd Value:  
Value Percent: **10.000**  
Continuous Index:  
Within 8" of Joint: **YES**  
Remarks:

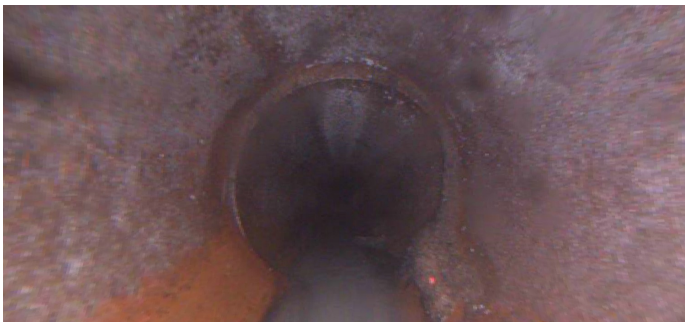
Code: **RMJ**  
Description: **Roots Medium Joint**

Distance (ft): **152.6**  
Structural Grade: **0**  
O&M Grade: **3**  
Clock Start/From: **9**  
Clock To: **5**  
1st Value:  
2nd Value:  
Value Percent: **10.000**  
Continuous Index:  
Within 8" of Joint: **YES**  
Remarks:

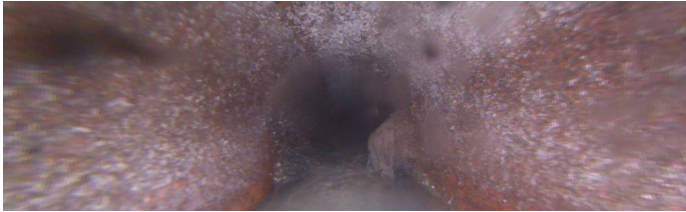
Code: **RMJ**  
Description: **Roots Medium Joint**

Distance (ft): **156.5**  
Structural Grade: **0**  
O&M Grade: **3**  
Clock Start/From: **7**  
Clock To: **5**  
1st Value:  
2nd Value:  
Value Percent: **10.000**  
Continuous Index:  
Within 8" of Joint: **YES**  
Remarks:

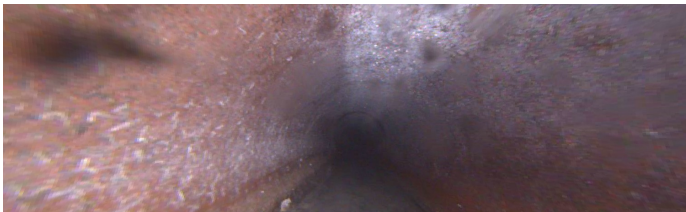
Code: **MSA**  
Description: **Abandoned Survey**

Distance (ft): **159.6**  
Structural Grade: **0**  
O&M Grade: **0**  
Clock Start/From:  
Clock To:  
1st Value:  
2nd Value:  
Value Percent:  
Continuous Index:  
Within 8" of Joint: **NO**  
Remarks: **camera stopped**
