Profile/Photo Observation Report

Street:	N INDIANA ST	Flow Control:	Not Controlled
City:	Hobart, IN	Year Renewed:	
Location:	Other	Tape/Media #:	
Purpose:	Not Known	Dia/Height:	10"
Use:	Sanitary	Material:	VCP
Drain Area:	NA	Lining:	
Category:	NA		
Comment:

Location Details:		Direction of Survey:	Downstream
US MH:	M-803-033	DS MH:	M-803-032
		Total Length Surveyed (ft):	159.6

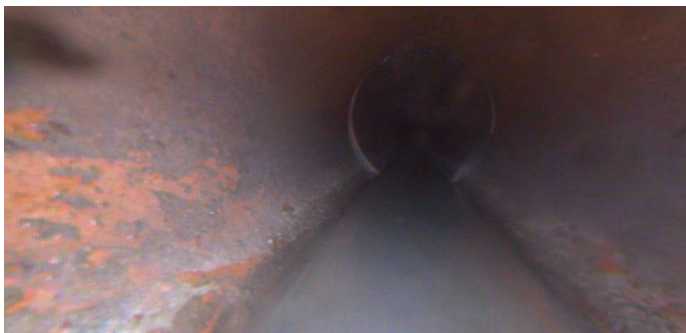
Code: **AMH**
Description: **Manhole**

Distance (ft): **.0**
Structural Grade: **0**
O&M Grade: **0**
Clock Start/From:
Clock To:
1st Value:
2nd Value:
Value Percent:
Continuous Index:
Within 8" of Joint: **NO**
Remarks: **M-803-033**

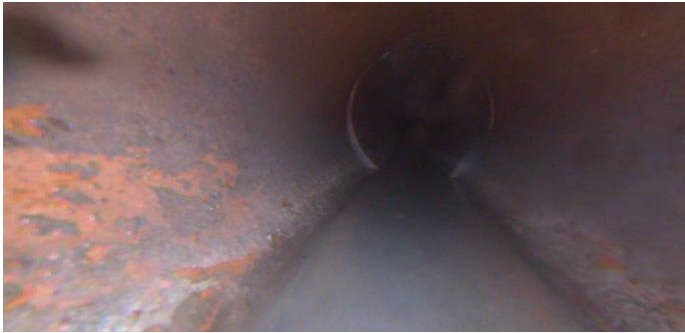
Code:	MWL
Description:	Water Level

Distance (ft):	.0
Structural Grade:	0
O&M Grade:	0
Clock Start/From:	
Clock To:	
1st Value:	
2nd Value:	
Value Percent:	5.000
Continuous Index:	
Within 8" of Joint:	NO
Remarks:

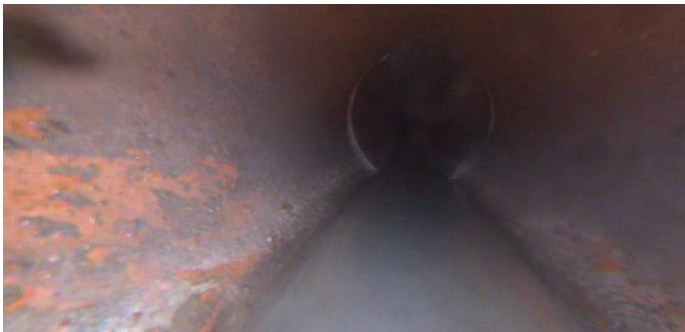
Code:	RFJ
Description:	Roots Fine Joint

Distance (ft):	.0
Structural Grade:	0
O&M Grade:	1
Clock Start/From:	4
Clock To:	5
1st Value:	
2nd Value:	
Value Percent:	
Continuous Index:	
Within 8" of Joint:	YES
Remarks:

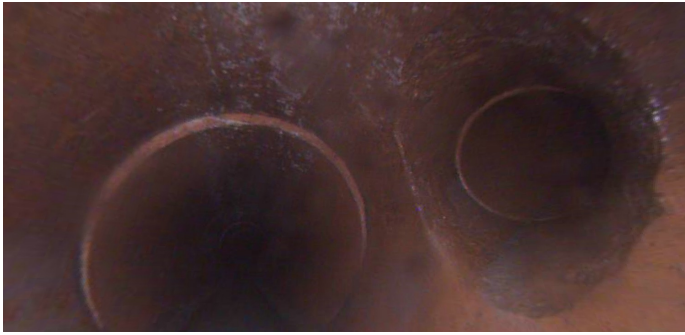
Code: **TF**
Description: **Tap Factory**

Distance (ft): **10.0**
Structural Grade: **0**
O&M Grade: **0**
Clock Start/From: **3**
Clock To:
1st Value: **4.000**
2nd Value:
Value Percent:
Continuous Index:
Within 8" of Joint:
Remarks:

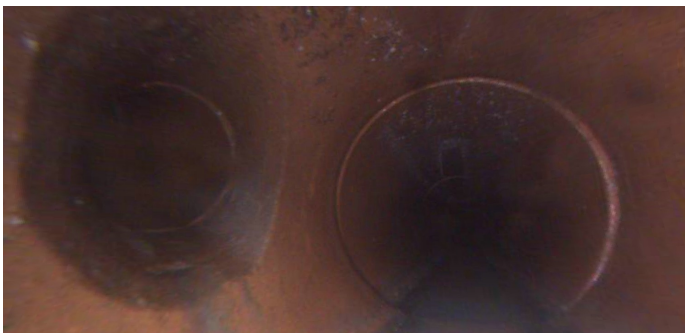
Code: **TF**
Description: **Tap Factory**

Distance (ft): **20.9**
Structural Grade: **0**
O&M Grade: **0**
Clock Start/From: **9**
Clock To:
1st Value: **4.000**
2nd Value:
Value Percent:
Continuous Index:
Within 8" of Joint:
Remarks:

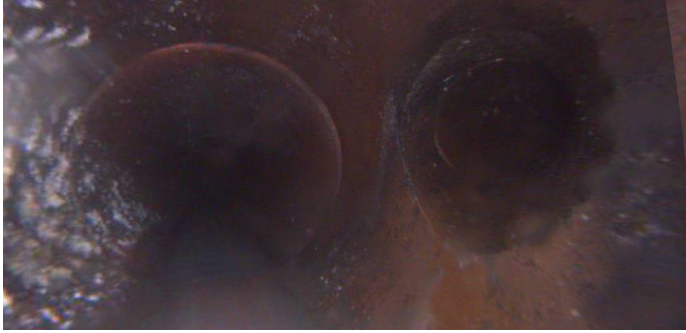
Code: **TF**
Description: **Tap Factory**

Distance (ft): **61.7**
Structural Grade: **0**
O&M Grade: **0**
Clock Start/From: **3**
Clock To:
1st Value: **4.000**
2nd Value:
Value Percent:
Continuous Index:
Within 8" of Joint:
Remarks:

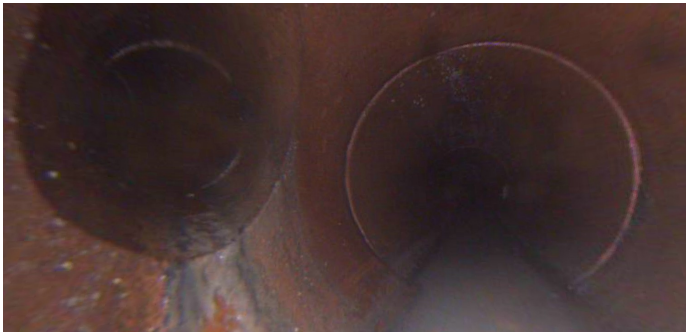
Code: **TF**
Description: **Tap Factory**

Distance (ft): **78.7**
Structural Grade: **0**
O&M Grade: **0**
Clock Start/From: **9**
Clock To:
1st Value: **4.000**
2nd Value:
Value Percent:
Continuous Index:
Within 8" of Joint:
Remarks:

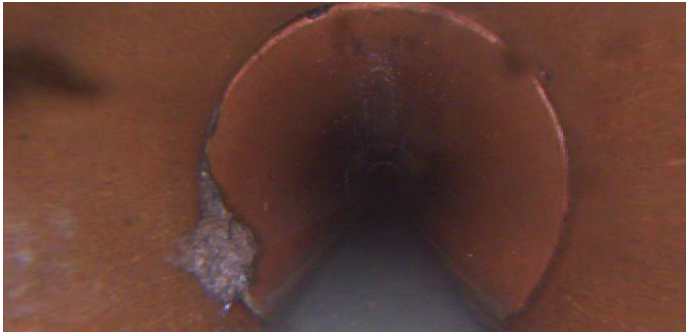
Code: **RFJ**
Description: **Roots Fine Joint**

Distance (ft): **85.1**
Structural Grade: **0**
O&M Grade: **1**
Clock Start/From: **7**
Clock To: **9**
1st Value:
2nd Value:
Value Percent:
Continuous Index:
Within 8" of Joint: **YES**
Remarks:

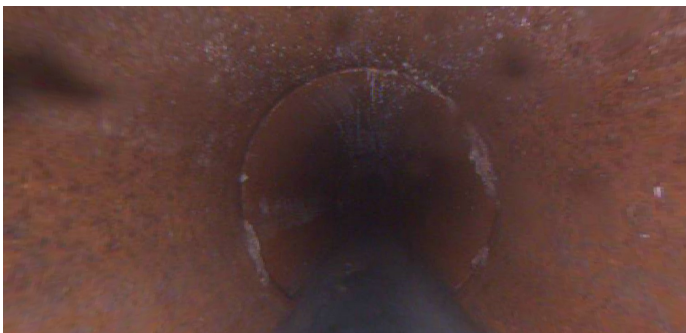
Code: **RFJ**
Description: **Roots Fine Joint**

Distance (ft): **96.5**
Structural Grade: **0**
O&M Grade: **1**
Clock Start/From: **7**
Clock To: **5**
1st Value:
2nd Value:
Value Percent:
Continuous Index:
Within 8" of Joint: **YES**
Remarks:

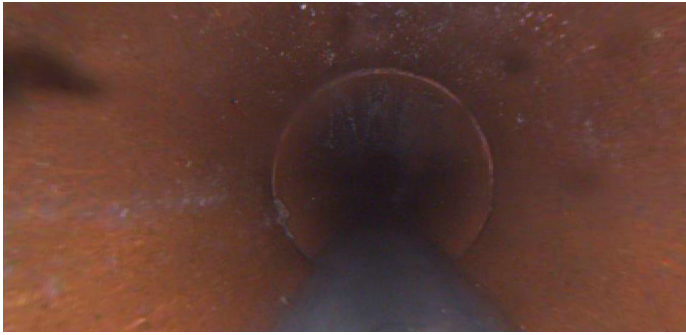
Code: **RFJ**
Description: **Roots Fine Joint**

Distance (ft): **99.3**
Structural Grade: **0**
O&M Grade: **1**
Clock Start/From: **7**
Clock To: **5**
1st Value:
2nd Value:
Value Percent:
Continuous Index:
Within 8" of Joint: **YES**
Remarks:

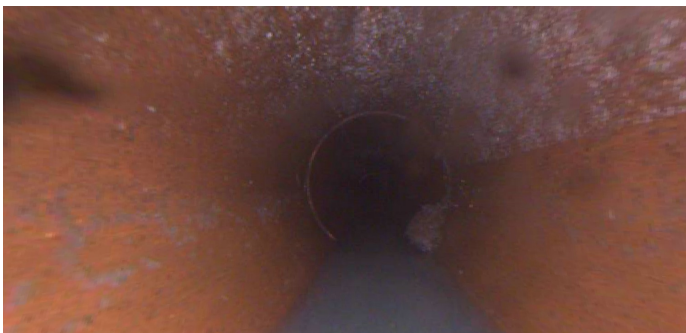
Code: **RMJ**
Description: **Roots Medium Joint**

Distance (ft): **102.7**
Structural Grade: **0**
O&M Grade: **3**
Clock Start/From: **2**
Clock To: **5**
1st Value:
2nd Value:
Value Percent: **10.000**
Continuous Index:
Within 8" of Joint: **YES**
Remarks:

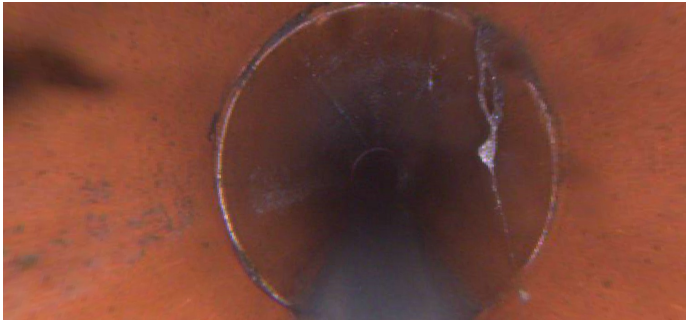
Code: **RFJ**
Description: **Roots Fine Joint**

Distance (ft): **107.9**
Structural Grade: **0**
O&M Grade: **1**
Clock Start/From: **7**
Clock To: **5**
1st Value:
2nd Value:
Value Percent:
Continuous Index:
Within 8" of Joint: **YES**
Remarks:

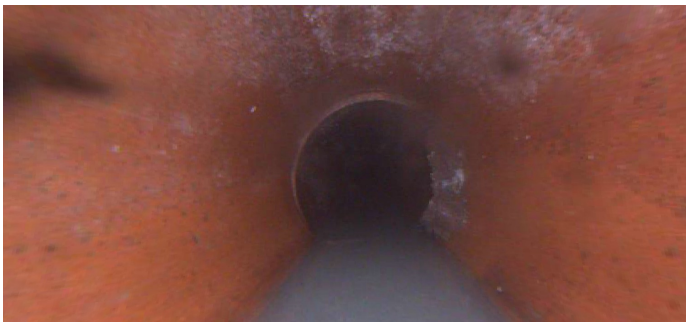
Code: **RMJ**
Description: **Roots Medium Joint**

Distance (ft): **111.1**
Structural Grade: **0**
O&M Grade: **3**
Clock Start/From: **12**
Clock To: **5**
1st Value:
2nd Value:
Value Percent: **10.000**
Continuous Index:
Within 8" of Joint: **YES**
Remarks:

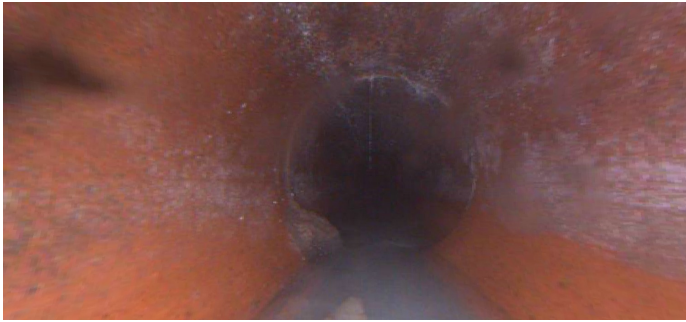
Code: **RMJ**
Description: **Roots Medium Joint**

Distance (ft): **115.4**
Structural Grade: **0**
O&M Grade: **3**
Clock Start/From: **7**
Clock To: **5**
1st Value:
2nd Value:
Value Percent: **10.000**
Continuous Index:
Within 8" of Joint: **YES**
Remarks:

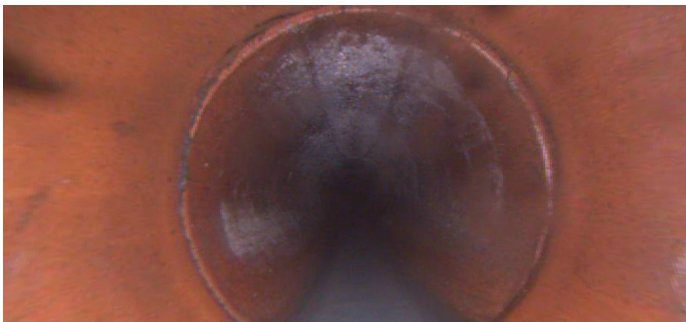
Code: **RFJ**
Description: **Roots Fine Joint**

Distance (ft): **123.2**
Structural Grade: **0**
O&M Grade: **1**
Clock Start/From: **7**
Clock To: **5**
1st Value:
2nd Value:
Value Percent:
Continuous Index:
Within 8" of Joint: **YES**
Remarks:

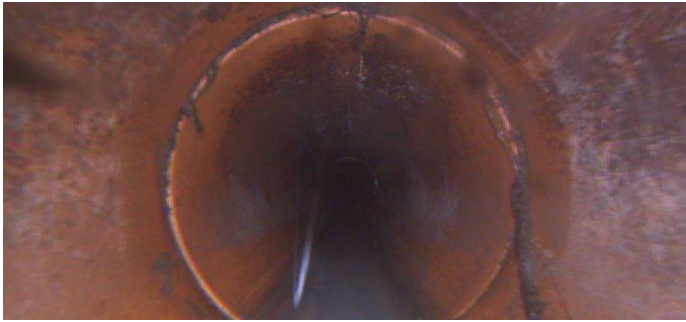
Code: **RFJ**
Description: **Roots Fine Joint**

Distance (ft): **140.3**
Structural Grade: **0**
O&M Grade: **1**
Clock Start/From: **9**
Clock To: **5**
1st Value:
2nd Value:
Value Percent:
Continuous Index:
Within 8" of Joint: **YES**
Remarks:

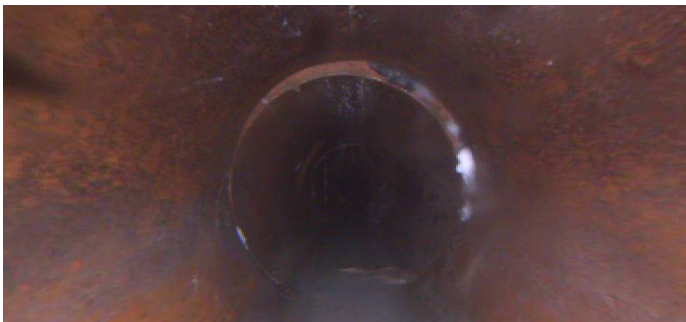
Code: **RFJ**
Description: **Roots Fine Joint**

Distance (ft): **143.9**
Structural Grade: **0**
O&M Grade: **1**
Clock Start/From: **7**
Clock To: **5**
1st Value:
2nd Value:
Value Percent:
Continuous Index:
Within 8" of Joint: **YES**
Remarks:

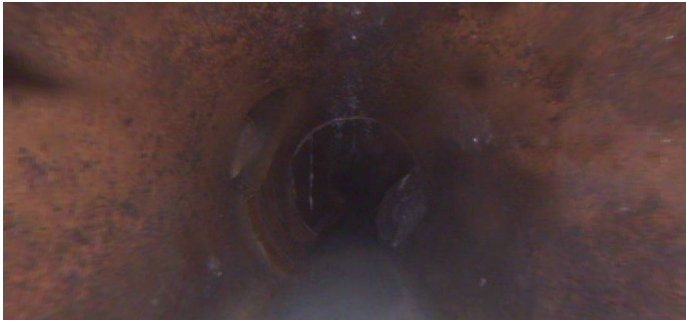
Code: **RMJ**
Description: **Roots Medium Joint**

Distance (ft): **145.0**
Structural Grade: **0**
O&M Grade: **3**
Clock Start/From: **7**
Clock To: **5**
1st Value:
2nd Value:
Value Percent: **10.000**
Continuous Index:
Within 8" of Joint: **YES**
Remarks:

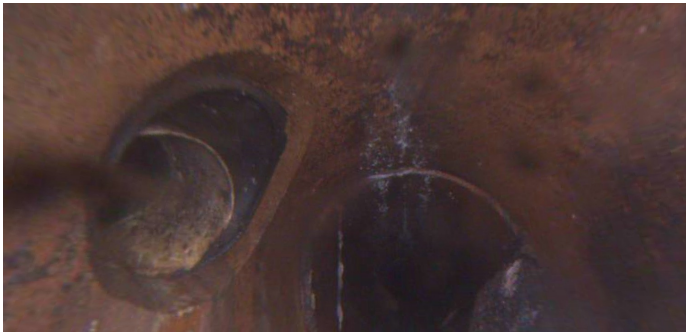
Code: **TB**
Description: **Tap Break-in**

Distance (ft): **145.7**
Structural Grade: **0**
O&M Grade: **0**
Clock Start/From: **10**
Clock To:
1st Value: **4.000**
2nd Value:
Value Percent:
Continuous Index:
Within 8" of Joint:
Remarks:

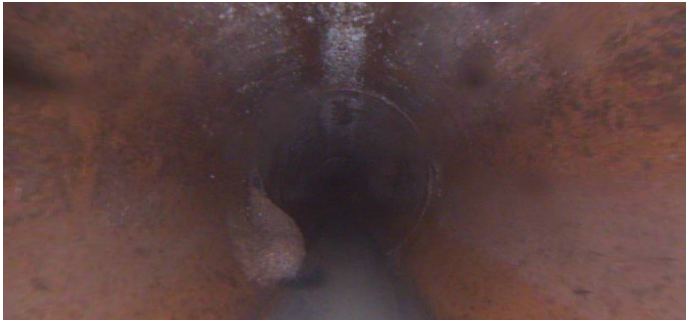
Code: **RMJ**
Description: **Roots Medium Joint**

Distance (ft): **148.2**
Structural Grade: **0**
O&M Grade: **3**
Clock Start/From: **7**
Clock To: **9**
1st Value:
2nd Value:
Value Percent: **10.000**
Continuous Index:
Within 8" of Joint: **YES**
Remarks:

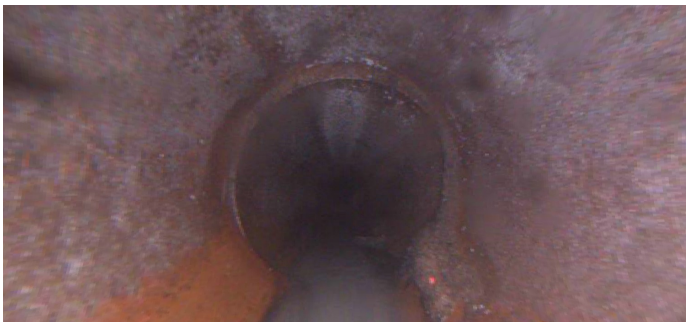
Code: **RMJ**
Description: **Roots Medium Joint**

Distance (ft): **152.6**
Structural Grade: **0**
O&M Grade: **3**
Clock Start/From: **9**
Clock To: **5**
1st Value:
2nd Value:
Value Percent: **10.000**
Continuous Index:
Within 8" of Joint: **YES**
Remarks:

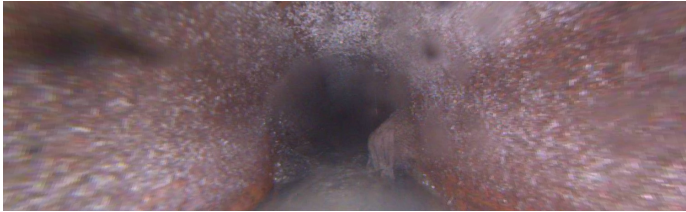
Code: **RMJ**
Description: **Roots Medium Joint**

Distance (ft): **156.5**
Structural Grade: **0**
O&M Grade: **3**
Clock Start/From: **7**
Clock To: **5**
1st Value:
2nd Value:
Value Percent: **10.000**
Continuous Index:
Within 8" of Joint: **YES**
Remarks:

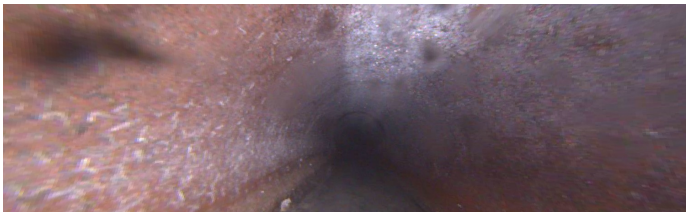
Code: **MSA**
Description: **Abandoned Survey**

Distance (ft): **159.6**
Structural Grade: **0**
O&M Grade: **0**
Clock Start/From:
Clock To:
1st Value:
2nd Value:
Value Percent:
Continuous Index:
Within 8" of Joint: **NO**
Remarks: **camera stopped**
