## Profile/Photo Observation Report

Street:	<b>ALLEY BETWEEN N INDIANA ST &amp; N</b>	Flow Control:	<b>Not Controlled</b>
City:	<b>Hobart, IN</b>	Year Renewed:	
Location:	<b>Light Highway</b>	Tape/Media #:	
Purpose:	<b>Routine Assessment</b>	Dia/Height:	<b>12"</b>
Use:	<b>Sanitary</b>	Material:	<b>VCP</b>
Drain Area:	<b>NA</b>	Lining:	
Category:	<b>NA</b>		
Comment:

Location Details:		Direction of Survey:	<b>Downstream</b>
US MH:	<b>M-803-033</b>	DS MH:	<b>M-803-032</b>
		Total Length Surveyed (ft):	<b>153.2</b>

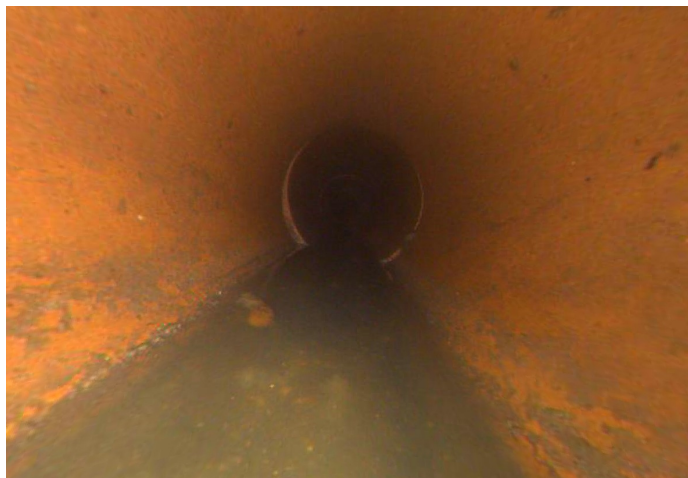
Code: **AMH**  
 Description: **Manhole**

Distance (ft): **.0**  
 Structural Grade: **0**  
 O&M Grade: **0**  
 Clock Start/From:  
 Clock To:  
 1st Value:  
 2nd Value:  
 Value Percent:  
 Continuous Index:  
 Within 8" of Joint: **NO**  
 Remarks: **M-803-033**

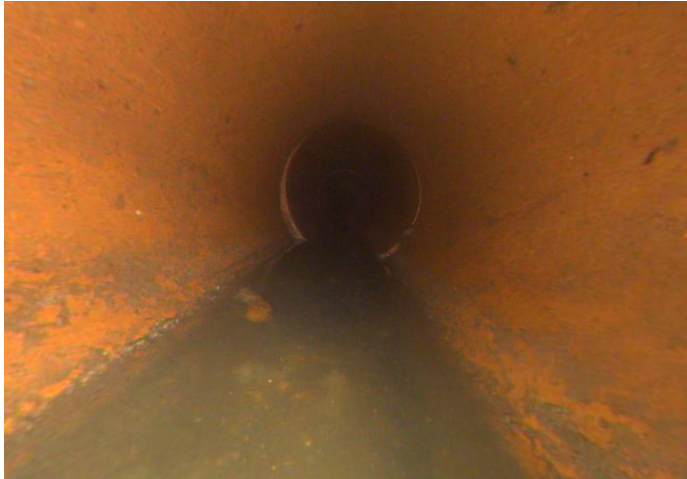
Code:	<b>MWL</b>
Description:	<b>Water Level</b>
Distance (ft):	<b>.0</b>
Structural Grade:	<b>0</b>
O&M Grade:	<b>0</b>
Clock Start/From:	
Clock To:	
1st Value:	
2nd Value:	
Value Percent:	<b>10.000</b>
Continuous Index:	
Within 8" of Joint:	<b>NO</b>
Remarks:

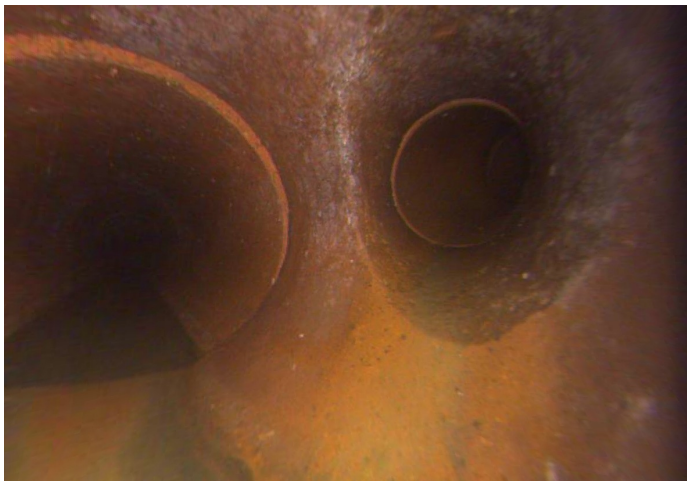
Code:	<b>TF</b>
Description:	<b>Tap Factory</b>
Distance (ft):	<b>8.5</b>
Structural Grade:	<b>0</b>
O&M Grade:	<b>0</b>
Clock Start/From:	<b>3</b>
Clock To:	
1st Value:	<b>6.000</b>
2nd Value:	
Value Percent:	
Continuous Index:	
Within 8" of Joint:	
Remarks:

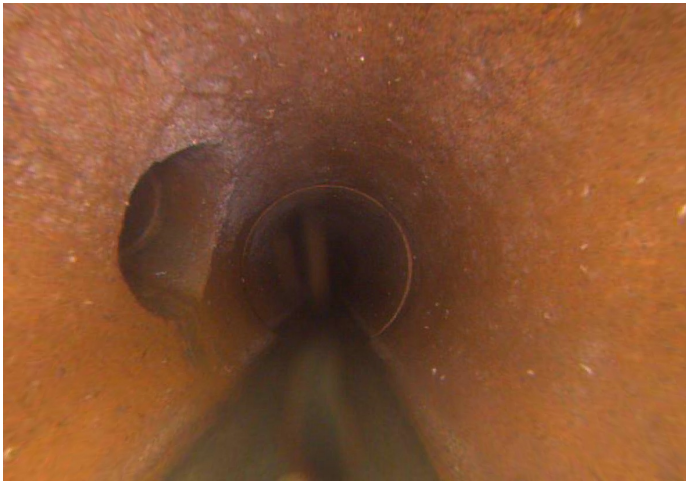
Code: **TF**  
Description: **Tap Factory**

Distance (ft): **18.6**  
Structural Grade: **0**  
O&M Grade: **0**  
Clock Start/From: **9**  
Clock To:  
1st Value: **6.000**  
2nd Value:  
Value Percent:  
Continuous Index:  
Within 8" of Joint:  
Remarks:

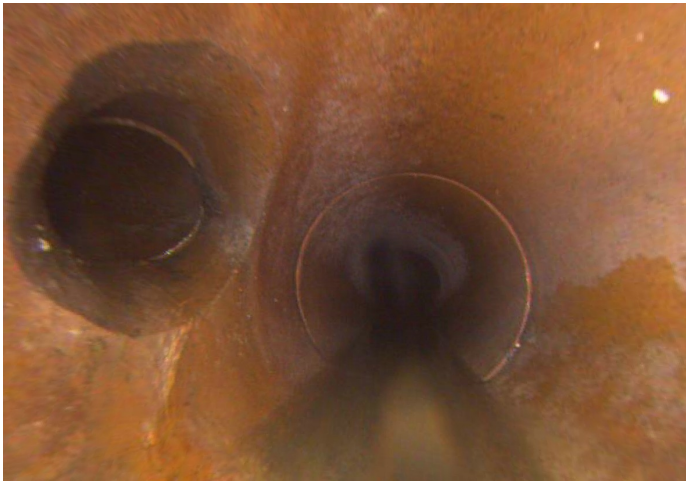
Code: **TF**  
Description: **Tap Factory**

Distance (ft): **75.4**  
Structural Grade: **0**  
O&M Grade: **0**  
Clock Start/From: **10**  
Clock To:  
1st Value: **6.000**  
2nd Value:  
Value Percent:  
Continuous Index:  
Within 8" of Joint:  
Remarks:

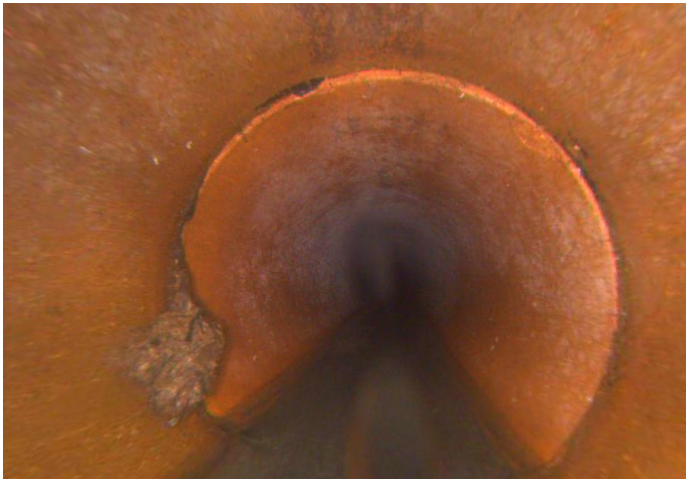
Code: **DAE**  
Description: **Deposits Attached Encrustation**

Distance (ft): **81.7**  
Structural Grade: **0**  
O&M Grade: **2**  
Clock Start/From: **8**  
Clock To:  
1st Value:  
2nd Value:  
Value Percent: **5.000**  
Continuous Index:  
Within 8" of Joint: **YES**  
Remarks:

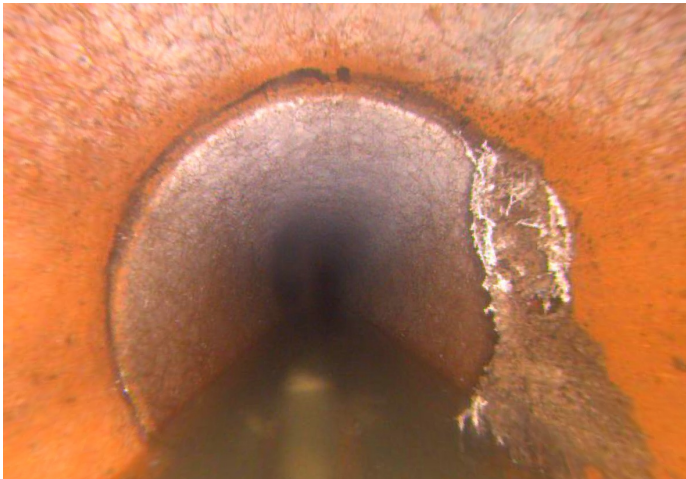
Code: **RFJ**  
Description: **Roots Fine Joint**

Distance (ft): **107.8**  
Structural Grade: **0**  
O&M Grade: **1**  
Clock Start/From: **2**  
Clock To: **4**  
1st Value:  
2nd Value:  
Value Percent:  
Continuous Index:  
Within 8" of Joint: **YES**  
Remarks:

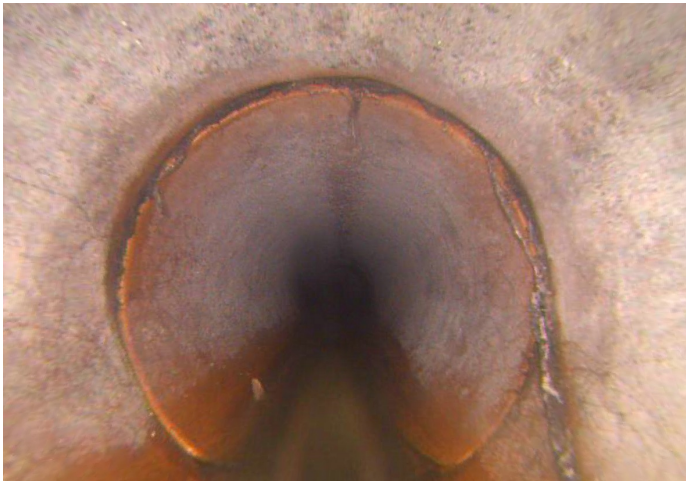
Code: **RFJ**  
Description: **Roots Fine Joint**

Distance (ft): **135.3**  
Structural Grade: **0**  
O&M Grade: **1**  
Clock Start/From: **10**  
Clock To: **3**  
1st Value:  
2nd Value:  
Value Percent:  
Continuous Index:  
Within 8" of Joint: **YES**  
Remarks:

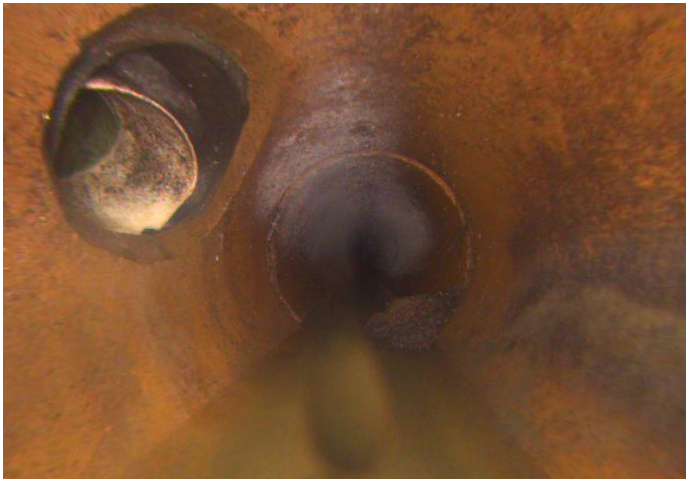
Code: **TFD**  
Description: **Tap Factory Defective**

Distance (ft): **140.6**  
Structural Grade: **0**  
O&M Grade: **2**  
Clock Start/From: **10**  
Clock To:  
1st Value: **6.000**  
2nd Value:  
Value Percent:  
Continuous Index:  
Within 8" of Joint:  
Remarks: **Connection Offset**

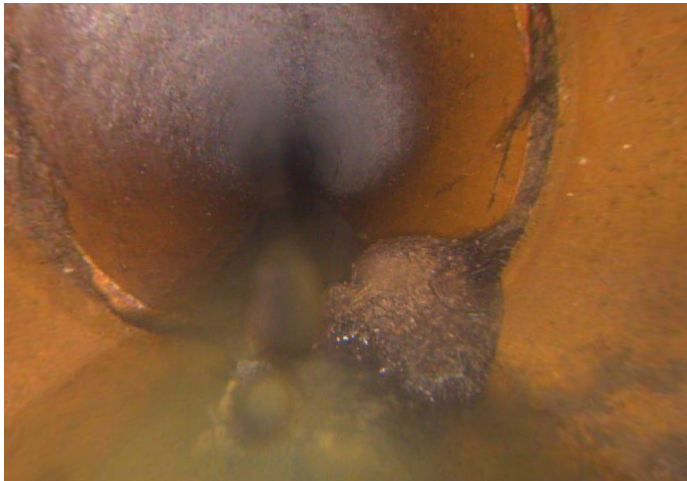
Code: **RMJ**  
Description: **Roots Medium Joint**

Distance (ft): **141.3**  
Structural Grade: **0**  
O&M Grade: **3**  
Clock Start/From: **5**  
Clock To:  
1st Value:  
2nd Value:  
Value Percent: **5.000**  
Continuous Index:  
Within 8" of Joint: **YES**  
Remarks:

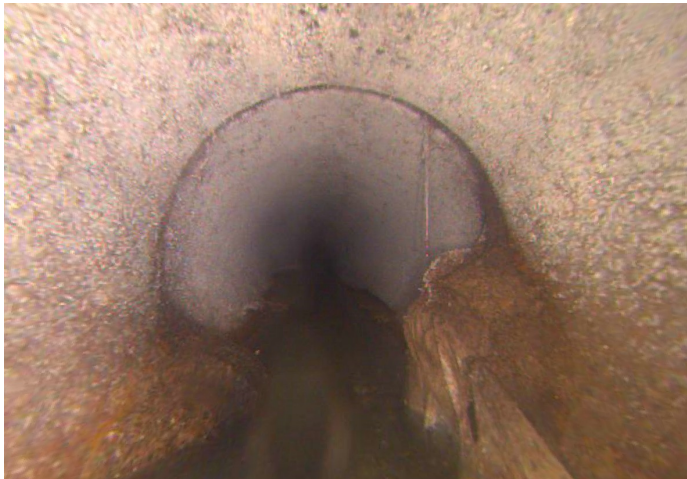
Code: **DAE**  
Description: **Deposits Attached Encrustation**

Distance (ft): **151.8**  
Structural Grade: **0**  
O&M Grade: **3**  
Clock Start/From: **3**  
Clock To:  
1st Value:  
2nd Value:  
Value Percent: **15.000**  
Continuous Index:  
Within 8" of Joint: **YES**  
Remarks:
