Profile/Photo Observation Report

Street:	N OHIO ST & E 40TH AVE	Flow Control:	Not Controlled
City:	Hobart, IN	Year Renewed:	
Location:	Other	Tape/Media #:	
Purpose:	Not Known	Dia/Height:	10"
Use:	Sanitary	Material:	VCP
Drain Area:	NA	Lining:	
Category:	NA		
Comment:

Location Details:		Direction of Survey:	Downstream
US MH:	M-803-034	DS MH:	M-803-026
		Total Length Surveyed (ft):	26.2

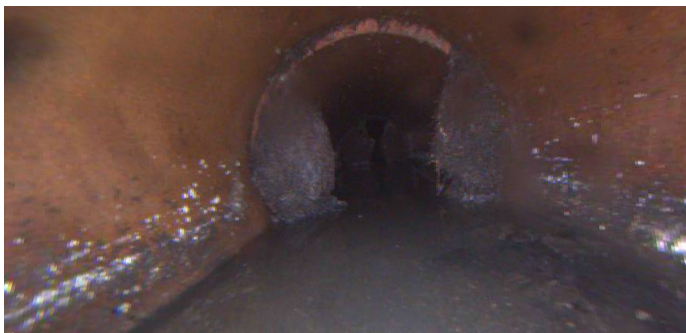
Code: **AMH**
Description: **Manhole**

Distance (ft): **.0**
Structural Grade: **0**
O&M Grade: **0**
Clock Start/From:
Clock To:
1st Value:
2nd Value:
Value Percent:
Continuous Index:
Within 8" of Joint: **NO**
Remarks: **M-803-034**

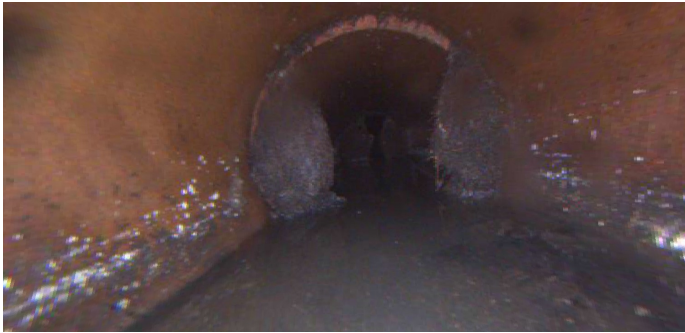
Code:	MWL
Description:	Water Level

Distance (ft):	.0
Structural Grade:	0
O&M Grade:	0
Clock Start/From:	
Clock To:	
1st Value:	
2nd Value:	
Value Percent:	5.000
Continuous Index:	
Within 8" of Joint:	NO
Remarks:

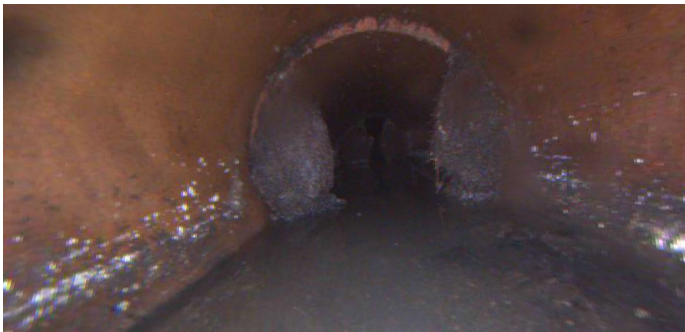
Code:	RMJ
Description:	Roots Medium Joint

Distance (ft):	.0
Structural Grade:	0
O&M Grade:	3
Clock Start/From:	7
Clock To:	5
1st Value:	
2nd Value:	
Value Percent:	40.000
Continuous Index:	S01
Within 8" of Joint:	YES
Remarks:

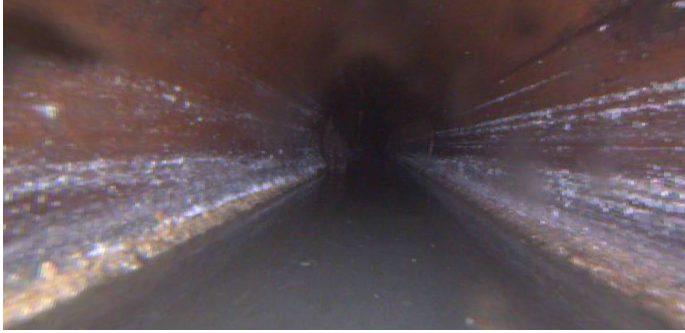
Code: **RMJ**
Description: **Roots Medium Joint**

Distance (ft): **26.2**
Structural Grade: **0**
O&M Grade: **3**
Clock Start/From: **7**
Clock To: **5**
1st Value:
2nd Value:
Value Percent: **40.000**
Continuous Index: **F01**
Within 8" of Joint: **YES**
Remarks:

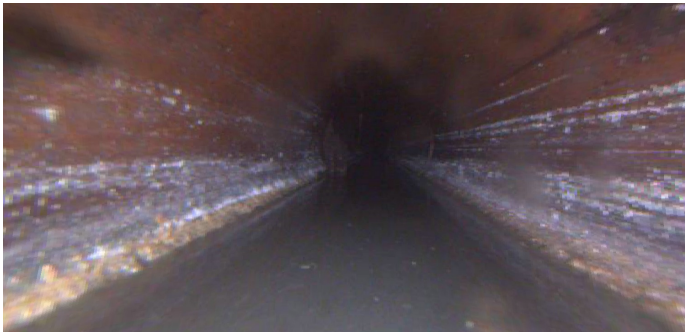
Code: **MSA**
Description: **Abandoned Survey**

Distance (ft): **26.2**
Structural Grade: **0**
O&M Grade: **0**
Clock Start/From:
Clock To:
1st Value:
2nd Value:
Value Percent:
Continuous Index:
Within 8" of Joint: **NO**
Remarks: **camera stoppedd**
