Profile/Photo Observation Report

Street:	N OHIO ST & E 40TH AVE	Flow Control:	Not Controlled
City:	Hobart, IN	Year Renewed:	
Location:	Light Highway	Tape/Media #:	
Purpose:	Routine Assessment	Dia/Height:	12"
Use:	Sanitary	Material:	VCP
Drain Area:	NA	Lining:	
Category:	NA		
Comment:

Location Details:		Direction of Survey:	Downstream
US MH:	M-803-034	DS MH:	M-803-026
		Total Length Surveyed (ft):	160.7

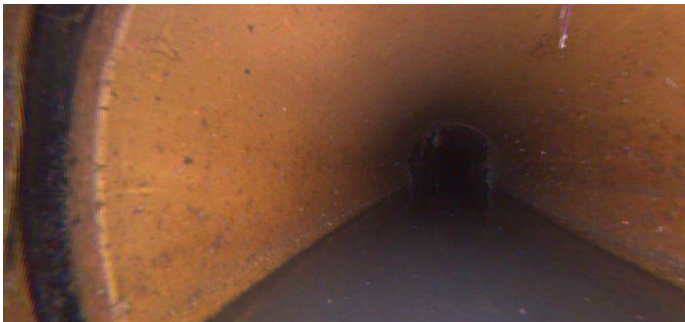
Code: **AMH**
Description: **Manhole**

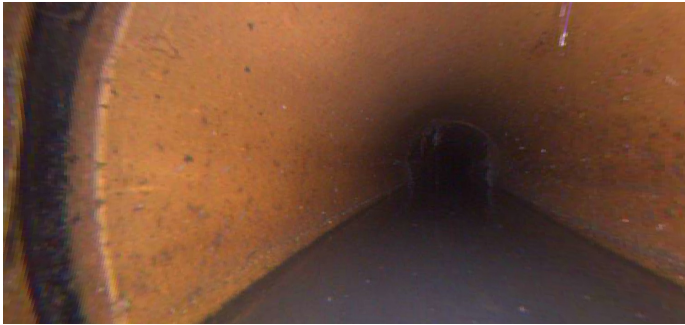
Code:	MWL
Description:	Water Level

Distance (ft):	.0
Structural Grade:	0
O&M Grade:	0
Clock Start/From:	
Clock To:	
1st Value:	
2nd Value:	
Value Percent:	5.000
Continuous Index:	
Within 8" of Joint:	NO
Remarks:

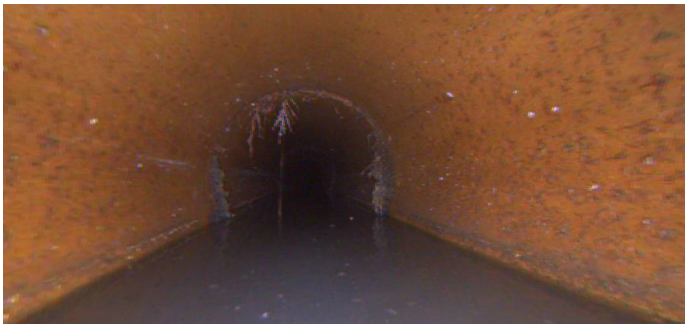
Code:	RFJ
Description:	Roots Fine Joint

Distance (ft):	2.6
Structural Grade:	0
O&M Grade:	1
Clock Start/From:	8
Clock To:	4
1st Value:	
2nd Value:	
Value Percent:	
Continuous Index:	S01
Within 8" of Joint:	YES
Remarks:

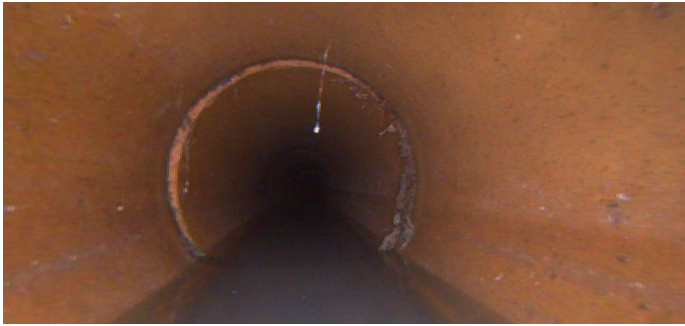
Code: **RFJ**
Description: **Roots Fine Joint**

Distance (ft): **14.7**
Structural Grade: **0**
O&M Grade: **1**
Clock Start/From: **8**
Clock To: **4**
1st Value:
2nd Value:
Value Percent:
Continuous Index: **F01**
Within 8" of Joint: **YES**
Remarks:

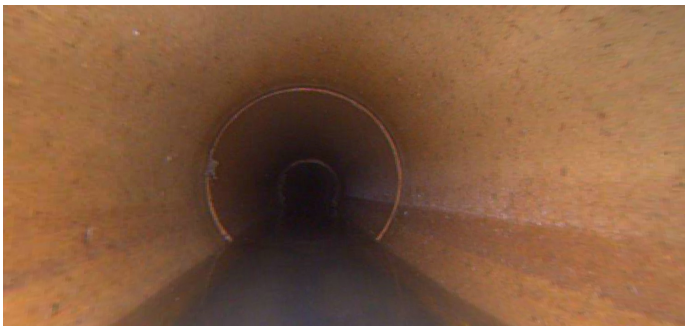
Code: **RFJ**
Description: **Roots Fine Joint**

Distance (ft): **20.3**
Structural Grade: **0**
O&M Grade: **1**
Clock Start/From: **9**
Clock To:
1st Value:
2nd Value:
Value Percent:
Continuous Index:
Within 8" of Joint: **YES**
Remarks:

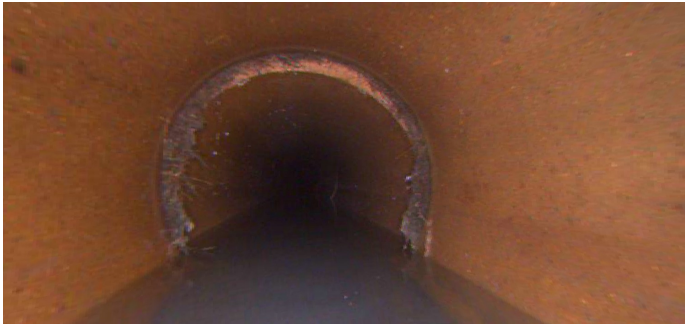
Code: **RFJ**
Description: **Roots Fine Joint**

Distance (ft): **23.6**
Structural Grade: **0**
O&M Grade: **1**
Clock Start/From: **8**
Clock To: **4**
1st Value:
2nd Value:
Value Percent:
Continuous Index: **S02**
Within 8" of Joint: **YES**
Remarks:

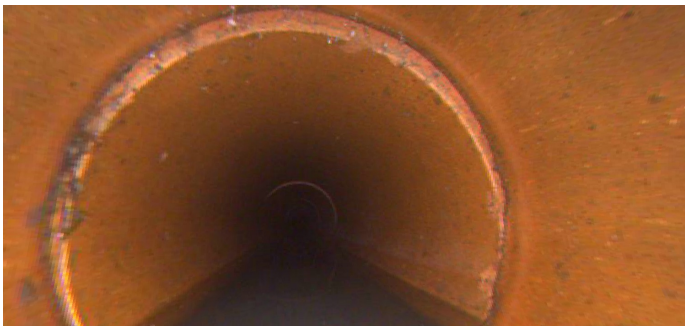
Code: **RFJ**
Description: **Roots Fine Joint**

Distance (ft): **65.7**
Structural Grade: **0**
O&M Grade: **1**
Clock Start/From: **8**
Clock To: **4**
1st Value:
2nd Value:
Value Percent:
Continuous Index: **F02**
Within 8" of Joint: **YES**
Remarks:

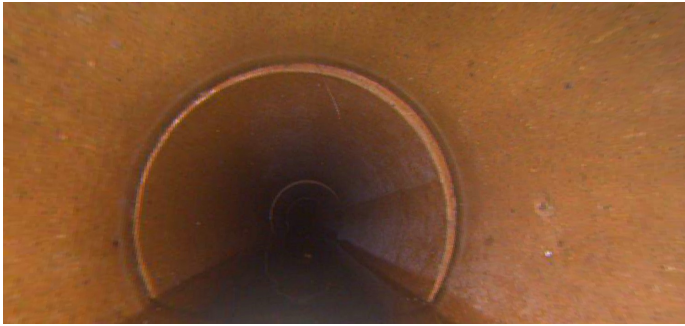
Code: **RFJ**
Description: **Roots Fine Joint**

Distance (ft): **71.4**
Structural Grade: **0**
O&M Grade: **1**
Clock Start/From: **12**
Clock To:
1st Value:
2nd Value:
Value Percent:
Continuous Index:
Within 8" of Joint: **YES**
Remarks:

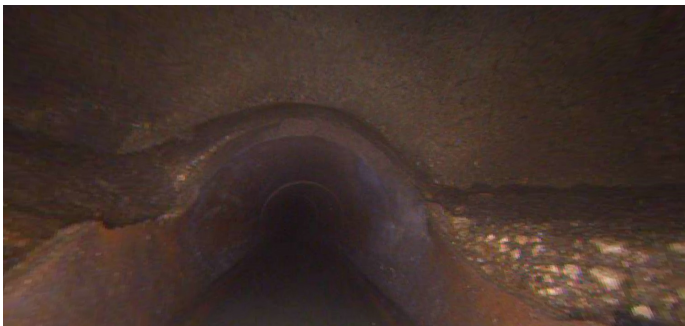
Code: **AMH**
Description: **Manhole**

Distance (ft): **160.7**
Structural Grade: **0**
O&M Grade: **0**
Clock Start/From:
Clock To:
1st Value:
2nd Value:
Value Percent:
Continuous Index:
Within 8" of Joint: **NO**
Remarks: **M-803-026**
