## Profile/Photo Observation Report

Street:	<b>40th. Ave.</b>	Flow Control:	<b>Not Controlled</b>
City:	<b>Hobart, IN</b>	Year Renewed:	
Location:	<b>Light Highway</b>	Tape/Media #:	
Purpose:	<b>Routine Assessment</b>	Dia/Height:	<b>12"</b>
Use:	<b>Sanitary</b>	Material:	<b>VCP</b>
Drain Area:	<b>NA</b>	Lining:	
Category:	<b>NA</b>		
Comment:

Location Details:		Direction of Survey:	<b>Downstream</b>
US MH:	<b>M-803-034</b>	DS MH:	<b>M-803-026</b>
		Total Length Surveyed (ft):	<b>160.7</b>

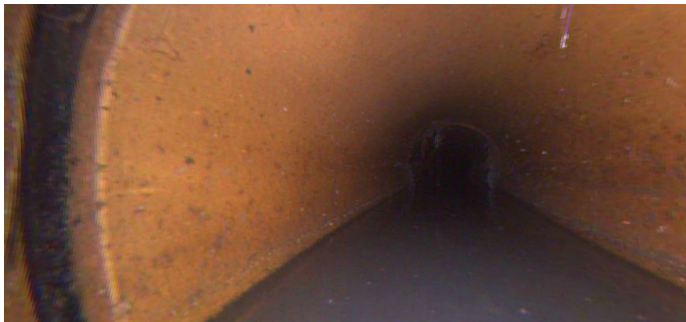
Code: **AMH**  
Description: **Manhole**

Distance (ft): **.0**  
Structural Grade: **0**  
O&M Grade: **0**  
Clock Start/From:  
Clock To:  
1st Value:  
2nd Value:  
Value Percent:  
Continuous Index:  
Within 8" of Joint: **NO**  
Remarks: **M-803-034**

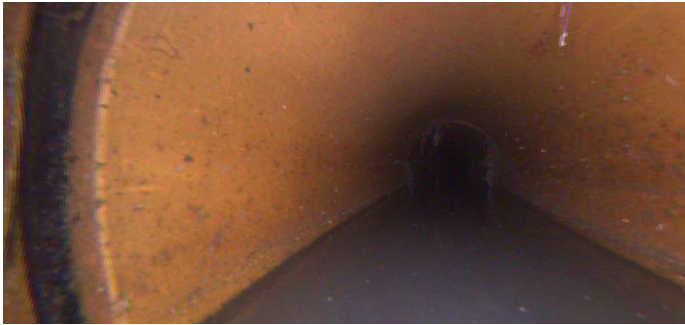
Code:	<b>MWL</b>
Description:	<b>Water Level</b>

Distance (ft):	<b>.0</b>
Structural Grade:	<b>0</b>
O&M Grade:	<b>0</b>
Clock Start/From:	
Clock To:	
1st Value:	
2nd Value:	
Value Percent:	<b>5.000</b>
Continuous Index:	
Within 8" of Joint:	<b>NO</b>
Remarks:

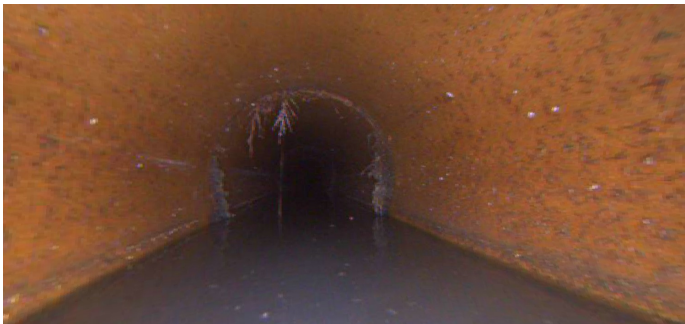
Code:	<b>RFJ</b>
Description:	<b>Roots Fine Joint</b>

Distance (ft):	<b>2.6</b>
Structural Grade:	<b>0</b>
O&M Grade:	<b>1</b>
Clock Start/From:	<b>8</b>
Clock To:	<b>4</b>
1st Value:	
2nd Value:	
Value Percent:	
Continuous Index:	<b>S01</b>
Within 8" of Joint:	<b>YES</b>
Remarks:

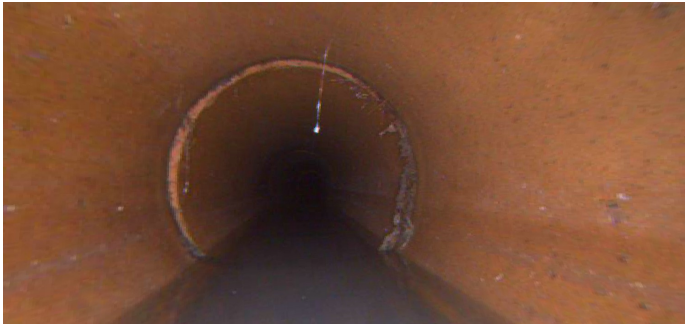
Code: **RFJ**  
Description: **Roots Fine Joint**

Distance (ft): **14.7**  
Structural Grade: **0**  
O&M Grade: **1**  
Clock Start/From: **8**  
Clock To: **4**  
1st Value:  
2nd Value:  
Value Percent:  
Continuous Index: **F01**  
Within 8" of Joint: **YES**  
Remarks:

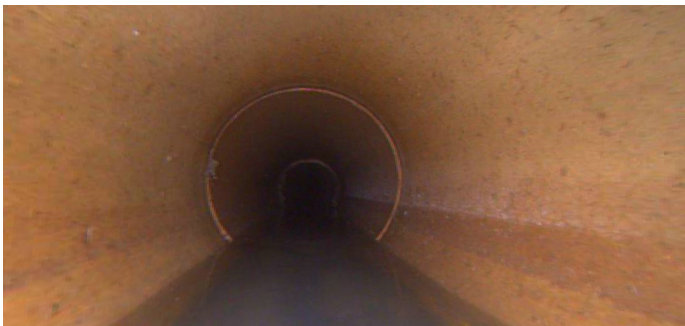
Code: **RFJ**  
Description: **Roots Fine Joint**

Distance (ft): **20.3**  
Structural Grade: **0**  
O&M Grade: **1**  
Clock Start/From: **9**  
Clock To:  
1st Value:  
2nd Value:  
Value Percent:  
Continuous Index:  
Within 8" of Joint: **YES**  
Remarks:

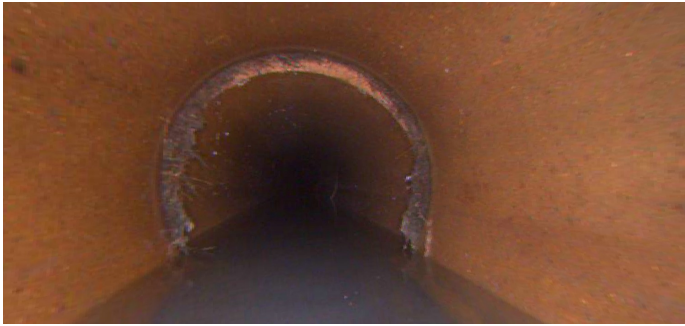
Code: **RFJ**  
Description: **Roots Fine Joint**

Distance (ft): **23.6**  
Structural Grade: **0**  
O&M Grade: **1**  
Clock Start/From: **8**  
Clock To: **4**  
1st Value:  
2nd Value:  
Value Percent:  
Continuous Index: **S02**  
Within 8" of Joint: **YES**  
Remarks:

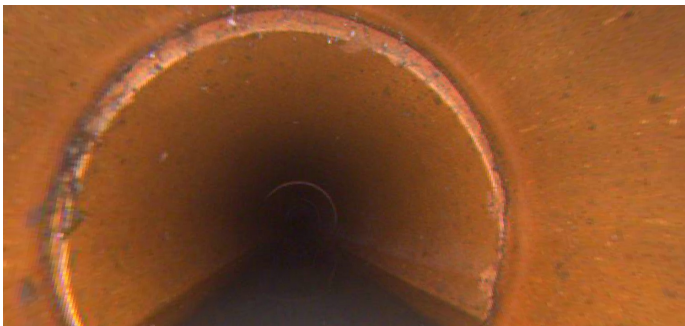
Code: **RFJ**  
Description: **Roots Fine Joint**

Distance (ft): **65.7**  
Structural Grade: **0**  
O&M Grade: **1**  
Clock Start/From: **8**  
Clock To: **4**  
1st Value:  
2nd Value:  
Value Percent:  
Continuous Index: **F02**  
Within 8" of Joint: **YES**  
Remarks:

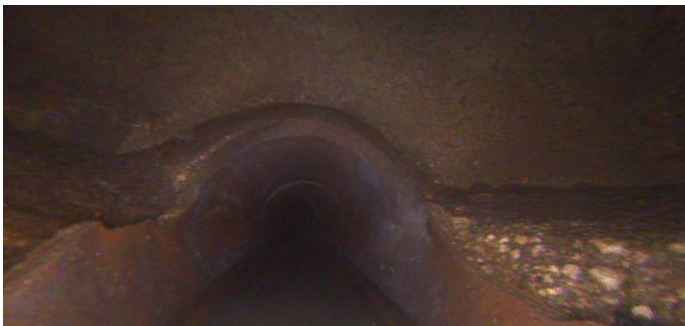
Code: **AMH**  
Description: **Manhole**

Distance (ft): **160.7**  
Structural Grade: **0**  
O&M Grade: **0**  
Clock Start/From:  
Clock To:  
1st Value:  
2nd Value:  
Value Percent:  
Continuous Index:  
Within 8" of Joint: **NO**  
Remarks: **M-803-026**
