Profile/Photo Observation Report

Date:	03/28/2018	Weather:		Coding:	PACP 6.0
Pipe Length (ft):	207.8	Owner:	NA	Pre Clean:	Not Known
P.O.#:		Surveyor:	Selasie Honu	PSR:	P-803-034-035
Customer:		Clean Date:	01/01/1900	Shape:	C

Street:	N INDIANA ST	Flow Control:	Not Controlled
City:	Hobart, IN	Year Renewed:	
Location:	Other	Tape/Media #:	
Purpose:	Not Known	Dia/Height:	10"
Use:	Sanitary	Material:	VCP
Drain Area:	NA	Lining:	
Category:	NA		
Comment:

Location Details:		Direction of Survey:	Downstream
US MH:	M-803-035	DS MH:	M-803-034
		Total Length Surveyed (ft):	53.1

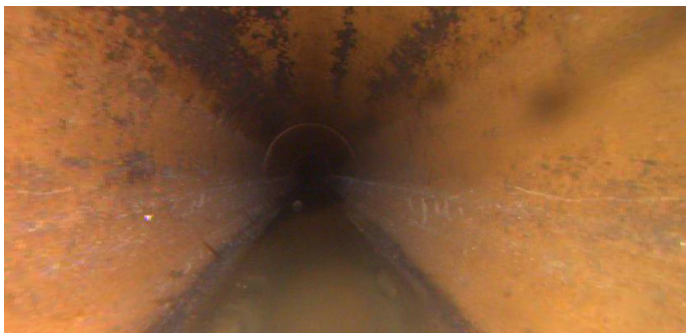
Code: **AMH**
Description: **Manhole**

Distance (ft): **.0**
Structural Grade: **0**
O&M Grade: **0**
Clock Start/From:
Clock To:
1st Value:
2nd Value:
Value Percent:
Continuous Index:
Within 8" of Joint: **NO**
Remarks: **M-803-035**

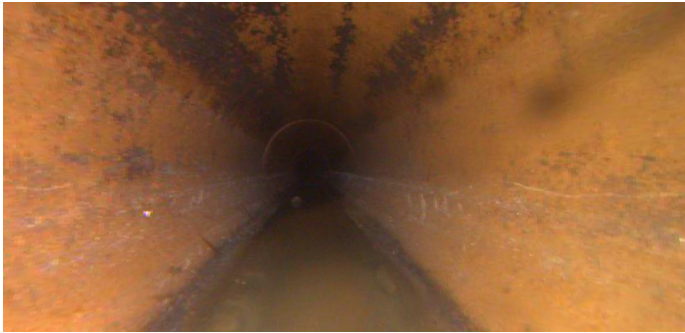
Code:	MWL
Description:	Water Level

Distance (ft):	.0
Structural Grade:	0
O&M Grade:	0
Clock Start/From:	
Clock To:	
1st Value:	
2nd Value:	
Value Percent:	5.000
Continuous Index:	
Within 8" of Joint:	NO
Remarks:

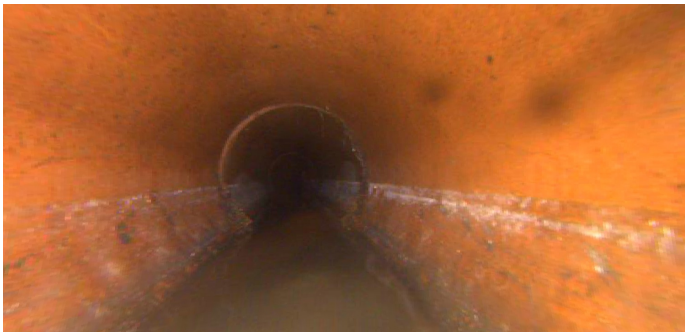
Code:	RFJ
Description:	Roots Fine Joint

Distance (ft):	6.4
Structural Grade:	0
O&M Grade:	1
Clock Start/From:	7
Clock To:	5
1st Value:	
2nd Value:	
Value Percent:	
Continuous Index:	
Within 8" of Joint:	YES
Remarks:

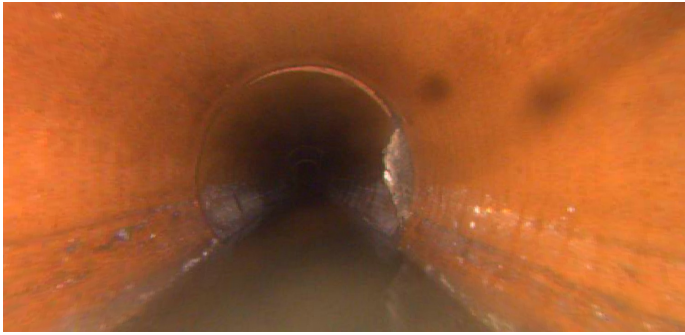
Code: **RFJ**
Description: **Roots Fine Joint**

Distance (ft): **14.9**
Structural Grade: **0**
O&M Grade: **1**
Clock Start/From: **3**
Clock To: **4**
1st Value:
2nd Value:
Value Percent:
Continuous Index:
Within 8" of Joint: **YES**
Remarks:

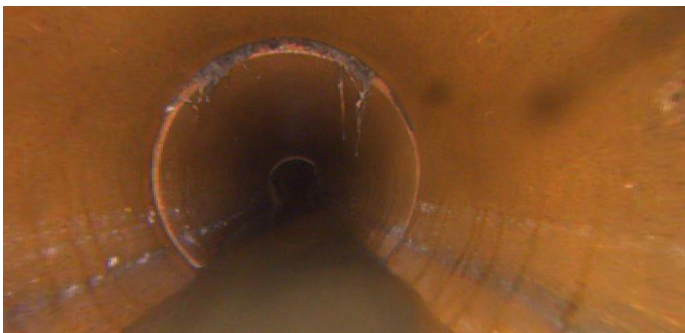
Code: **RFJ**
Description: **Roots Fine Joint**

Distance (ft): **19.2**
Structural Grade: **0**
O&M Grade: **1**
Clock Start/From: **11**
Clock To: **2**
1st Value:
2nd Value:
Value Percent:
Continuous Index:
Within 8" of Joint: **YES**
Remarks:

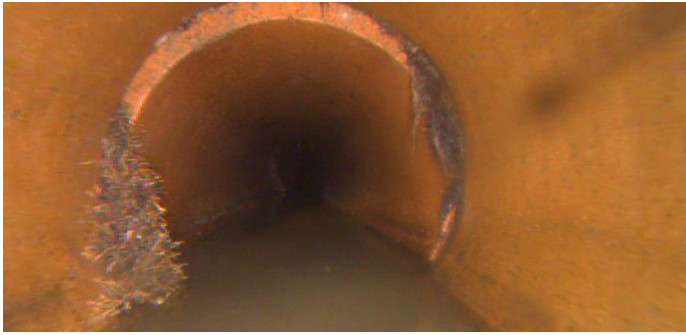
Code: **RFJ**
Description: **Roots Fine Joint**

Distance (ft): **23.5**
Structural Grade: **0**
O&M Grade: **1**
Clock Start/From: **7**
Clock To: **5**
1st Value:
2nd Value:
Value Percent:
Continuous Index:
Within 8" of Joint: **YES**
Remarks:

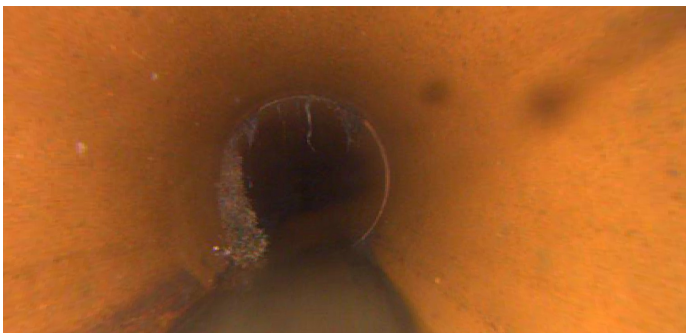
Code: **RFJ**
Description: **Roots Fine Joint**

Distance (ft): **26.7**
Structural Grade: **0**
O&M Grade: **1**
Clock Start/From: **7**
Clock To: **5**
1st Value:
2nd Value:
Value Percent:
Continuous Index:
Within 8" of Joint: **YES**
Remarks:

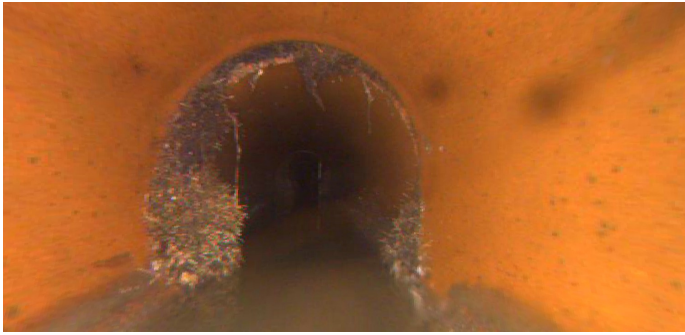
Code: **RMJ**
Description: **Roots Medium Joint**

Distance (ft): **35.3**
Structural Grade: **0**
O&M Grade: **3**
Clock Start/From: **7**
Clock To: **5**
1st Value:
2nd Value:
Value Percent: **30.000**
Continuous Index: **S01**
Within 8" of Joint: **YES**
Remarks:

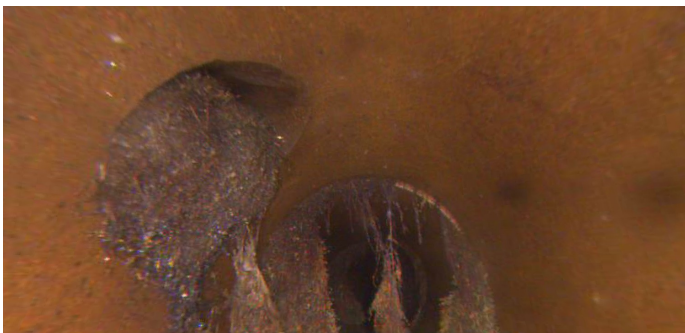
Code: **TFD**
Description: **Tap Factory Defective**

Distance (ft): **49.3**
Structural Grade: **0**
O&M Grade: **2**
Clock Start/From: **10**
Clock To:
1st Value: **4.000**
2nd Value:
Value Percent:
Continuous Index:
Within 8" of Joint:
Remarks: **RML**

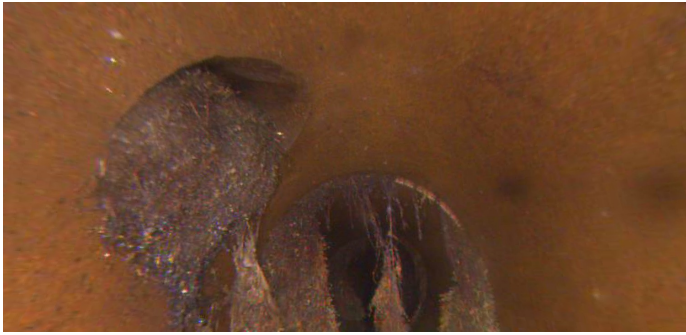
Code: **RML**
Description: **Roots Medium Lateral**

Distance (ft): **49.3**
Structural Grade: **0**
O&M Grade: **3**
Clock Start/From: **9**
Clock To: **10**
1st Value:
2nd Value:
Value Percent: **5.000**
Continuous Index:
Within 8" of Joint: **NO**
Remarks:

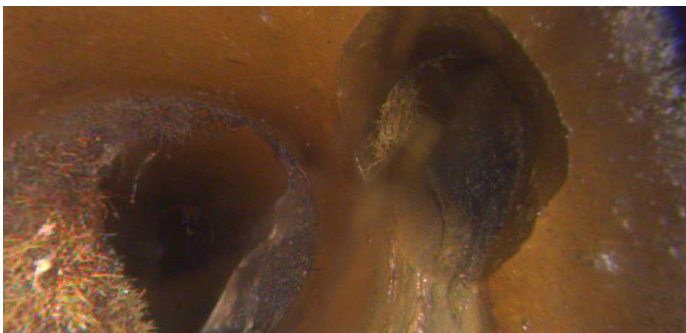
Code: **TFD**
Description: **Tap Factory Defective**

Distance (ft): **51.6**
Structural Grade: **0**
O&M Grade: **2**
Clock Start/From: **2**
Clock To:
1st Value: **4.000**
2nd Value:
Value Percent:
Continuous Index:
Within 8" of Joint:
Remarks: **ROOTS**

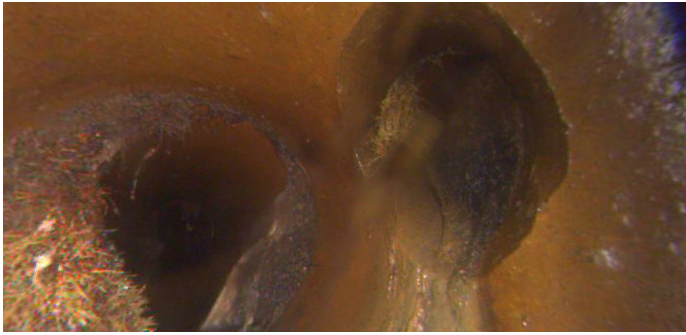
Code: **RFL**
Description: **Roots Fine Lateral**

Distance (ft): **51.6**
Structural Grade: **0**
O&M Grade: **1**
Clock Start/From: **2**
Clock To:
1st Value:
2nd Value:
Value Percent:
Continuous Index:
Within 8" of Joint: **NO**
Remarks:

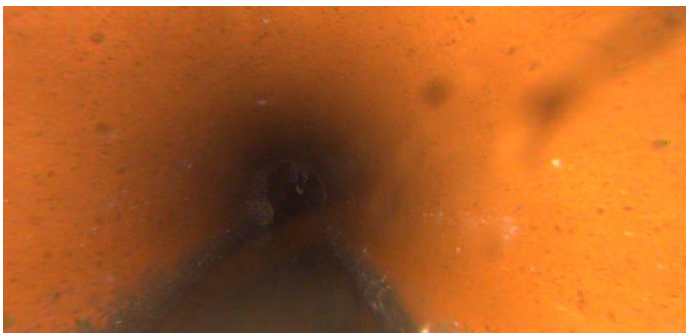
Code: **RMJ**
Description: **Roots Medium Joint**

Distance (ft): **53.1**
Structural Grade: **0**
O&M Grade: **3**
Clock Start/From: **7**
Clock To: **5**
1st Value:
2nd Value:
Value Percent: **30.000**
Continuous Index: **F01**
Within 8" of Joint: **YES**
Remarks:

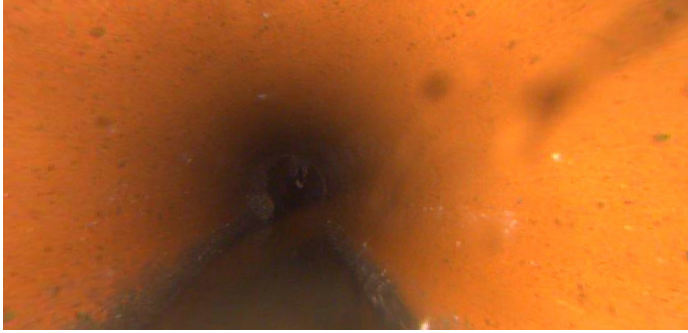
Code:	MSA
Description:	Abandoned Survey
Distance (ft):	53.1
Structural Grade:	0
O&M Grade:	0
Clock Start/From:	
Clock To:	
1st Value:	
2nd Value:	
Value Percent:	
Continuous Index:	
Within 8" of Joint:	NO
Remarks:	camera stopped
