## Profile/Photo Observation Report

Street:	<b>40th. Ave.</b>	Flow Control:	<b>Not Controlled</b>
City:	<b>Hobart, IN</b>	Year Renewed:	
Location:	<b>Light Highway</b>	Tape/Media #:	
Purpose:	<b>Routine Assessment</b>	Dia/Height:	<b>12"</b>
Use:	<b>Sanitary</b>	Material:	<b>VCP</b>
Drain Area:	<b>NA</b>	Lining:	
Category:	<b>NA</b>		
Comment:

Location Details:		Direction of Survey:	<b>Upstream</b>
US MH:	<b>M-803-035</b>	DS MH:	<b>M-803-034</b>
		Total Length Surveyed (ft):	<b>202.5</b>

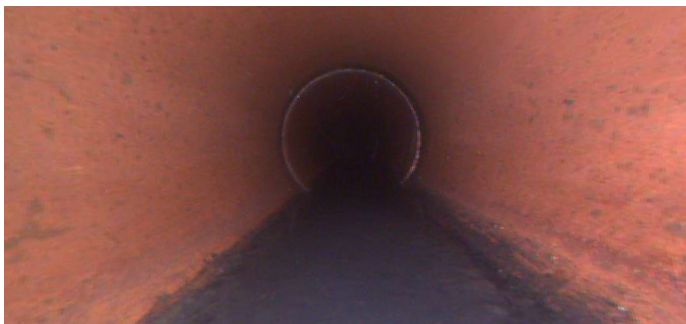
Code: **AMH**  
Description: **Manhole**

Distance (ft): **.0**  
Structural Grade: **0**  
O&M Grade: **0**  
Clock Start/From:  
Clock To:  
1st Value:  
2nd Value:  
Value Percent:  
Continuous Index:  
Within 8" of Joint: **NO**  
Remarks: **M-803-034**

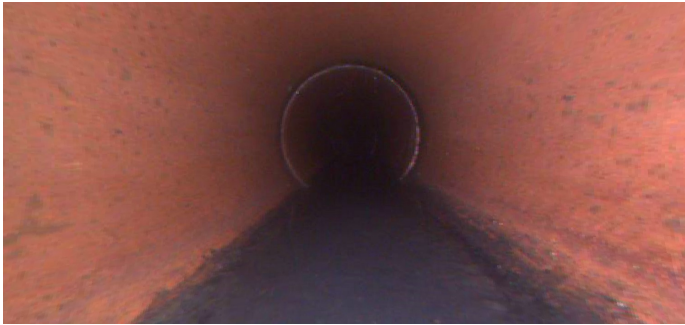
Code:	<b>MWL</b>
Description:	<b>Water Level</b>

Distance (ft):	<b>.0</b>
Structural Grade:	<b>0</b>
O&M Grade:	<b>0</b>
Clock Start/From:	
Clock To:	
1st Value:	
2nd Value:	
Value Percent:	<b>10.000</b>
Continuous Index:	
Within 8" of Joint:	<b>NO</b>
Remarks:

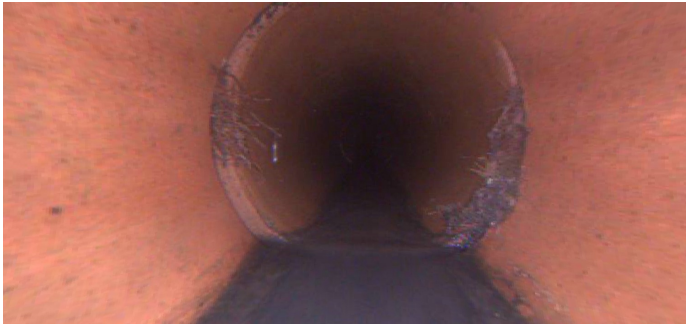
Code: **RFJ**  
Description: **Roots Fine Joint**

Distance (ft): **18.6**  
Structural Grade: **0**  
O&M Grade: **1**  
Clock Start/From: **9**  
Clock To: **5**  
1st Value:  
2nd Value:  
Value Percent:  
Continuous Index:  
Within 8" of Joint: **YES**  
Remarks:

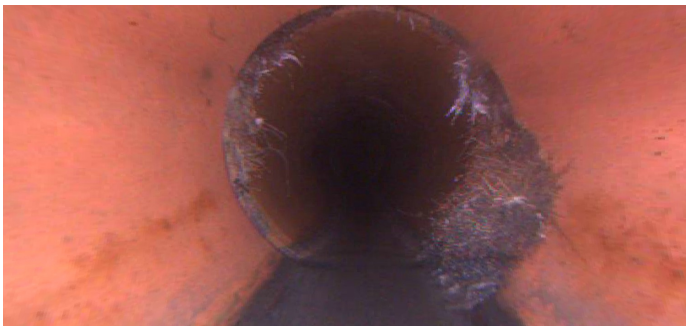
Code: **RFJ**  
Description: **Roots Fine Joint**

Distance (ft): **26.7**  
Structural Grade: **0**  
O&M Grade: **1**  
Clock Start/From: **9**  
Clock To: **5**  
1st Value:  
2nd Value:  
Value Percent:  
Continuous Index:  
Within 8" of Joint: **YES**  
Remarks:

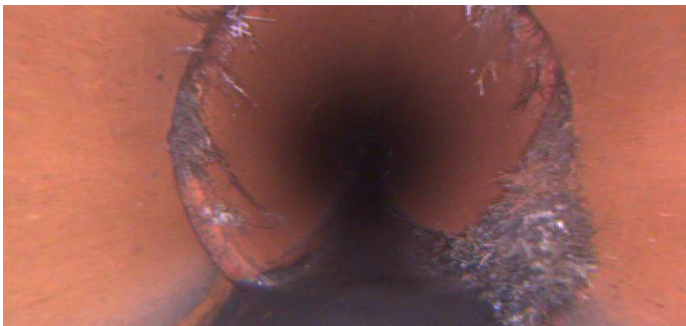
Code: **RFJ**  
Description: **Roots Fine Joint**

Distance (ft): **43.3**  
Structural Grade: **0**  
O&M Grade: **1**  
Clock Start/From: **8**  
Clock To: **5**  
1st Value:  
2nd Value:  
Value Percent:  
Continuous Index:  
Within 8" of Joint: **YES**  
Remarks:

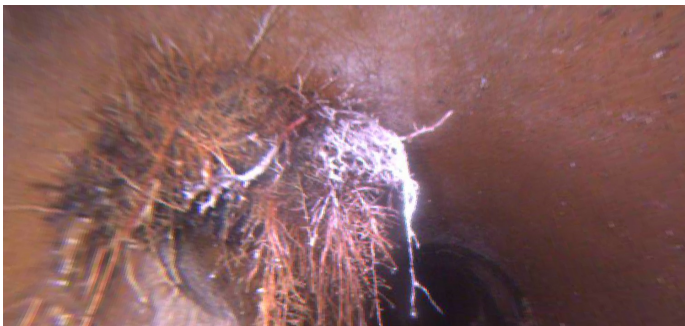
Code: **TFD**  
Description: **Tap Factory Defective**

Distance (ft): **52.3**  
Structural Grade: **0**  
O&M Grade: **2**  
Clock Start/From: **10**  
Clock To:  
1st Value: **4.000**  
2nd Value:  
Value Percent:  
Continuous Index:  
Within 8" of Joint:  
Remarks: **RF COMING FROM TAP**

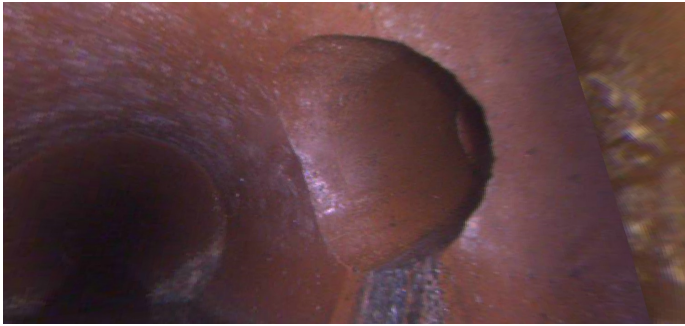
Code: **TF**  
Description: **Tap Factory**

Distance (ft): **54.5**  
Structural Grade: **0**  
O&M Grade: **0**  
Clock Start/From: **2**  
Clock To:  
1st Value: **4.000**  
2nd Value:  
Value Percent:  
Continuous Index:  
Within 8" of Joint:  
Remarks:

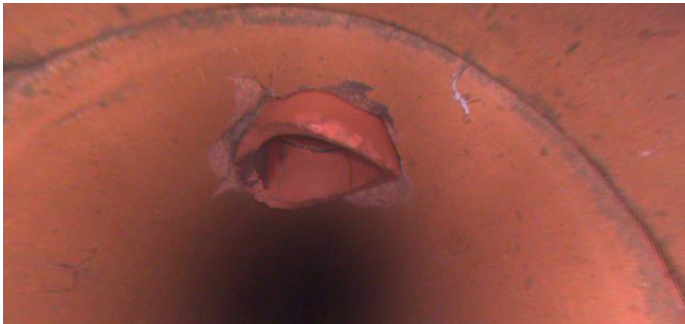
Code: **TBI**  
Description: **Tap Break-in Intruding**

Distance (ft): **72.3**  
Structural Grade: **0**  
O&M Grade: **2**  
Clock Start/From: **12**  
Clock To:  
1st Value: **4.000**  
2nd Value: **0.500**  
Value Percent:  
Continuous Index:  
Within 8" of Joint:  
Remarks:

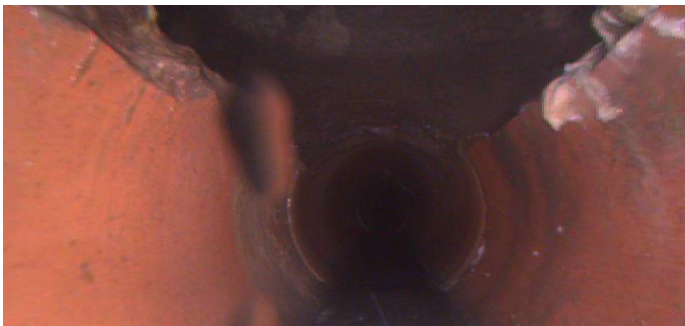
Code: **RFJ**  
Description: **Roots Fine Joint**

Distance (ft): **202.5**  
Structural Grade: **0**  
O&M Grade: **1**  
Clock Start/From: **7**  
Clock To: **5**  
1st Value:  
2nd Value:  
Value Percent:  
Continuous Index: **F01**  
Within 8" of Joint: **YES**  
Remarks: **WANDER**
