Profile/Photo Observation Report

Date:	03/28/2018	Weather:		Coding:	PACP 6.0
Pipe Length (ft):	227.6	Owner:	NA	Pre Clean:	Not Known
P.O.#:		Surveyor:	Selasie Honu	PSR:	P-803-035-036
Customer:		Clean Date:	01/01/1900	Shape:	C

Street:	ALLEY BETWEEN N INDIANA ST & N	Flow Control:	Not Controlled
City:	Hobart, IN	Year Renewed:	
Location:	Other	Tape/Media #:	
Purpose:	Not Known	Dia/Height:	10"
Use:	Sanitary	Material:	VCP
Drain Area:	NA	Lining:	
Category:	NA		
Comment:

Location Details:		Direction of Survey:	Upstream
US MH:	M-803-036	DS MH:	M-803-035
		Total Length Surveyed (ft):	222.3

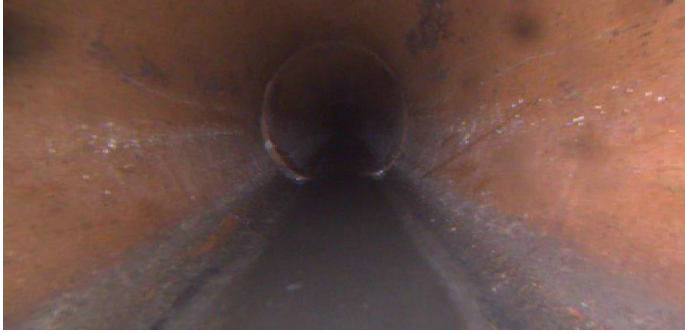
Code: **AMH**
Description: **Manhole**

Distance (ft): **.0**
Structural Grade: **0**
O&M Grade: **0**
Clock Start/From:
Clock To:
1st Value:
2nd Value:
Value Percent:
Continuous Index:
Within 8" of Joint: **NO**
Remarks: **M-803-035**

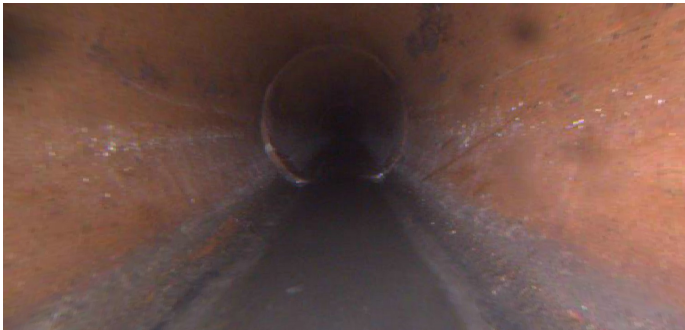
Code: **MWL**
Description: **Water Level**

Distance (ft): **.0**
Structural Grade: **0**
O&M Grade: **0**
Clock Start/From:
Clock To:
1st Value:
2nd Value:
Value Percent: **5.000**
Continuous Index:
Within 8" of Joint: **NO**
Remarks:

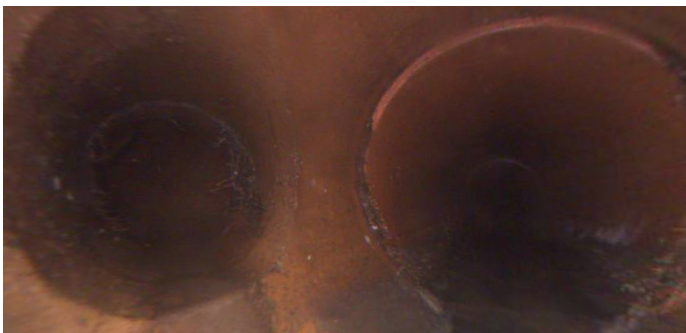
Code: **TF**
Description: **Tap Factory**

Distance (ft): **24.0**
Structural Grade: **0**
O&M Grade: **0**
Clock Start/From: **3**
Clock To:
1st Value: **4.000**
2nd Value:
Value Percent:
Continuous Index:
Within 8" of Joint:
Remarks:

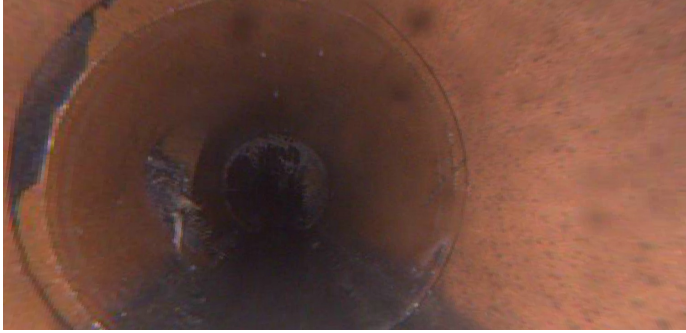
Code: **RFJ**
Description: **Roots Fine Joint**

Distance (ft): **32.3**
Structural Grade: **0**
O&M Grade: **1**
Clock Start/From: **10**
Clock To: **5**
1st Value:
2nd Value:
Value Percent:
Continuous Index:
Within 8" of Joint: **YES**
Remarks:

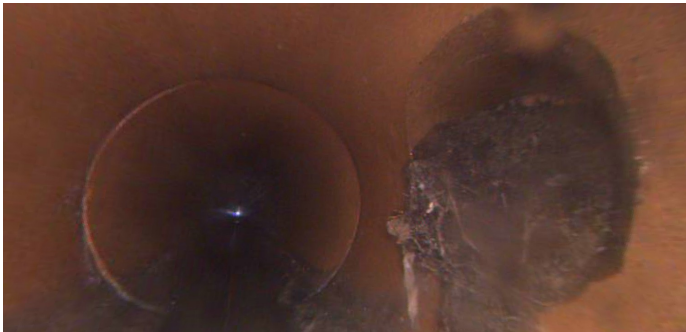
Code: **TFD**
Description: **Tap Factory Defective**

Distance (ft): **34.1**
Structural Grade: **0**
O&M Grade: **2**
Clock Start/From: **9**
Clock To:
1st Value: **4.000**
2nd Value:
Value Percent:
Continuous Index:
Within 8" of Joint:
Remarks: **roots**

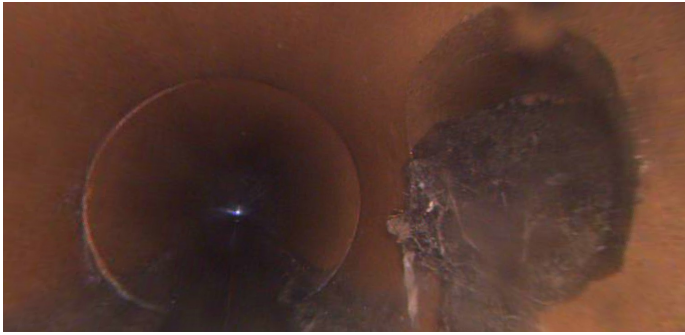
Code: **RML**
Description: **Roots Medium Lateral**

Distance (ft): **34.1**
Structural Grade: **0**
O&M Grade: **3**
Clock Start/From: **9**
Clock To:
1st Value:
2nd Value:
Value Percent: **5.000**
Continuous Index:
Within 8" of Joint: **NO**
Remarks:

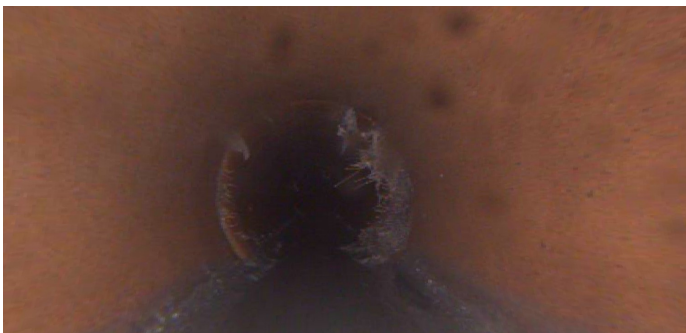
Code: **RMJ**
Description: **Roots Medium Joint**

Distance (ft): **49.4**
Structural Grade: **0**
O&M Grade: **3**
Clock Start/From: **7**
Clock To: **5**
1st Value:
2nd Value:
Value Percent: **10.000**
Continuous Index:
Within 8" of Joint: **YES**
Remarks:

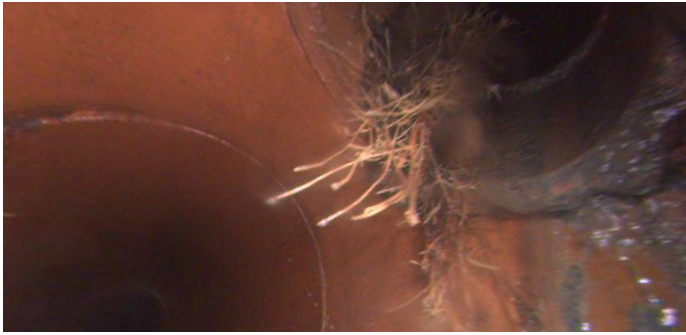
Code: **RML**
Description: **Roots Medium Lateral**

Distance (ft): **67.8**
Structural Grade: **0**
O&M Grade: **3**
Clock Start/From: **10**
Clock To:
1st Value:
2nd Value:
Value Percent: **5.000**
Continuous Index:
Within 8" of Joint: **NO**
Remarks:

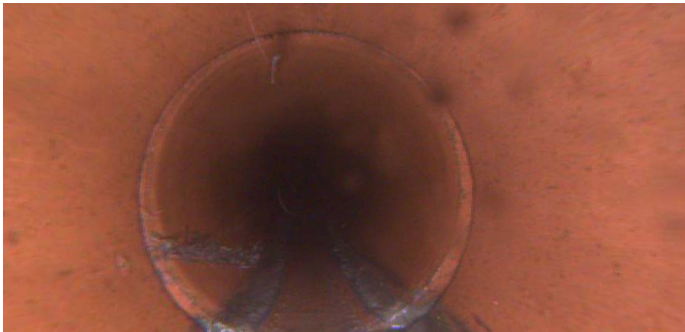
Code: **RFB**
Description: **Roots Fine Barrel**

Distance (ft): **110.7**
Structural Grade: **0**
O&M Grade: **2**
Clock Start/From: **8**
Clock To:
1st Value:
2nd Value:
Value Percent:
Continuous Index:
Within 8" of Joint: **NO**
Remarks:

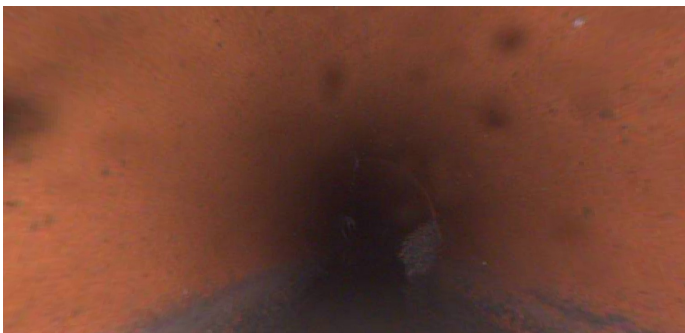
Code: **RMJ**
Description: **Roots Medium Joint**

Distance (ft): **129.7**
Structural Grade: **0**
O&M Grade: **3**
Clock Start/From: **5**
Clock To: **5**
1st Value:
2nd Value:
Value Percent: **15.000**
Continuous Index: **S02**
Within 8" of Joint: **YES**
Remarks:

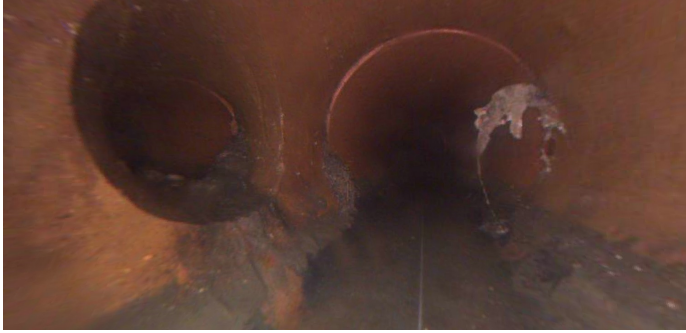
Code: **TF**
Description: **Tap Factory**

Distance (ft): **137.0**
Structural Grade: **0**
O&M Grade: **0**
Clock Start/From: **3**
Clock To:
1st Value: **4.000**
2nd Value:
Value Percent:
Continuous Index:
Within 8" of Joint:
Remarks:

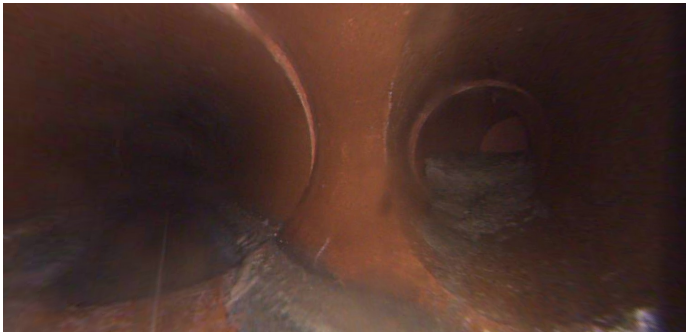
Code: **TF**
Description: **Tap Factory**

Distance (ft): **178.5**
Structural Grade: **0**
O&M Grade: **0**
Clock Start/From: **9**
Clock To:
1st Value: **4.000**
2nd Value:
Value Percent:
Continuous Index:
Within 8" of Joint:
Remarks:

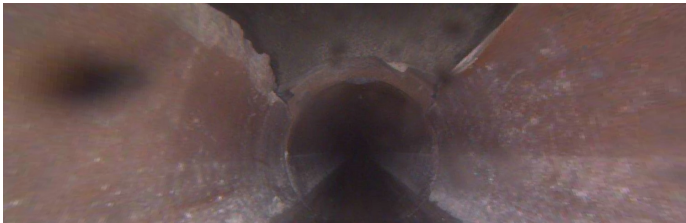
Code: **RMJ**
Description: **Roots Medium Joint**

Distance (ft): **222.3**
Structural Grade: **0**
O&M Grade: **3**
Clock Start/From: **5**
Clock To: **5**
1st Value:
2nd Value:
Value Percent: **15.000**
Continuous Index: **F02**
Within 8" of Joint: **YES**
Remarks:

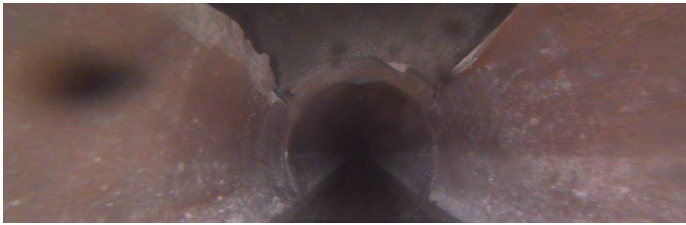
Code: **AMH**
Description: **Manhole**

Distance (ft): **222.3**
Structural Grade: **0**
O&M Grade: **0**
Clock Start/From:
Clock To:
1st Value:
2nd Value:
Value Percent:
Continuous Index:
Within 8" of Joint: **NO**
Remarks: **M-803-036**
