Profile/Photo Observation Report

Date:	03/28/2018	Weather:		Coding:	PACP 6.0
Pipe Length (ft):	227.6	Owner:	NA	Pre Clean:	Not Known
P.O.#:		Surveyor:	Selasie Honu	PSR:	P-803-035-036
Customer:		Clean Date:	01/01/1900	Shape:	C

Street:	N INDIANA ST	Flow Control:	Not Controlled
City:	Hobart, IN	Year Renewed:	
Location:	Other	Tape/Media #:	
Purpose:	Not Known	Dia/Height:	10"
Use:	Sanitary	Material:	VCP
Drain Area:	NA	Lining:	
Category:	NA		
Comment:

Location Details:		Direction of Survey:	Upstream
US MH:	M-803-036	DS MH:	M-803-035
		Total Length Surveyed (ft):	222.3

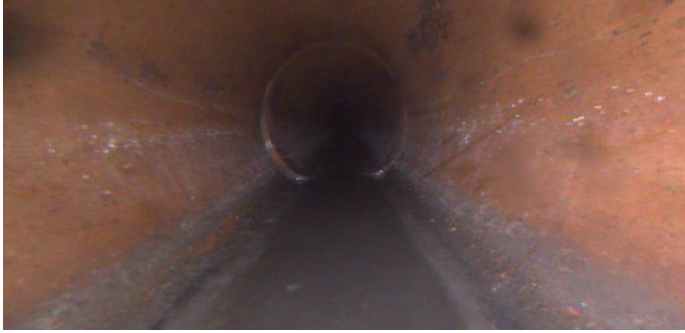
Code: **AMH**
Description: **Manhole**

Distance (ft): **.0**
Structural Grade: **0**
O&M Grade: **0**
Clock Start/From:
Clock To:
1st Value:
2nd Value:
Value Percent:
Continuous Index:
Within 8" of Joint: **NO**
Remarks: **M-803-035**

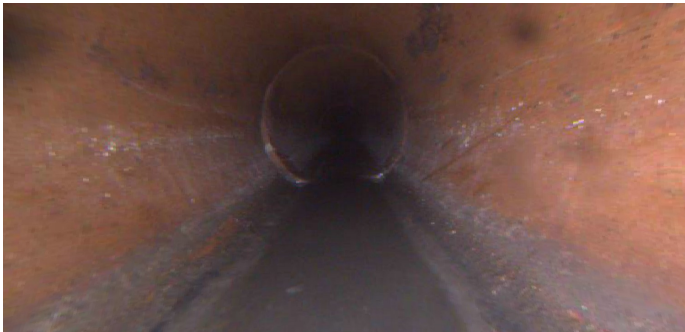
Code: **MWL**
Description: **Water Level**

Distance (ft): **.0**
Structural Grade: **0**
O&M Grade: **0**
Clock Start/From:
Clock To:
1st Value:
2nd Value:
Value Percent: **5.000**
Continuous Index:
Within 8" of Joint: **NO**
Remarks:

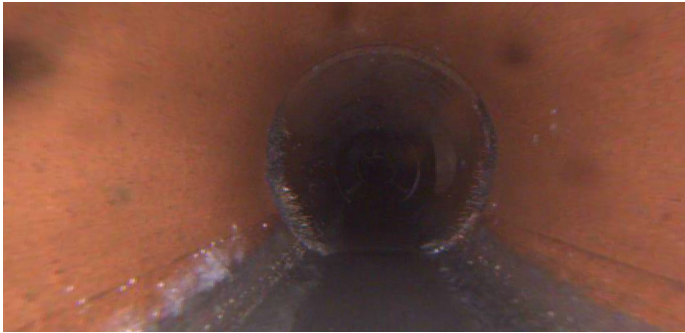
Code: **RFJ**
Description: **Roots Fine Joint**

Distance (ft): **21.6**
Structural Grade: **0**
O&M Grade: **1**
Clock Start/From: **2**
Clock To: **10**
1st Value:
2nd Value:
Value Percent:
Continuous Index:
Within 8" of Joint: **YES**
Remarks:

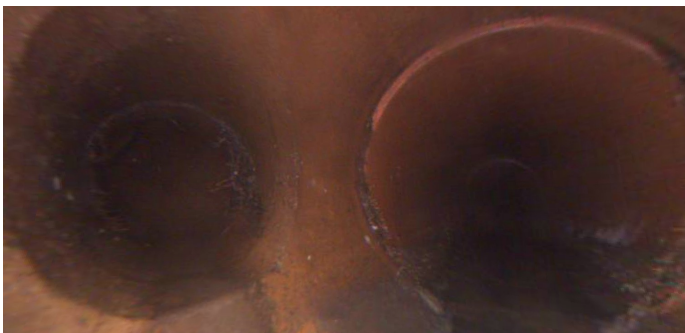
Code: **TF**
Description: **Tap Factory**

Distance (ft): **24.0**
Structural Grade: **0**
O&M Grade: **0**
Clock Start/From: **3**
Clock To:
1st Value: **4.000**
2nd Value:
Value Percent:
Continuous Index:
Within 8" of Joint:
Remarks:

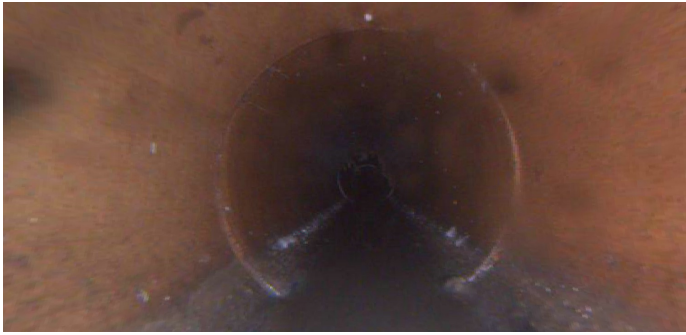
Code: **RFJ**
Description: **Roots Fine Joint**

Distance (ft): **24.1**
Structural Grade: **0**
O&M Grade: **1**
Clock Start/From: **10**
Clock To: **2**
1st Value:
2nd Value:
Value Percent:
Continuous Index:
Within 8" of Joint: **YES**
Remarks:

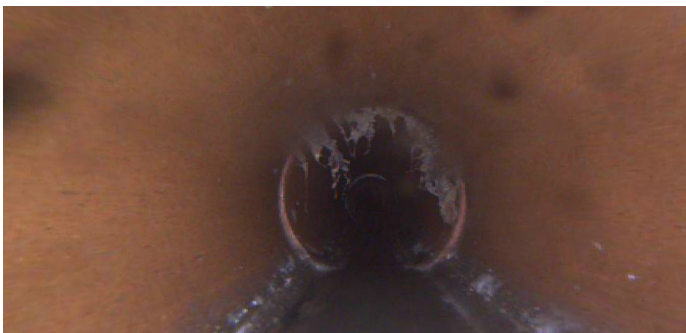
Code: **RMJ**
Description: **Roots Medium Joint**

Distance (ft): **27.4**
Structural Grade: **0**
O&M Grade: **3**
Clock Start/From: **8**
Clock To: **4**
1st Value:
2nd Value:
Value Percent: **10.000**
Continuous Index:
Within 8" of Joint: **YES**
Remarks:

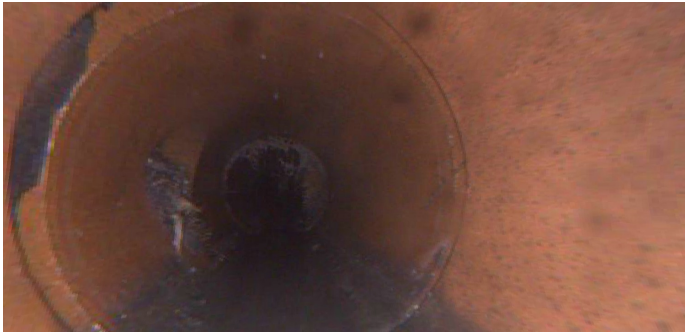
Code: **RFJ**
Description: **Roots Fine Joint**

Distance (ft): **32.3**
Structural Grade: **0**
O&M Grade: **1**
Clock Start/From: **10**
Clock To: **5**
1st Value:
2nd Value:
Value Percent:
Continuous Index:
Within 8" of Joint: **YES**
Remarks:

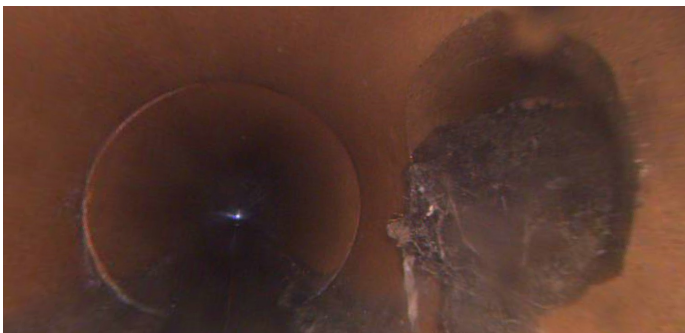
Code: **TFD**
Description: **Tap Factory Defective**

Distance (ft): **34.1**
Structural Grade: **0**
O&M Grade: **2**
Clock Start/From: **9**
Clock To:
1st Value: **4.000**
2nd Value:
Value Percent:
Continuous Index:
Within 8" of Joint:
Remarks: **roots**

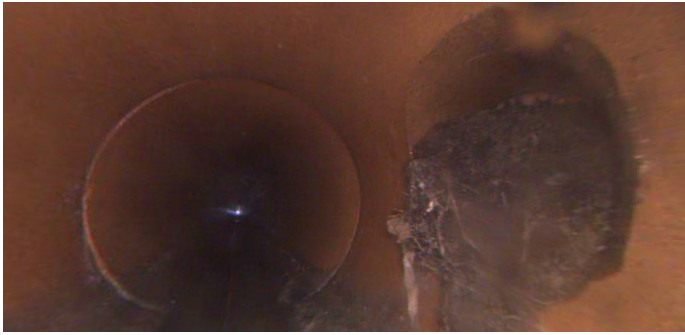
Code: **RML**
Description: **Roots Medium Lateral**

Distance (ft): **34.1**
Structural Grade: **0**
O&M Grade: **3**
Clock Start/From: **9**
Clock To:
1st Value:
2nd Value:
Value Percent: **5.000**
Continuous Index:
Within 8" of Joint: **NO**
Remarks:

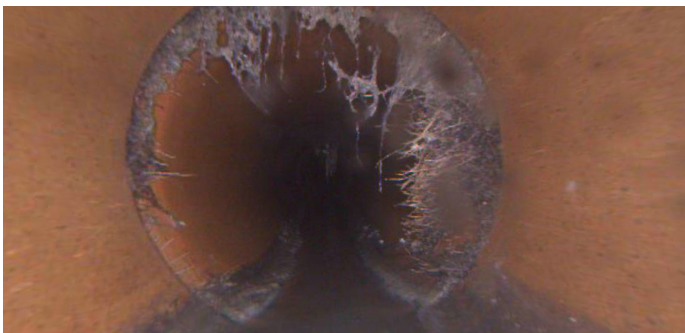
Code: **RMJ**
Description: **Roots Medium Joint**

Distance (ft): **34.2**
Structural Grade: **0**
O&M Grade: **3**
Clock Start/From: **8**
Clock To: **4**
1st Value:
2nd Value:
Value Percent: **15.000**
Continuous Index:
Within 8" of Joint: **YES**
Remarks:

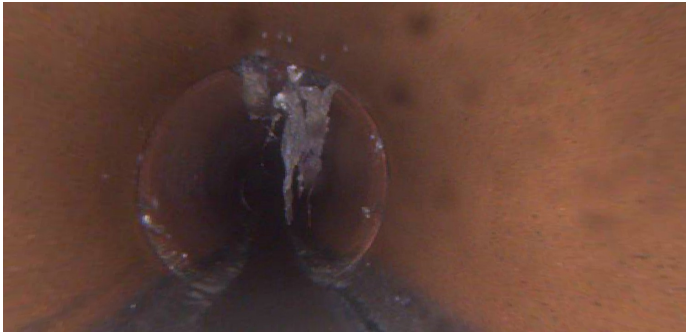
Code: **RFJ**
Description: **Roots Fine Joint**

Distance (ft): **37.7**
Structural Grade: **0**
O&M Grade: **1**
Clock Start/From: **12**
Clock To: **1**
1st Value:
2nd Value:
Value Percent:
Continuous Index:
Within 8" of Joint: **YES**
Remarks:

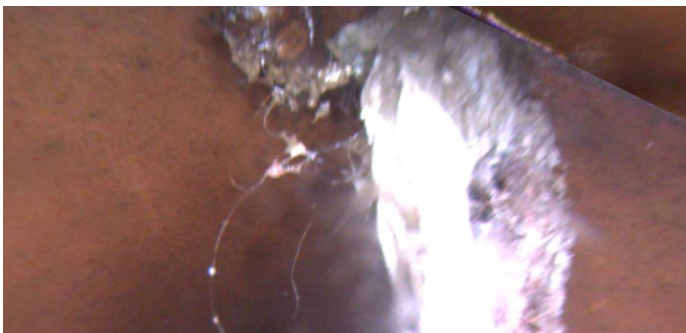
Code: **DAR**
Description: **Deposits Attached Ragging**

Distance (ft): **38.8**
Structural Grade: **0**
O&M Grade: **2**
Clock Start/From: **12**
Clock To: **1**
1st Value:
2nd Value:
Value Percent: **10.000**
Continuous Index:
Within 8" of Joint: **YES**
Remarks:

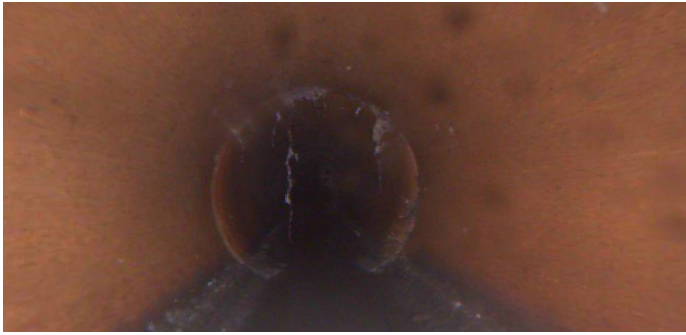
Code: **RFJ**
Description: **Roots Fine Joint**

Distance (ft): **45.5**
Structural Grade: **0**
O&M Grade: **1**
Clock Start/From: **10**
Clock To: **5**
1st Value:
2nd Value:
Value Percent:
Continuous Index:
Within 8" of Joint: **YES**
Remarks:

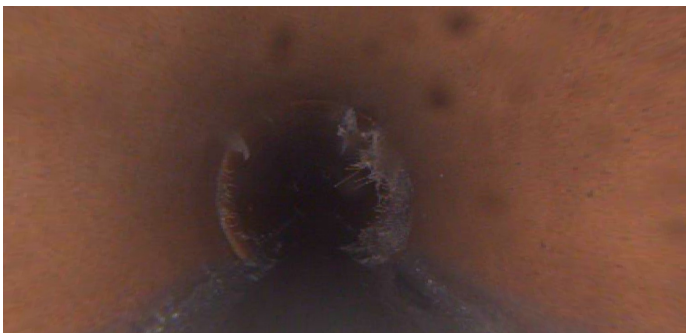
Code: **RMJ**
Description: **Roots Medium Joint**

Distance (ft): **49.4**
Structural Grade: **0**
O&M Grade: **3**
Clock Start/From: **7**
Clock To: **5**
1st Value:
2nd Value:
Value Percent: **10.000**
Continuous Index:
Within 8" of Joint: **YES**
Remarks:

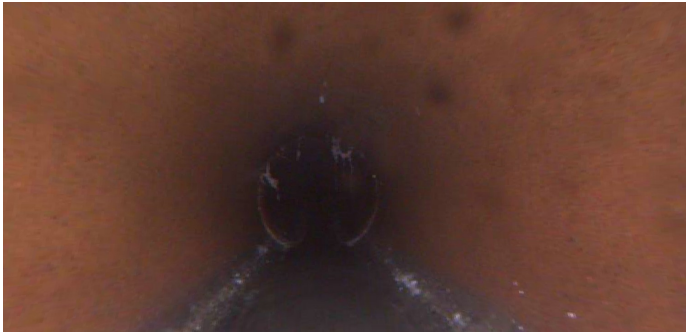
Code: **RFJ**
Description: **Roots Fine Joint**

Distance (ft): **52.6**
Structural Grade: **0**
O&M Grade: **1**
Clock Start/From: **9**
Clock To: **2**
1st Value:
2nd Value:
Value Percent:
Continuous Index:
Within 8" of Joint: **YES**
Remarks:

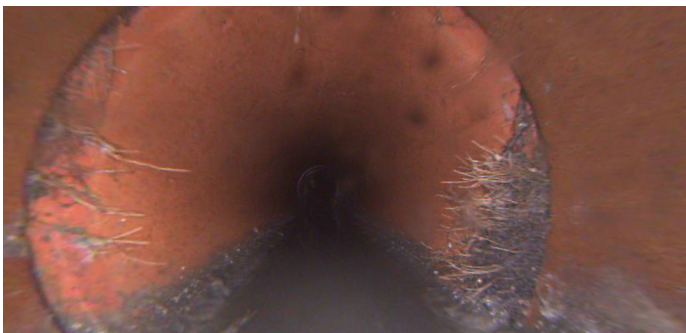
Code: **RMJ**
Description: **Roots Medium Joint**

Distance (ft): **62.4**
Structural Grade: **0**
O&M Grade: **3**
Clock Start/From: **8**
Clock To: **4**
1st Value:
2nd Value:
Value Percent: **10.000**
Continuous Index: **S03**
Within 8" of Joint: **YES**
Remarks:

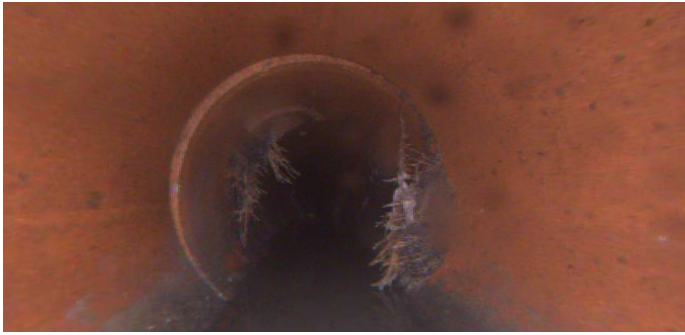
Code: **RFJ**
Description: **Roots Fine Joint**

Distance (ft): **65.9**
Structural Grade: **0**
O&M Grade: **1**
Clock Start/From: **1**
Clock To: **5**
1st Value:
2nd Value:
Value Percent:
Continuous Index:
Within 8" of Joint: **YES**
Remarks:

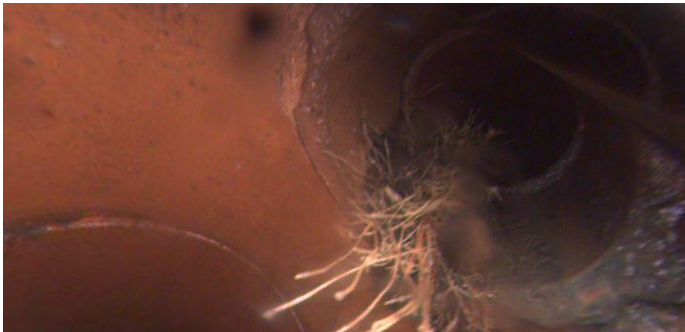
Code: **TBD**
Description: **Tap Break-in Defective**

Distance (ft): **67.8**
Structural Grade: **0**
O&M Grade: **3**
Clock Start/From: **10**
Clock To:
1st Value: **4.000**
2nd Value:
Value Percent:
Continuous Index:
Within 8" of Joint:
Remarks: **roots**

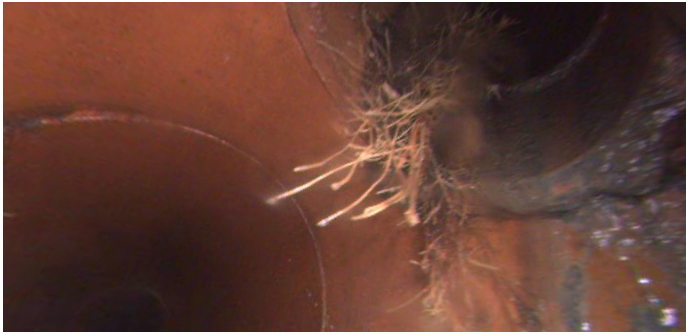
Code: **RML**
Description: **Roots Medium Lateral**

Distance (ft): **67.8**
Structural Grade: **0**
O&M Grade: **3**
Clock Start/From: **10**
Clock To:
1st Value:
2nd Value:
Value Percent: **5.000**
Continuous Index:
Within 8" of Joint: **NO**
Remarks:

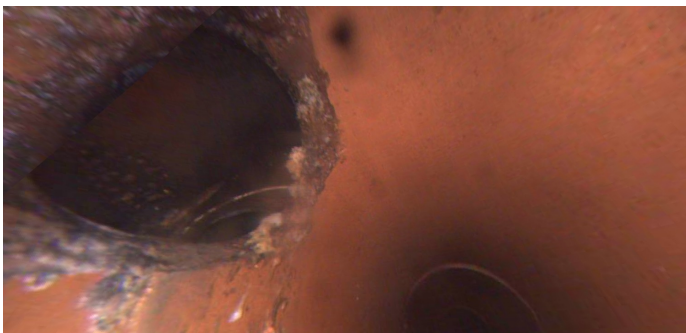
Code: **TB**
Description: **Tap Break-in**

Distance (ft): **81.5**
Structural Grade: **0**
O&M Grade: **0**
Clock Start/From: **2**
Clock To:
1st Value: **4.000**
2nd Value:
Value Percent:
Continuous Index:
Within 8" of Joint: **NO**
Remarks:

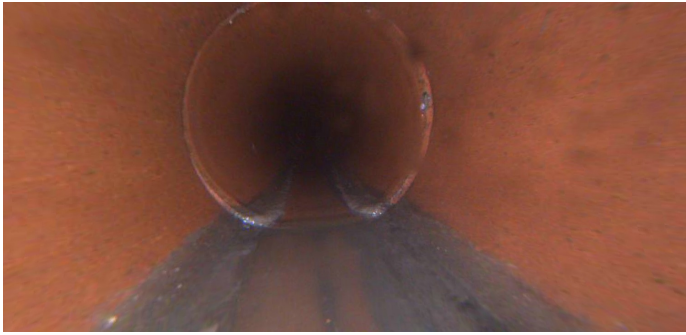
Code: **RMJ**
Description: **Roots Medium Joint**

Distance (ft): **86.3**
Structural Grade: **0**
O&M Grade: **3**
Clock Start/From: **8**
Clock To: **4**
1st Value:
2nd Value:
Value Percent: **10.000**
Continuous Index: **F03**
Within 8" of Joint: **YES**
Remarks:

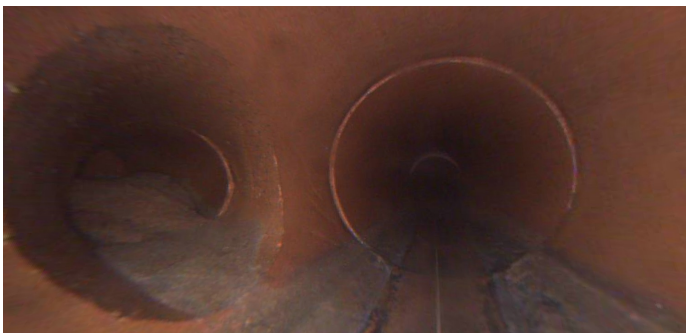
Code: **TF**
Description: **Tap Factory**

Distance (ft): **104.5**
Structural Grade: **0**
O&M Grade: **0**
Clock Start/From: **3**
Clock To:
1st Value: **4.000**
2nd Value:
Value Percent:
Continuous Index:
Within 8" of Joint:
Remarks:

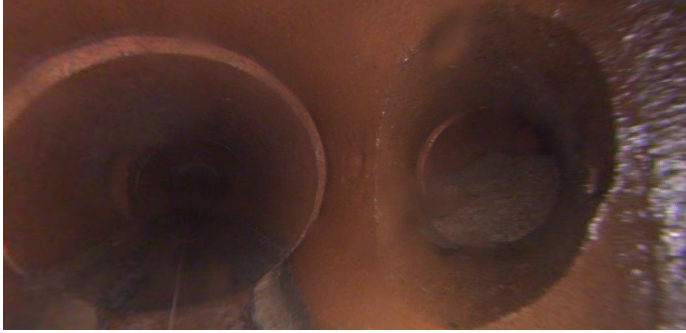
Code: **TF**
Description: **Tap Factory**

Distance (ft): **106.5**
Structural Grade: **0**
O&M Grade: **0**
Clock Start/From: **9**
Clock To:
1st Value: **4.000**
2nd Value:
Value Percent:
Continuous Index:
Within 8" of Joint:
Remarks:

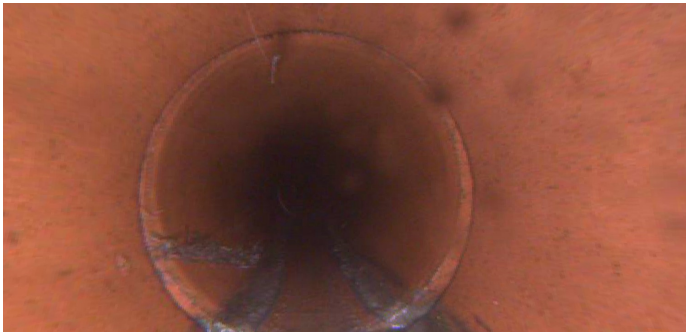
Code: **RFB**
Description: **Roots Fine Barrel**

Distance (ft): **110.7**
Structural Grade: **0**
O&M Grade: **2**
Clock Start/From: **8**
Clock To:
1st Value:
2nd Value:
Value Percent:
Continuous Index:
Within 8" of Joint: **NO**
Remarks:

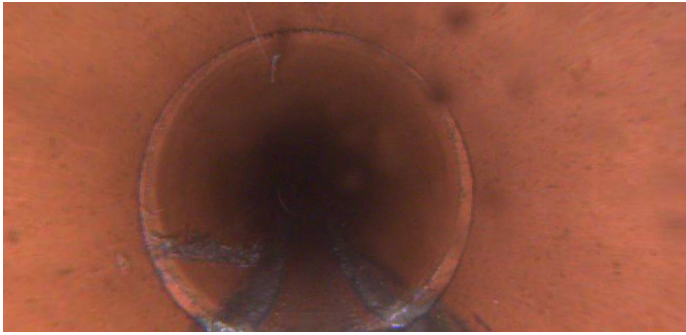
Code: **RFJ**
Description: **Roots Fine Joint**

Distance (ft): **110.7**
Structural Grade: **0**
O&M Grade: **1**
Clock Start/From: **12**
Clock To:
1st Value:
2nd Value:
Value Percent:
Continuous Index:
Within 8" of Joint: **YES**
Remarks:

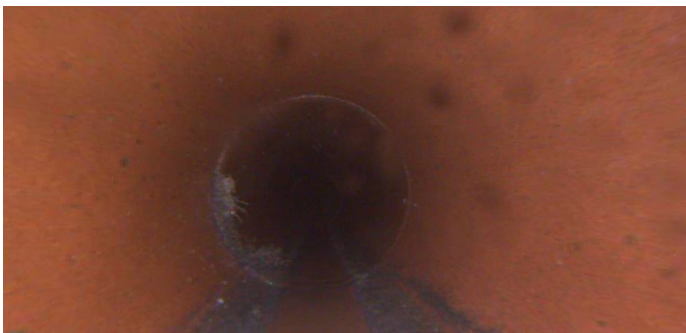
Code: **RFJ**
Description: **Roots Fine Joint**

Distance (ft): **118.2**
Structural Grade: **0**
O&M Grade: **1**
Clock Start/From: **3**
Clock To: **9**
1st Value:
2nd Value:
Value Percent:
Continuous Index:
Within 8" of Joint: **YES**
Remarks:

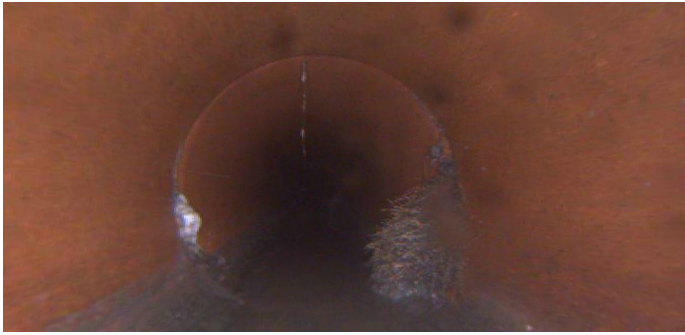
Code: **RMJ**
Description: **Roots Medium Joint**

Distance (ft): **126.7**
Structural Grade: **0**
O&M Grade: **3**
Clock Start/From: **7**
Clock To: **5**
1st Value:
2nd Value:
Value Percent: **10.000**
Continuous Index:
Within 8" of Joint: **YES**
Remarks:

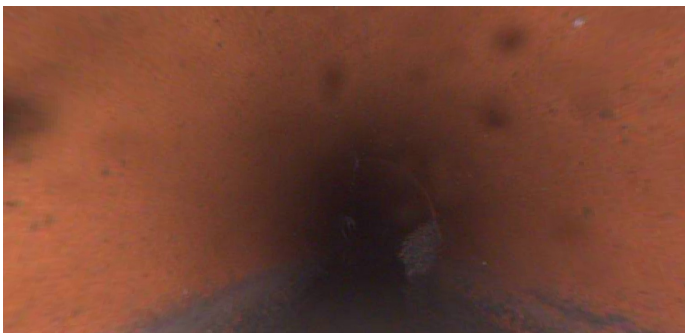
Code: **RMJ**
Description: **Roots Medium Joint**

Distance (ft): **129.7**
Structural Grade: **0**
O&M Grade: **3**
Clock Start/From: **5**
Clock To: **5**
1st Value:
2nd Value:
Value Percent: **15.000**
Continuous Index: **S02**
Within 8" of Joint: **YES**
Remarks:

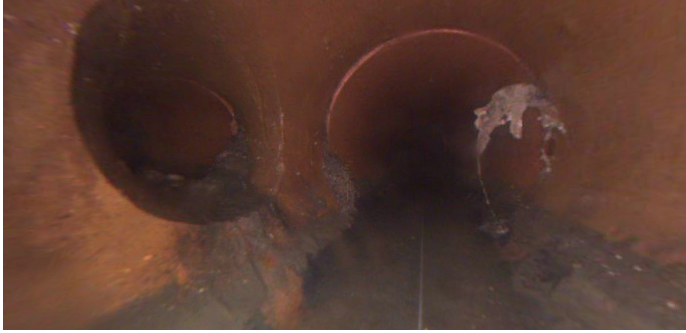
Code: **TF**
Description: **Tap Factory**

Distance (ft): **137.0**
Structural Grade: **0**
O&M Grade: **0**
Clock Start/From: **3**
Clock To:
1st Value: **4.000**
2nd Value:
Value Percent:
Continuous Index:
Within 8" of Joint:
Remarks:

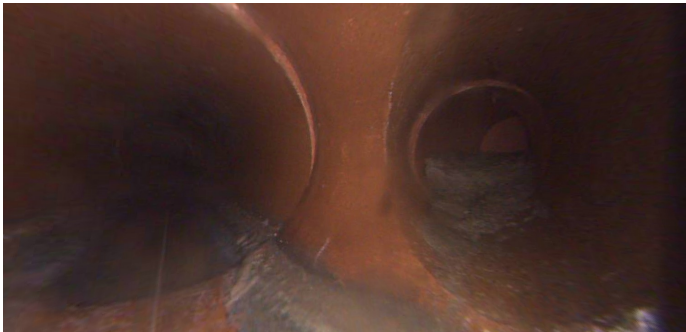
Code: **TF**
Description: **Tap Factory**

Distance (ft): **178.5**
Structural Grade: **0**
O&M Grade: **0**
Clock Start/From: **9**
Clock To:
1st Value: **4.000**
2nd Value:
Value Percent:
Continuous Index:
Within 8" of Joint:
Remarks:

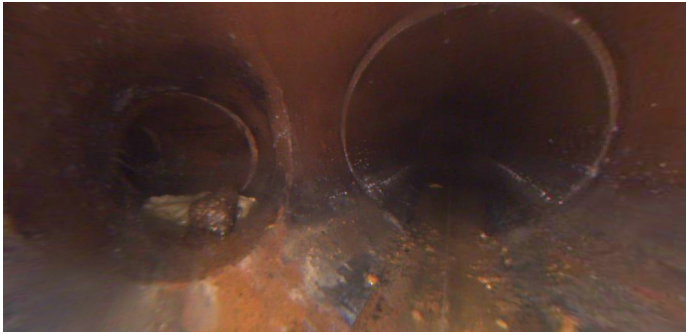
Code: **TF**
Description: **Tap Factory**

Distance (ft): **198.7**
Structural Grade: **0**
O&M Grade: **0**
Clock Start/From: **3**
Clock To:
1st Value: **4.000**
2nd Value:
Value Percent:
Continuous Index:
Within 8" of Joint:
Remarks:

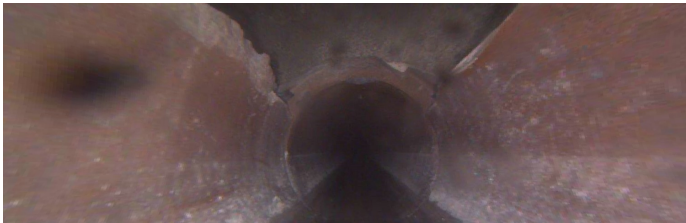
Code: **RMJ**
Description: **Roots Medium Joint**

Distance (ft): **222.3**
Structural Grade: **0**
O&M Grade: **3**
Clock Start/From: **5**
Clock To: **5**
1st Value:
2nd Value:
Value Percent: **15.000**
Continuous Index: **F02**
Within 8" of Joint: **YES**
Remarks:

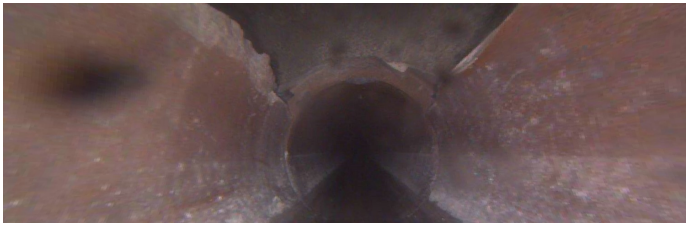
Code: **AMH**
Description: **Manhole**

Distance (ft): **222.3**
Structural Grade: **0**
O&M Grade: **0**
Clock Start/From:
Clock To:
1st Value:
2nd Value:
Value Percent:
Continuous Index:
Within 8" of Joint: **NO**
Remarks: **M-803-036**
