Profile/Photo Observation Report

Date:	03/28/2018	Weather:		Coding:	PACP 6.0
Pipe Length (ft):	232.7	Owner:	NA	Pre Clean:	Not Known
P.O.#:		Surveyor:	Selasie Honu	PSR:	P-803-036-037
Customer:		Clean Date:	01/01/1900	Shape:	C

Street:	E RAND ST	Flow Control:	Not Controlled
City:	Hobart, IN	Year Renewed:	
Location:	Other	Tape/Media #:	
Purpose:	Not Known	Dia/Height:	10"
Use:	Sanitary	Material:	VCP
Drain Area:	NA	Lining:	
Category:	NA		
Comment:

Location Details:		Direction of Survey:	Downstream
US MH:	M-803-037	DS MH:	M-803-036
		Total Length Surveyed (ft):	223.8

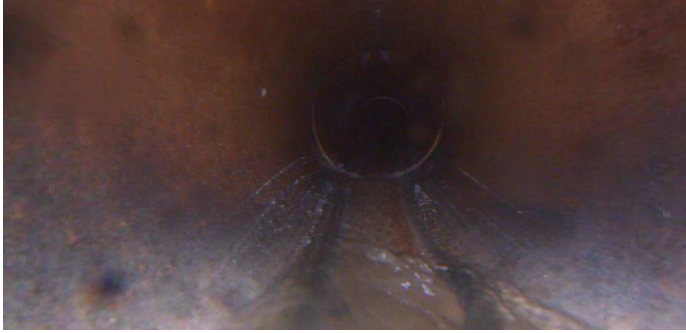
Code: **AMH**
Description: **Manhole**

Distance (ft): **.0**
Structural Grade: **0**
O&M Grade: **0**
Clock Start/From:
Clock To:
1st Value:
2nd Value:
Value Percent:
Continuous Index:
Within 8" of Joint: **NO**
Remarks: **M-803-037**

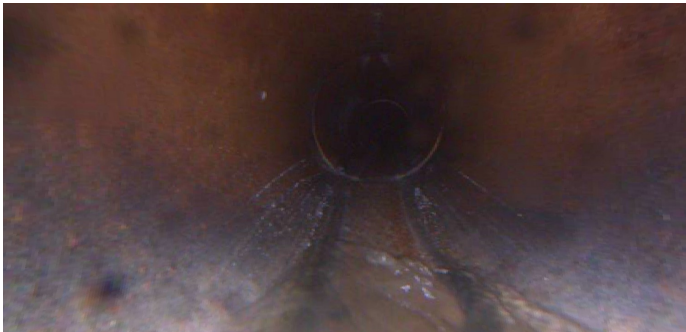
Code: **MWL**
Description: **Water Level**

Distance (ft): **.0**
Structural Grade: **0**
O&M Grade: **0**
Clock Start/From:
Clock To:
1st Value:
2nd Value:
Value Percent: **5.000**
Continuous Index:
Within 8" of Joint: **NO**
Remarks:

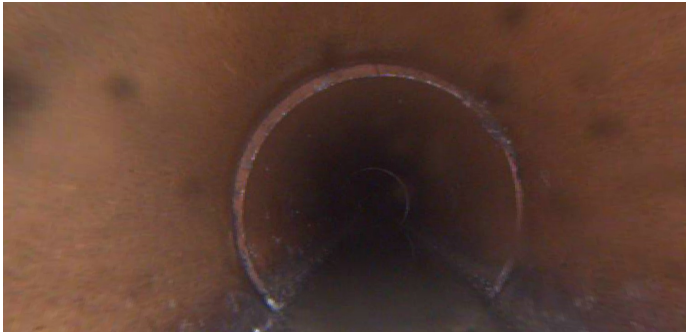
Code: **RFJ**
Description: **Roots Fine Joint**

Distance (ft): **11.1**
Structural Grade: **0**
O&M Grade: **1**
Clock Start/From: **1**
Clock To: **2**
1st Value:
2nd Value:
Value Percent:
Continuous Index:
Within 8" of Joint: **YES**
Remarks:

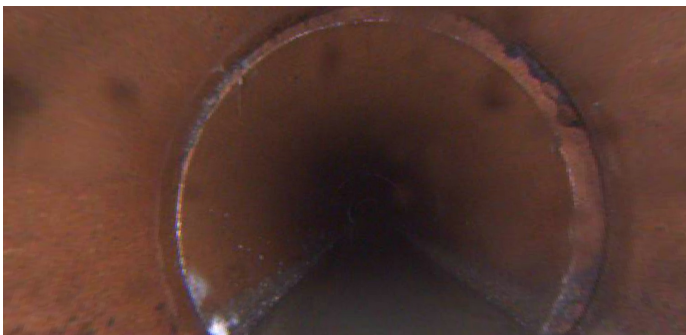
Code: **RFJ**
Description: **Roots Fine Joint**

Distance (ft): **14.4**
Structural Grade: **0**
O&M Grade: **1**
Clock Start/From: **11**
Clock To: **2**
1st Value:
2nd Value:
Value Percent:
Continuous Index:
Within 8" of Joint: **YES**
Remarks:

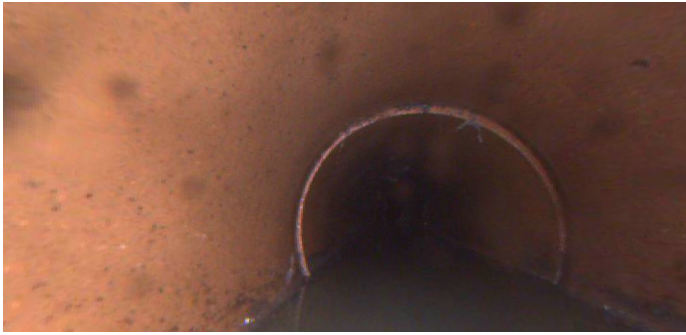
Code: **RFJ**
Description: **Roots Fine Joint**

Distance (ft): **22.8**
Structural Grade: **0**
O&M Grade: **1**
Clock Start/From: **11**
Clock To: **1**
1st Value:
2nd Value:
Value Percent:
Continuous Index:
Within 8" of Joint: **YES**
Remarks:

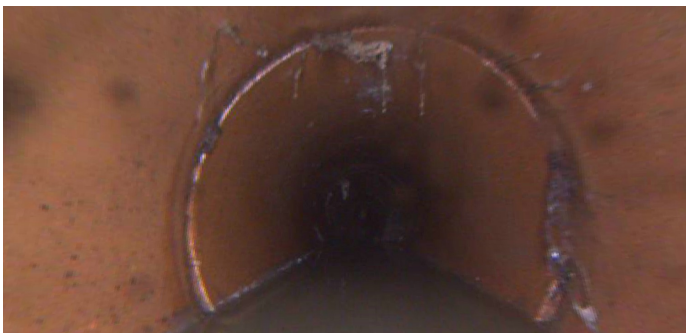
Code: **RFJ**
Description: **Roots Fine Joint**

Distance (ft): **26.0**
Structural Grade: **0**
O&M Grade: **1**
Clock Start/From: **7**
Clock To: **5**
1st Value:
2nd Value:
Value Percent:
Continuous Index: **S01**
Within 8" of Joint: **YES**
Remarks:

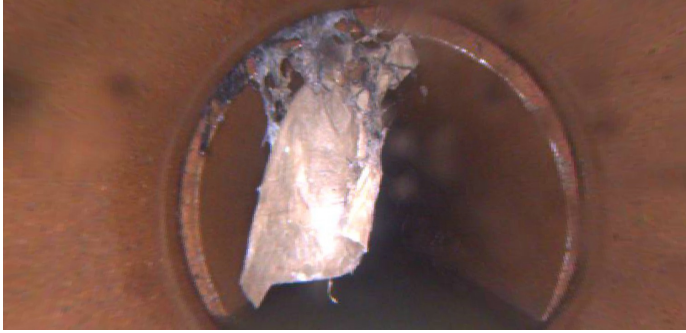
Code: **DAR**
Description: **Deposits Attached Ragging**

Distance (ft): **37.8**
Structural Grade: **0**
O&M Grade: **2**
Clock Start/From: **12**
Clock To:
1st Value:
2nd Value:
Value Percent: **10.000**
Continuous Index:
Within 8" of Joint: **YES**
Remarks:

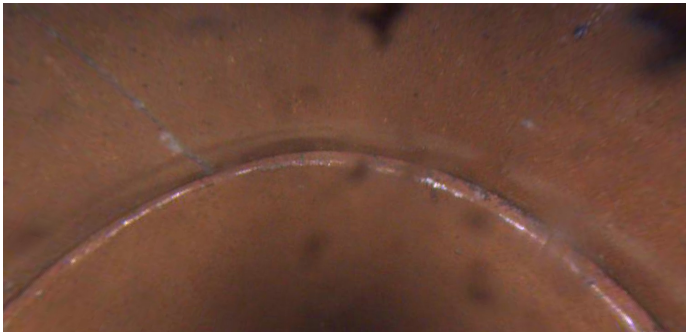
Code: **CL**
Description: **Crack Longitudinal**

Distance (ft): **65.7**
Structural Grade: **2**
O&M Grade: **0**
Clock Start/From: **11**
Clock To:
1st Value:
2nd Value:
Value Percent:
Continuous Index:
Within 8" of Joint: **YES**
Remarks:

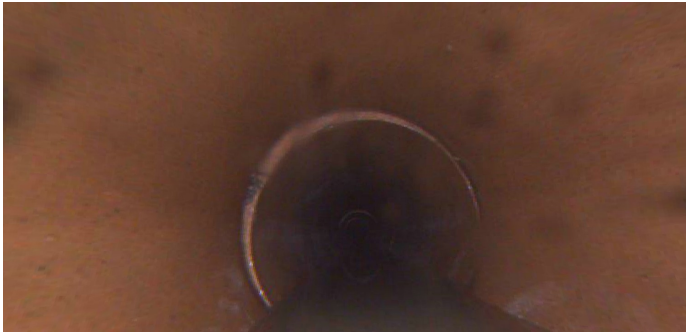
Code: **RFJ**
Description: **Roots Fine Joint**

Distance (ft): **85.7**
Structural Grade: **0**
O&M Grade: **1**
Clock Start/From: **7**
Clock To: **5**
1st Value:
2nd Value:
Value Percent:
Continuous Index: **F01**
Within 8" of Joint: **YES**
Remarks:

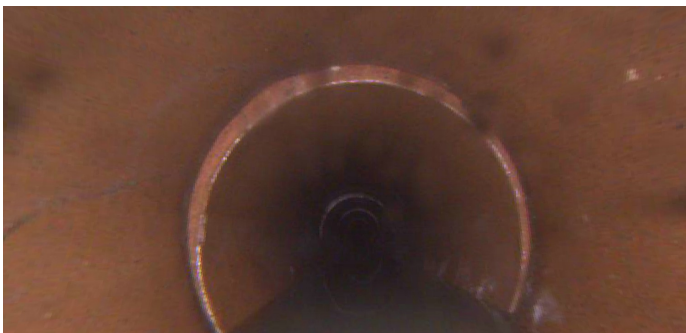
Code: **FC**
Description: **Fracture Circumferential**

Distance (ft): **91.9**
Structural Grade: **2**
O&M Grade: **0**
Clock Start/From: **8**
Clock To: **11**
1st Value:
2nd Value:
Value Percent:
Continuous Index:
Within 8" of Joint: **YES**
Remarks:

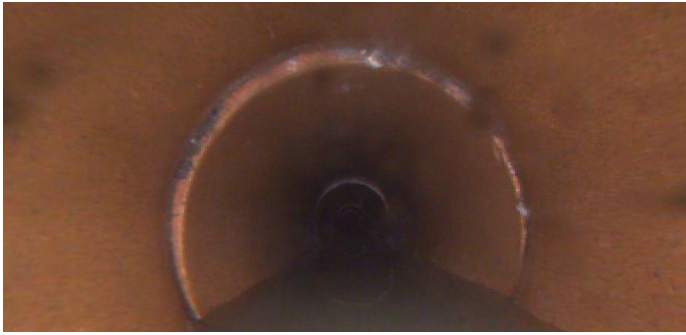
Code: **RFJ**
Description: **Roots Fine Joint**

Distance (ft): **94.9**
Structural Grade: **0**
O&M Grade: **1**
Clock Start/From: **9**
Clock To: **3**
1st Value:
2nd Value:
Value Percent:
Continuous Index:
Within 8" of Joint: **YES**
Remarks:

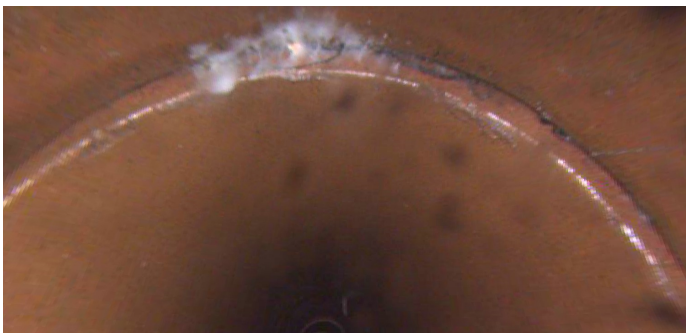
Code: **RFJ**
Description: **Roots Fine Joint**

Distance (ft): **98.3**
Structural Grade: **0**
O&M Grade: **1**
Clock Start/From: **12**
Clock To: **2**
1st Value:
2nd Value:
Value Percent:
Continuous Index:
Within 8" of Joint: **YES**
Remarks:

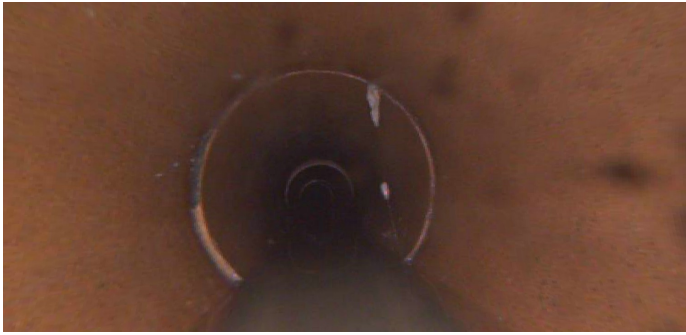
Code: **RFJ**
Description: **Roots Fine Joint**

Distance (ft): **100.5**
Structural Grade: **0**
O&M Grade: **1**
Clock Start/From: **9**
Clock To: **5**
1st Value:
2nd Value:
Value Percent:
Continuous Index:
Within 8" of Joint: **YES**
Remarks:

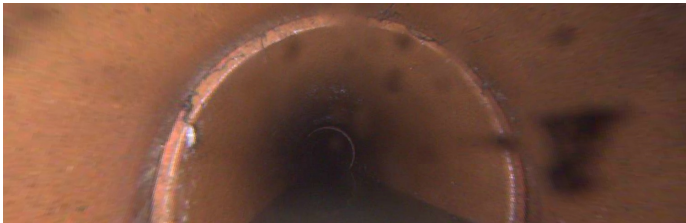
Code: **RFJ**
Description: **Roots Fine Joint**

Distance (ft): **107.0**
Structural Grade: **0**
O&M Grade: **1**
Clock Start/From: **9**
Clock To: **3**
1st Value:
2nd Value:
Value Percent:
Continuous Index:
Within 8" of Joint: **YES**
Remarks:

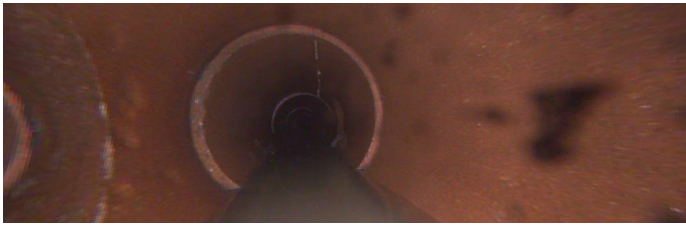
Code: **RFJ**
Description: **Roots Fine Joint**

Distance (ft): **129.3**
Structural Grade: **0**
O&M Grade: **1**
Clock Start/From: **1**
Clock To:
1st Value:
2nd Value:
Value Percent:
Continuous Index:
Within 8" of Joint: **YES**
Remarks:

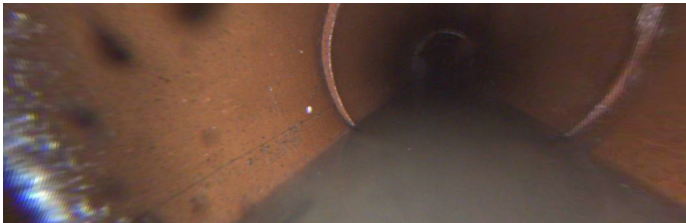
Code: **FL**
Description: **Fracture Longitudinal**

Distance (ft): **134.5**
Structural Grade: **3**
O&M Grade: **0**
Clock Start/From: **8**
Clock To:
1st Value:
2nd Value:
Value Percent:
Continuous Index:
Within 8" of Joint: **YES**
Remarks:

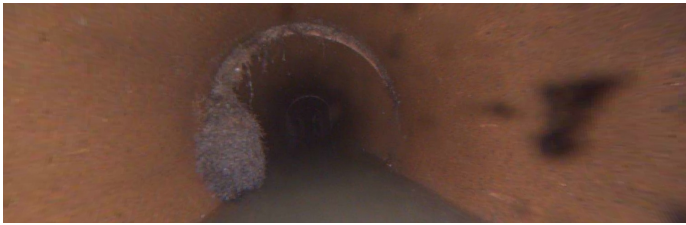
Code: **RMJ**
Description: **Roots Medium Joint**

Distance (ft): **137.3**
Structural Grade: **0**
O&M Grade: **3**
Clock Start/From: **7**
Clock To: **5**
1st Value:
2nd Value:
Value Percent: **20.000**
Continuous Index: **S02**
Within 8" of Joint: **YES**
Remarks: **M-803-036**

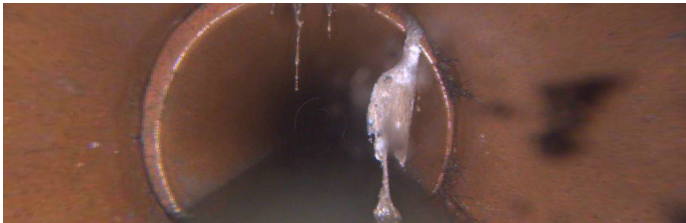
Code: **RMJ**
Description: **Roots Medium Joint**

Distance (ft): **146.5**
Structural Grade: **0**
O&M Grade: **3**
Clock Start/From: **7**
Clock To: **5**
1st Value:
2nd Value:
Value Percent: **20.000**
Continuous Index: **F02**
Within 8" of Joint: **YES**
Remarks: **M-803-036**

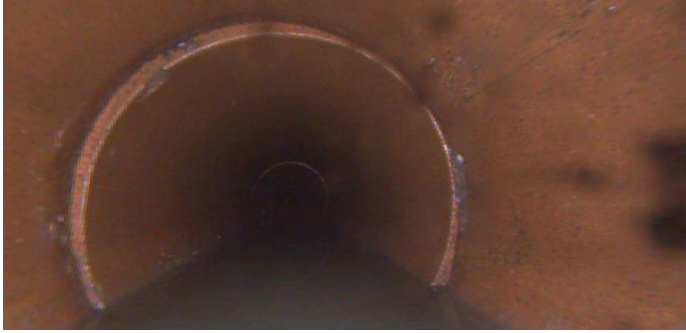
Code: **RFJ**
Description: **Roots Fine Joint**

Distance (ft): **149.3**
Structural Grade: **0**
O&M Grade: **1**
Clock Start/From: **11**
Clock To: **4**
1st Value:
2nd Value:
Value Percent:
Continuous Index:
Within 8" of Joint: **YES**
Remarks:

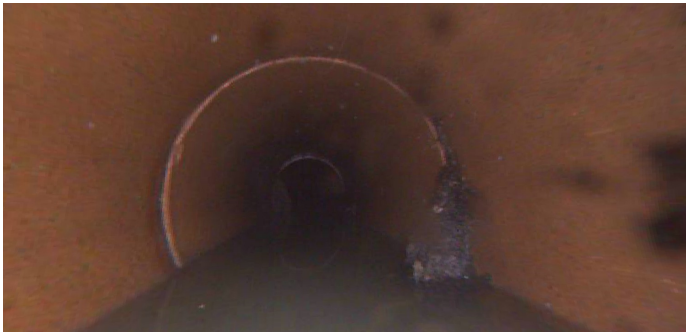
Code: **RFJ**
Description: **Roots Fine Joint**

Distance (ft): **158.0**
Structural Grade: **0**
O&M Grade: **1**
Clock Start/From: **7**
Clock To: **5**
1st Value:
2nd Value:
Value Percent:
Continuous Index: **S03**
Within 8" of Joint: **YES**
Remarks:

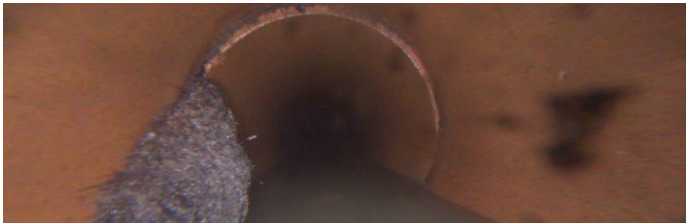
Code: **RFJ**
Description: **Roots Fine Joint**

Distance (ft): **161.2**
Structural Grade: **0**
O&M Grade: **1**
Clock Start/From: **7**
Clock To: **5**
1st Value:
2nd Value:
Value Percent:
Continuous Index: **F03**
Within 8" of Joint: **YES**
Remarks:

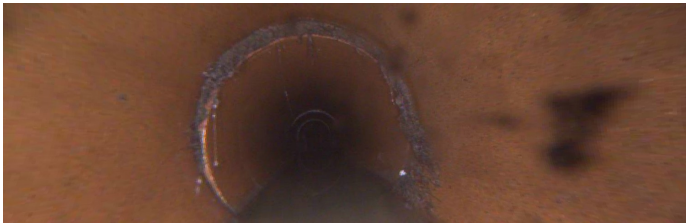
Code: **RFJ**
Description: **Roots Fine Joint**

Distance (ft): **166.9**
Structural Grade: **0**
O&M Grade: **1**
Clock Start/From: **7**
Clock To: **5**
1st Value:
2nd Value:
Value Percent:
Continuous Index:
Within 8" of Joint: **YES**
Remarks:

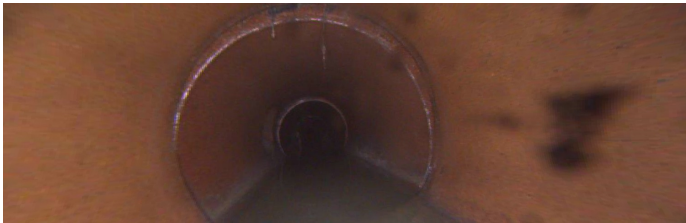
Code: **RFJ**
Description: **Roots Fine Joint**

Distance (ft): **170.0**
Structural Grade: **0**
O&M Grade: **1**
Clock Start/From: **11**
Clock To: **1**
1st Value:
2nd Value:
Value Percent:
Continuous Index:
Within 8" of Joint: **YES**
Remarks:

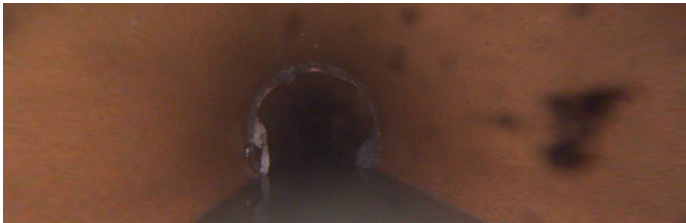
Code: **RFJ**
Description: **Roots Fine Joint**

Distance (ft): **174.3**
Structural Grade: **0**
O&M Grade: **1**
Clock Start/From: **7**
Clock To: **5**
1st Value:
2nd Value:
Value Percent:
Continuous Index: **S04**
Within 8" of Joint: **YES**
Remarks:

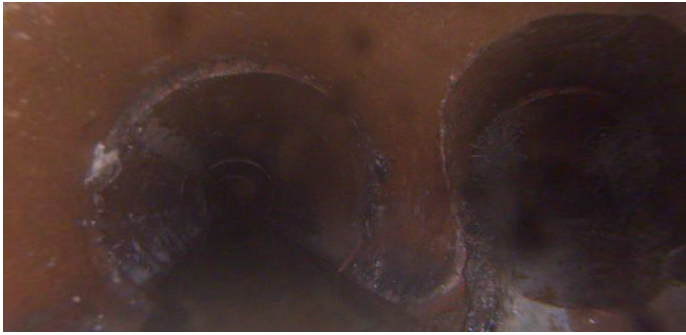
Code: **TFD**
Description: **Tap Factory Defective**

Distance (ft): **197.4**
Structural Grade: **0**
O&M Grade: **2**
Clock Start/From: **3**
Clock To:
1st Value: **4.000**
2nd Value:
Value Percent:
Continuous Index:
Within 8" of Joint:
Remarks: **roots**

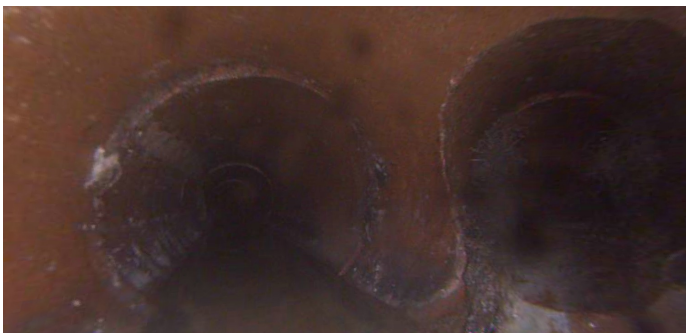
Code: **RFL**
Description: **Roots Fine Lateral**

Distance (ft): **197.4**
Structural Grade: **0**
O&M Grade: **1**
Clock Start/From: **3**
Clock To:
1st Value:
2nd Value:
Value Percent:
Continuous Index:
Within 8" of Joint: **NO**
Remarks:

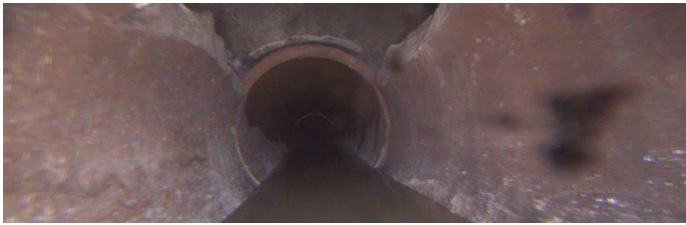
Code: **RFJ**
Description: **Roots Fine Joint**

Distance (ft): **223.8**
Structural Grade: **0**
O&M Grade: **1**
Clock Start/From: **7**
Clock To: **5**
1st Value:
2nd Value:
Value Percent:
Continuous Index: **F04**
Within 8" of Joint: **YES**
Remarks:

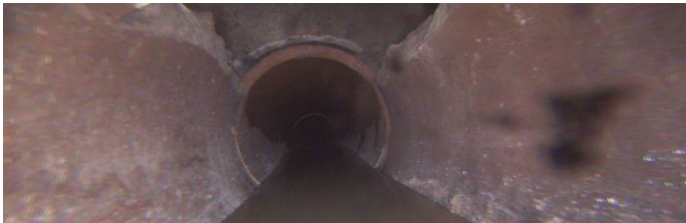
Code: **AMH**
Description: **Manhole**

Distance (ft): **223.8**
Structural Grade: **0**
O&M Grade: **0**
Clock Start/From:
Clock To:
1st Value:
2nd Value:
Value Percent:
Continuous Index:
Within 8" of Joint: **NO**
Remarks: **M-803-036**
