Profile/Photo Observation Report

Street:	E RAND ST & N INDIANA ST	Flow Control:	Not Controlled
City:	Hobart, IN	Year Renewed:	
Location:	Other	Tape/Media #:	
Purpose:	Not Known	Dia/Height:	12"
Use:	Sanitary	Material:	VCP
Drain Area:	NA	Lining:	
Category:	NA		
Comment:

Location Details:		Direction of Survey:	Upstream
US MH:	M-803-038	DS MH:	M-803-039
		Total Length Surveyed (ft):	128.2

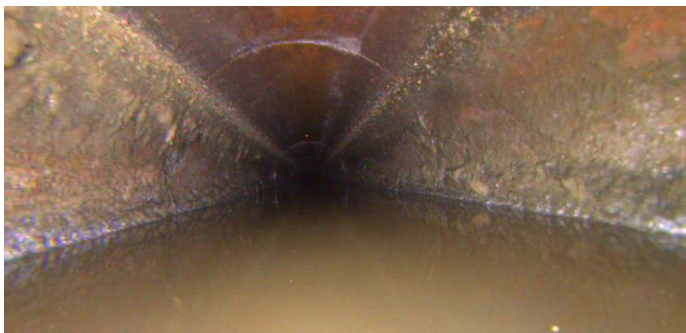
Code: **AMH**
Description: **Manhole**

Distance (ft): **.0**
Structural Grade: **0**
O&M Grade: **0**
Clock Start/From:
Clock To:
1st Value:
2nd Value:
Value Percent:
Continuous Index:
Within 8" of Joint: **NO**
Remarks: **M-803-039**

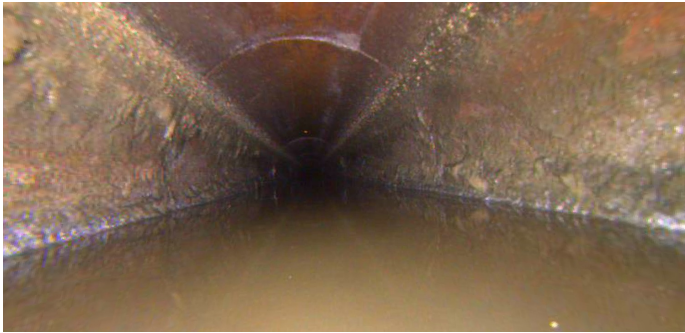
Code:	MWL
Description:	Water Level

Distance (ft):	.0
Structural Grade:	0
O&M Grade:	0
Clock Start/From:	
Clock To:	
1st Value:	
2nd Value:	
Value Percent:	40.000
Continuous Index:	
Within 8" of Joint:	NO
Remarks:

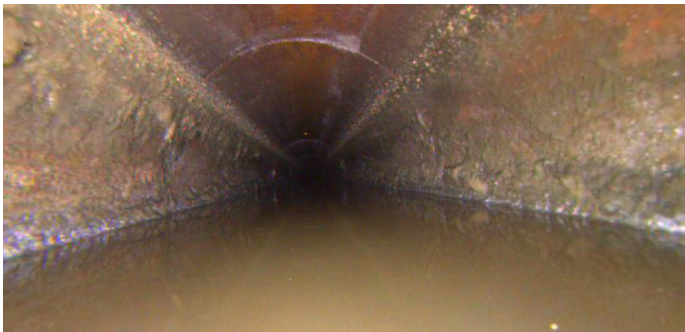
Code:	DAGS
Description:	Deposits Attached Grease

Distance (ft):	.0
Structural Grade:	0
O&M Grade:	2
Clock Start/From:	8
Clock To:	4
1st Value:	
2nd Value:	
Value Percent:	10.000
Continuous Index:	S01
Within 8" of Joint:	NO
Remarks:

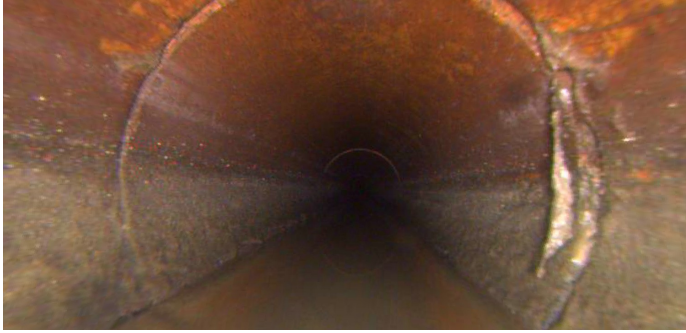
Code: **DAR**
Description: **Deposits Attached Ragging**

Distance (ft): **74.9**
Structural Grade: **0**
O&M Grade: **2**
Clock Start/From: **2**
Clock To:
1st Value:
2nd Value:
Value Percent: **5.000**
Continuous Index:
Within 8" of Joint: **YES**
Remarks:

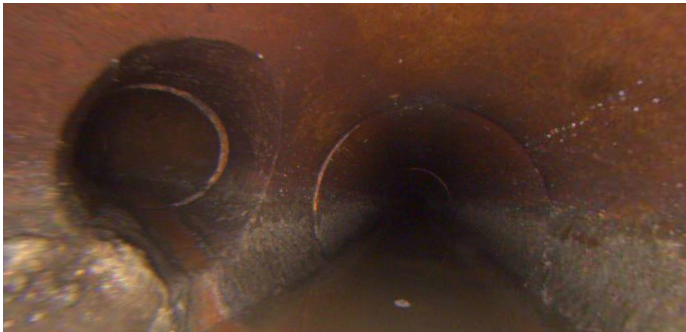
Code: **TF**
Description: **Tap Factory**

Distance (ft): **100.0**
Structural Grade: **0**
O&M Grade: **0**
Clock Start/From: **9**
Clock To:
1st Value: **4.000**
2nd Value:
Value Percent:
Continuous Index:
Within 8" of Joint:
Remarks:

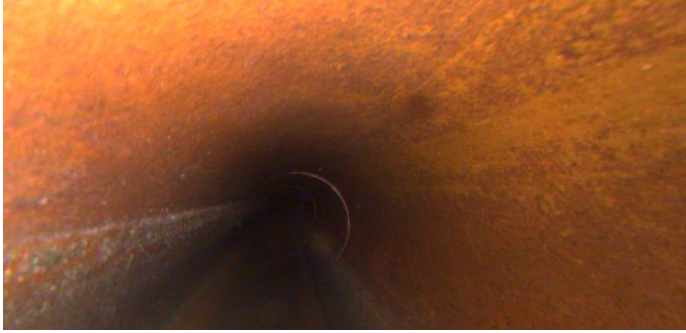
Code: **MSA**
Description: **Abandoned Survey**

Distance (ft): **128.2**
Structural Grade: **0**
O&M Grade: **0**
Clock Start/From:
Clock To:
1st Value:
2nd Value:
Value Percent:
Continuous Index:
Within 8" of Joint: **NO**
Remarks: **OVERTURNED**

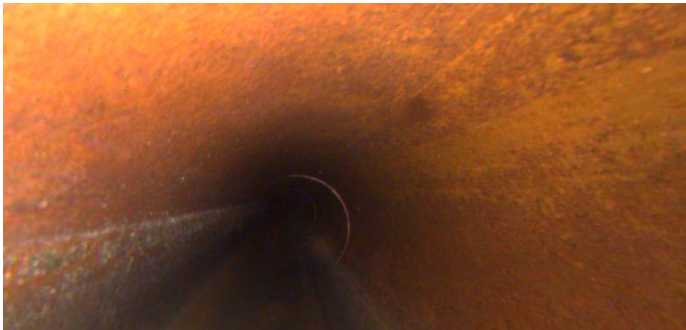
Code: **DAGS**
Description: **Deposits Attached Grease**

Distance (ft): **128.2**
Structural Grade: **0**
O&M Grade: **2**
Clock Start/From: **8**
Clock To: **4**
1st Value:
2nd Value:
Value Percent: **10.000**
Continuous Index: **F01**
Within 8" of Joint: **NO**
Remarks:
