Profile/Photo Observation Report

Street:	Rand St.	Flow Control:	Not Controlled
City:	Hobart, IN	Year Renewed:	
Location:	Other	Tape/Media #:	
Purpose:	Not Known	Dia/Height:	12"
Use:	Sanitary	Material:	VCP
Drain Area:	NA	Lining:	
Category:	NA		
Comment:

Location Details:		Direction of Survey:	Upstream
US MH:	M-803-038	DS MH:	M-803-039
		Total Length Surveyed (ft):	128.2

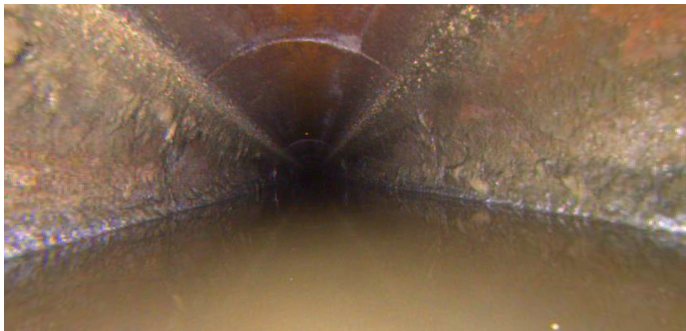
Code: **AMH**
Description: **Manhole**

Distance (ft): **.0**
Structural Grade: **0**
O&M Grade: **0**
Clock Start/From:
Clock To:
1st Value:
2nd Value:
Value Percent:
Continuous Index:
Within 8" of Joint: **NO**
Remarks: **M-803-039**

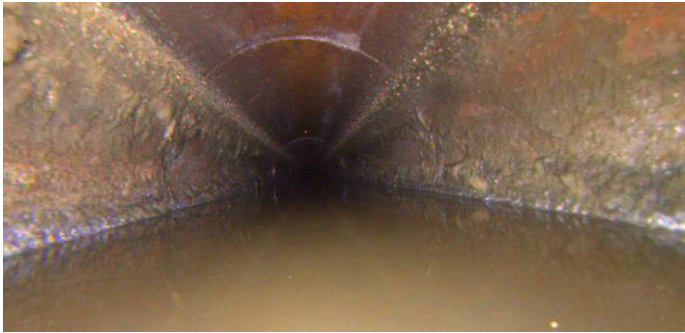
Code:	MWL
Description:	Water Level

Distance (ft):	.0
Structural Grade:	0
O&M Grade:	0
Clock Start/From:	
Clock To:	
1st Value:	
2nd Value:	
Value Percent:	40.000
Continuous Index:	
Within 8" of Joint:	NO
Remarks:

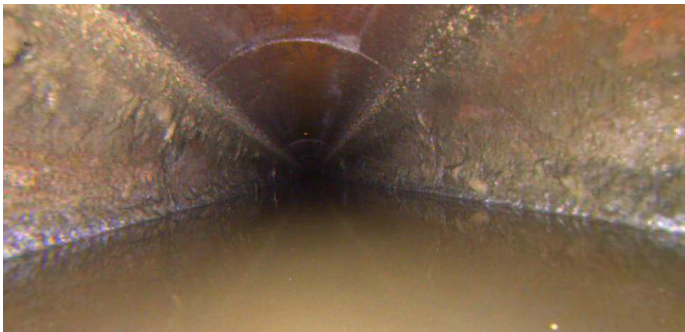
Code:	DAGS
Description:	Deposits Attached Grease

Distance (ft):	.0
Structural Grade:	0
O&M Grade:	2
Clock Start/From:	8
Clock To:	4
1st Value:	
2nd Value:	
Value Percent:	10.000
Continuous Index:	S01
Within 8" of Joint:	NO
Remarks:

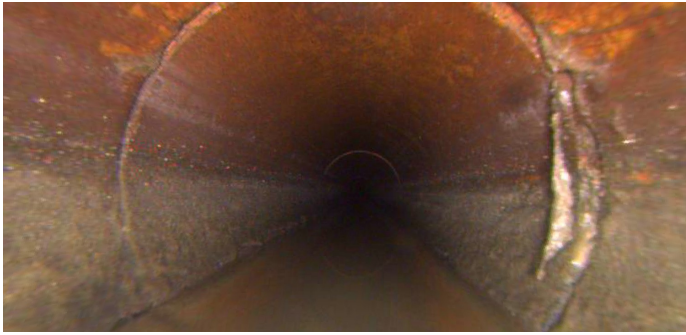
Code: **DAR**
Description: **Deposits Attached Ragging**

Distance (ft): **74.9**
Structural Grade: **0**
O&M Grade: **2**
Clock Start/From: **2**
Clock To:
1st Value:
2nd Value:
Value Percent: **5.000**
Continuous Index:
Within 8" of Joint: **YES**
Remarks:

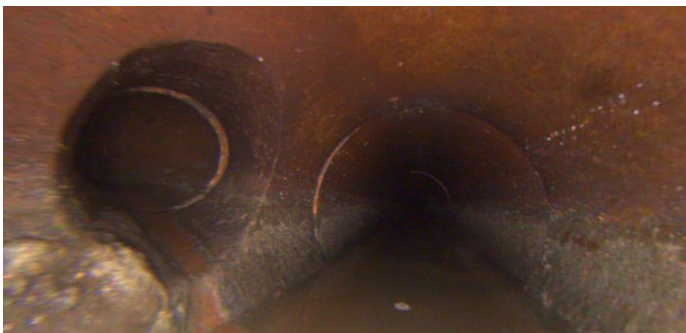
Code: **TF**
Description: **Tap Factory**

Distance (ft): **100.0**
Structural Grade: **0**
O&M Grade: **0**
Clock Start/From: **9**
Clock To:
1st Value: **4.000**
2nd Value:
Value Percent:
Continuous Index:
Within 8" of Joint:
Remarks:

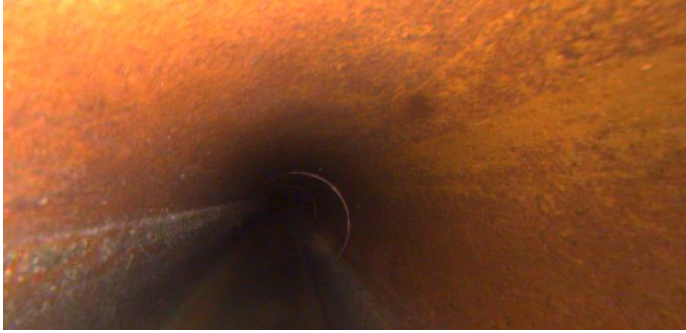
Code: **MSA**
Description: **Abandoned Survey**

Distance (ft): **128.2**
Structural Grade: **0**
O&M Grade: **0**
Clock Start/From:
Clock To:
1st Value:
2nd Value:
Value Percent:
Continuous Index:
Within 8" of Joint: **NO**
Remarks: **OVERTURNED**

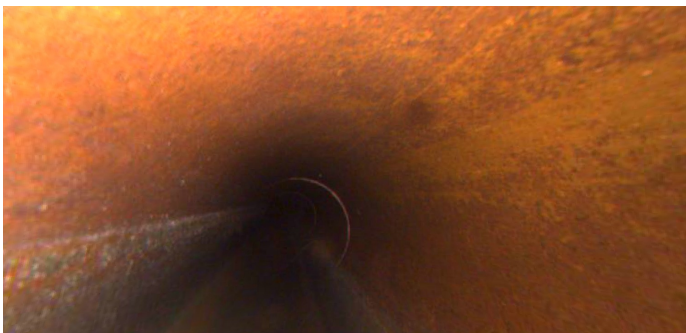
Code: **DAGS**
Description: **Deposits Attached Grease**

Distance (ft): **128.2**
Structural Grade: **0**
O&M Grade: **2**
Clock Start/From: **8**
Clock To: **4**
1st Value:
2nd Value:
Value Percent: **10.000**
Continuous Index: **F01**
Within 8" of Joint: **NO**
Remarks:
