Profile/Photo Observation Report

Street:	E RAND ST & N INDIANA ST	Flow Control:	Not Controlled
City:	Hobart, IN	Year Renewed:	
Location:	Other	Tape/Media #:	
Purpose:	Not Known	Dia/Height:	12"
Use:	Sanitary	Material:	VCP
Drain Area:	NA	Lining:	
Category:	NA		
Comment:

Location Details:		Direction of Survey:	Downstream
US MH:	M-803-038	DS MH:	M-803-039
		Total Length Surveyed (ft):	35.4

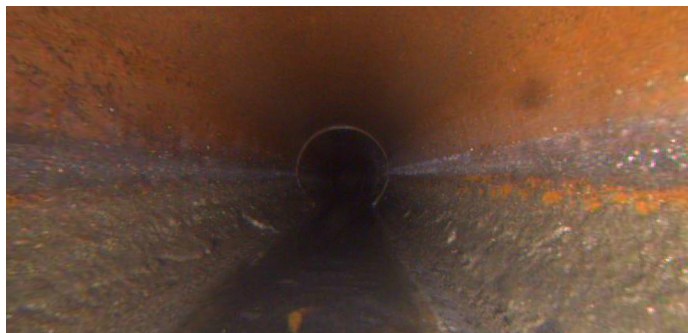
Code: **AMH**
Description: **Manhole**

Distance (ft): **.0**
Structural Grade: **0**
O&M Grade: **0**
Clock Start/From:
Clock To:
1st Value:
2nd Value:
Value Percent:
Continuous Index:
Within 8" of Joint: **NO**
Remarks: **M-803-038**

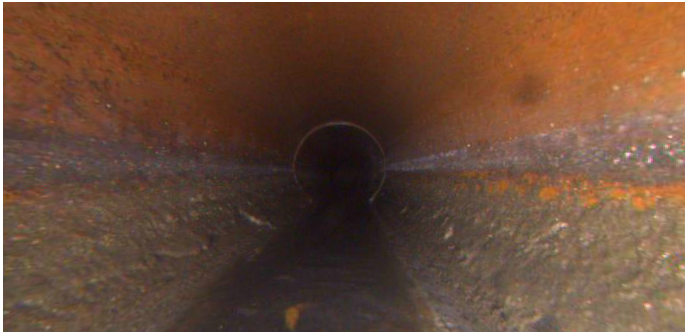
Code:	MWL
Description:	Water Level

Distance (ft):	.0
Structural Grade:	0
O&M Grade:	0
Clock Start/From:	
Clock To:	
1st Value:	
2nd Value:	
Value Percent:	5.000
Continuous Index:	
Within 8" of Joint:	NO
Remarks:

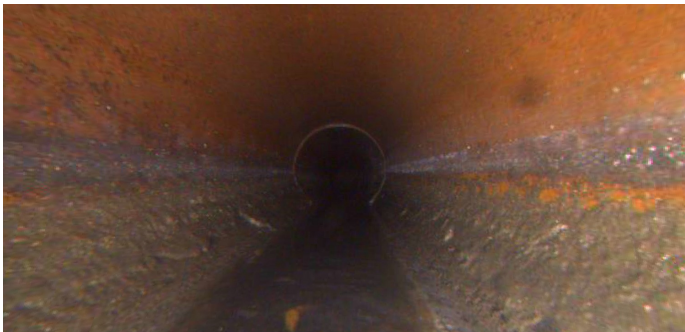
Code:	DAGS
Description:	Deposits Attached Grease

Distance (ft):	.0
Structural Grade:	0
O&M Grade:	2
Clock Start/From:	8
Clock To:	4
1st Value:	
2nd Value:	
Value Percent:	5.000
Continuous Index:	
Within 8" of Joint:	NO
Remarks:

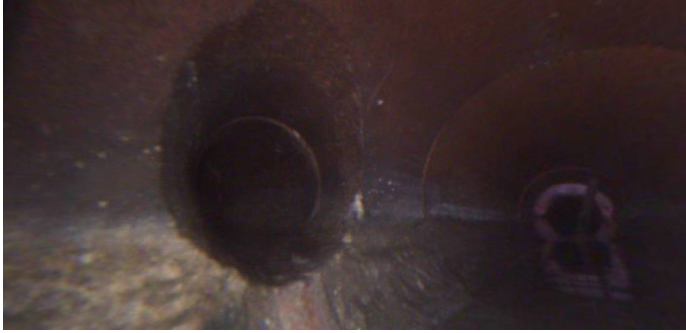
Code: **TF**
Description: **Tap Factory**

Distance (ft): **5.2**
Structural Grade: **0**
O&M Grade: **0**
Clock Start/From: **3**
Clock To:
1st Value: **4.000**
2nd Value:
Value Percent:
Continuous Index:
Within 8" of Joint:
Remarks:

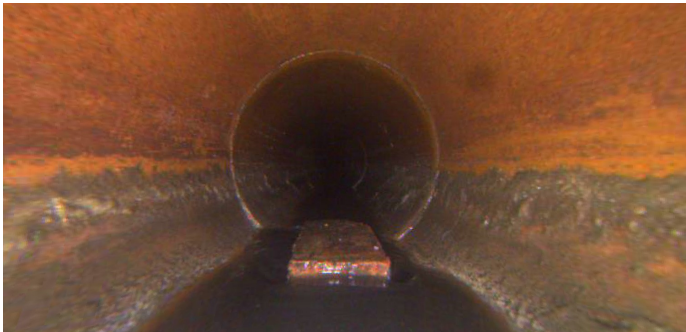
Code: **OBR**
Description: **Obstacle Rocks**

Distance (ft): **34.2**
Structural Grade: **0**
O&M Grade: **2**
Clock Start/From: **6**
Clock To:
1st Value:
2nd Value:
Value Percent: **5.000**
Continuous Index:
Within 8" of Joint: **NO**
Remarks:

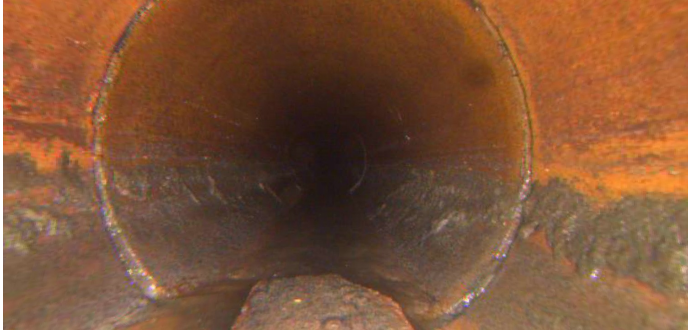
Code:	MSA
Description:	Abandoned Survey
Distance (ft):	35.4
Structural Grade:	0
O&M Grade:	0
Clock Start/From:	
Clock To:	
1st Value:	
2nd Value:	
Value Percent:	
Continuous Index:	
Within 8" of Joint:	NO
Remarks:	obr
