Profile/Photo Observation Report

Street:	Rand St.	Flow Control:	Not Controlled
City:	Hobart, IN	Year Renewed:	
Location:	Other	Tape/Media #:	
Purpose:	Not Known	Dia/Height:	12"
Use:	Sanitary	Material:	VCP
Drain Area:	NA	Lining:	
Category:	NA		
Comment:

Location Details:		Direction of Survey:	Downstream
US MH:	M-803-038	DS MH:	M-803-039
		Total Length Surveyed (ft):	35.4

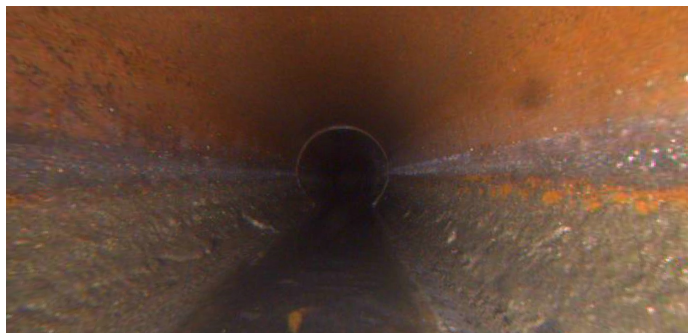
Code: **AMH**
Description: **Manhole**

Distance (ft): **.0**
Structural Grade: **0**
O&M Grade: **0**
Clock Start/From:
Clock To:
1st Value:
2nd Value:
Value Percent:
Continuous Index:
Within 8" of Joint: **NO**
Remarks: **M-803-038**

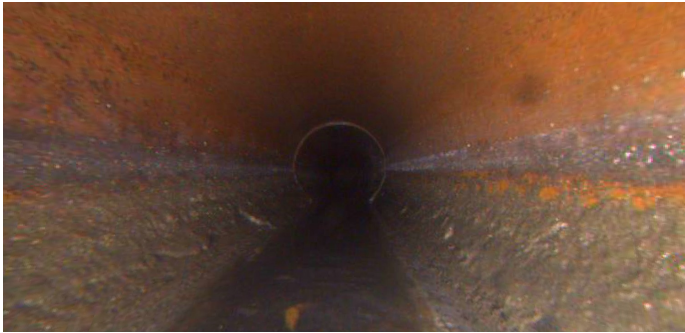
Code:	MWL
Description:	Water Level

Distance (ft):	.0
Structural Grade:	0
O&M Grade:	0
Clock Start/From:	
Clock To:	
1st Value:	
2nd Value:	
Value Percent:	5.000
Continuous Index:	
Within 8" of Joint:	NO
Remarks:

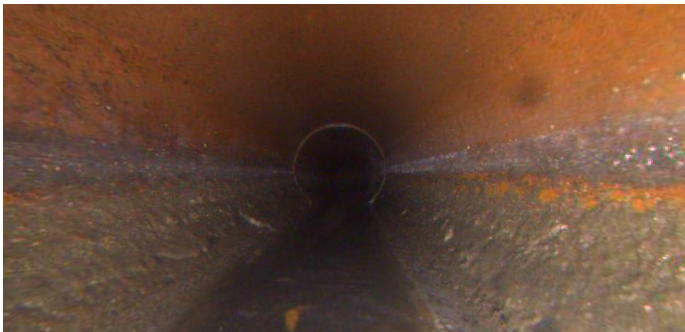
Code:	DAGS
Description:	Deposits Attached Grease

Distance (ft):	.0
Structural Grade:	0
O&M Grade:	2
Clock Start/From:	8
Clock To:	4
1st Value:	
2nd Value:	
Value Percent:	5.000
Continuous Index:	
Within 8" of Joint:	NO
Remarks:

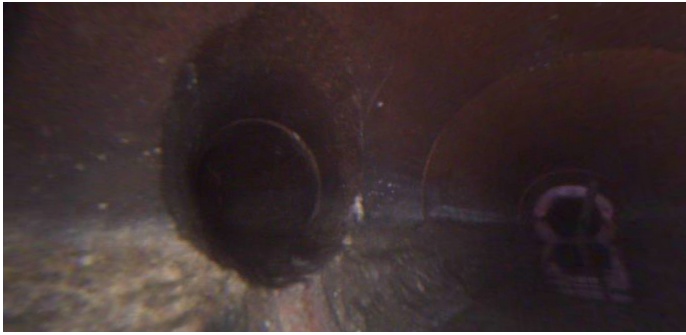
Code: **TF**
Description: **Tap Factory**

Distance (ft): **5.2**
Structural Grade: **0**
O&M Grade: **0**
Clock Start/From: **3**
Clock To:
1st Value: **4.000**
2nd Value:
Value Percent:
Continuous Index:
Within 8" of Joint:
Remarks:

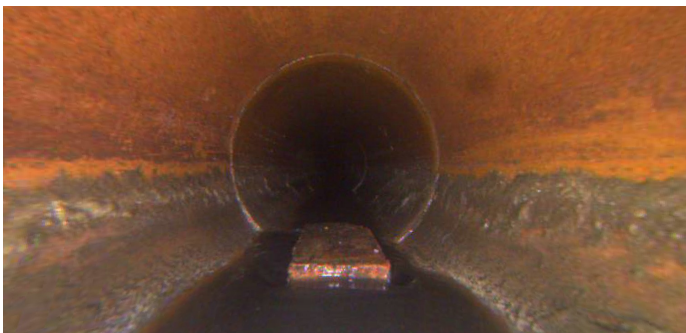
Code: **OBR**
Description: **Obstacle Rocks**

Distance (ft): **34.2**
Structural Grade: **0**
O&M Grade: **2**
Clock Start/From: **6**
Clock To:
1st Value:
2nd Value:
Value Percent: **5.000**
Continuous Index:
Within 8" of Joint: **NO**
Remarks:

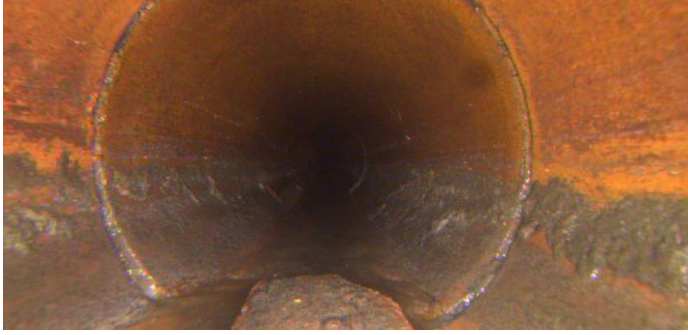
Code:	MSA
Description:	Abandoned Survey
Distance (ft):	35.4
Structural Grade:	0
O&M Grade:	0
Clock Start/From:	
Clock To:	
1st Value:	
2nd Value:	
Value Percent:	
Continuous Index:	
Within 8" of Joint:	NO
Remarks:	obr
