Profile/Photo Observation Report

Date:	04/13/2018	Weather:		Coding:	PACP 4.2
Pipe Length (ft):	5.8	Owner:	City of Hobart	Pre Clean:	No Pre-Cleaning
P.O.#:	2004	Surveyor:	SAN	PSR:	P-803-039-059
Customer:	Red Zone	Clean Date:		Shape:	C

Street:	Rand St	Flow Control:	Not Controlled
City:	Hobart In	Year Renewed:	
Location:	Light Highway	Tape/Media #:	Deliverable 1
Purpose:	Routine Assessment	Dia/Height:	15"
Use:	Sanitary	Material:	VCP
Drain Area:	Northeast	Lining:	
Category:	NA		
Comment:	410-1		
Location Details:	Flows through easement	Direction of Survey:	Upstream
US MH:	M-803-039	DS MH:	M-803-059
		Total Length Surveyed (ft):	3.8

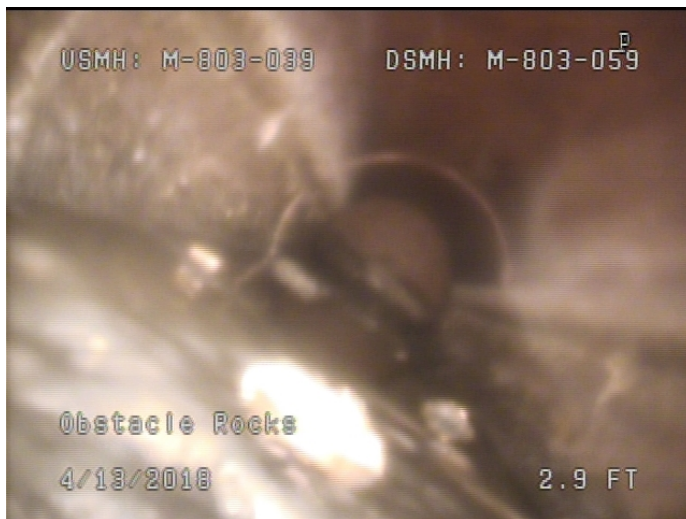
Code: **OBR**
Description: **Obstacle Rocks**

Distance (ft): **2.9**
Structural Grade: **0**
O&M Grade: **3**
Clock Start/From: **5**
Clock To: **7**
1st Value:
2nd Value:
Value Percent: **15.000**
Continuous Index:
Within 8" of Joint: **NO**
Remarks:

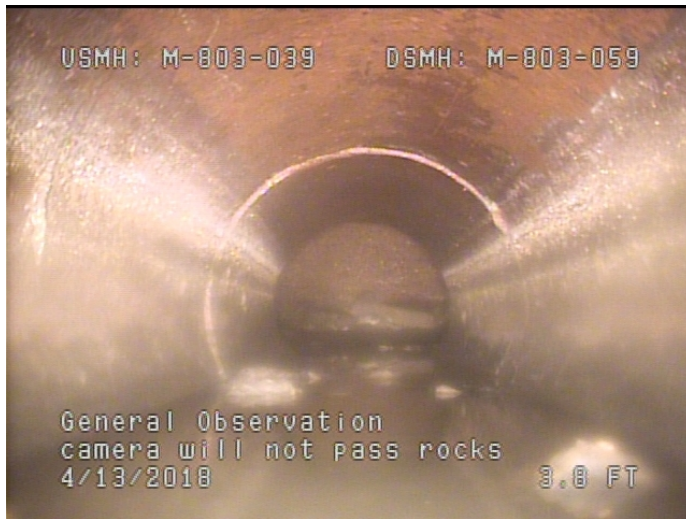
Code:	MGO
Description:	General Observation
Distance (ft):	3.8
Structural Grade:	0
O&M Grade:	0
Clock Start/From:	
Clock To:	
1st Value:	
2nd Value:	
Value Percent:	
Continuous Index:	
Within 8" of Joint:	NO
Remarks:	camera will not pass rocks

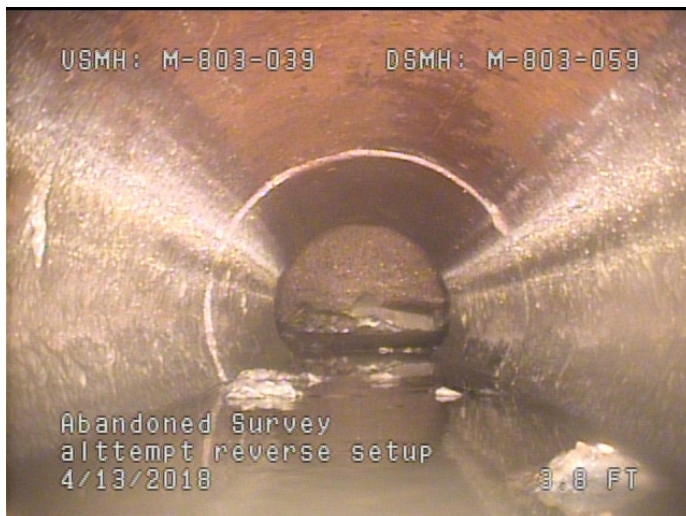
Code:	MSA
Description:	Abandoned Survey
Distance (ft):	3.8
Structural Grade:	0
O&M Grade:	0
Clock Start/From:	
Clock To:	
1st Value:	
2nd Value:	
Value Percent:	
Continuous Index:	
Within 8" of Joint:	NO
Remarks:	alttempt reverse setup
