Profile/Photo Observation Report

Date:	04/13/2018	Weather:		Coding:	PACP 4.2
Pipe Length (ft):	220.1	Owner:	City of Hobart	Pre Clean:	No Pre-Cleaning
P.O.#:	2004	Surveyor:	SAN	PSR:	P-803-040-041
Customer:	Red Zone	Clean Date:		Shape:	C

Street:	526 Indiana St	Flow Control:	Not Controlled
City:	Hobart In	Year Renewed:	
Location:	Easement/Right of Way	Tape/Media #:	Deliverable 1
Purpose:	Routine Assessment	Dia/Height:	15"
Use:	Sanitary	Material:	VCP
Drain Area:	Northeast	Lining:	
Category:	NA		
Comment:	411-2		
Location Details:	Flows through easement	Direction of Survey:	Upstream
US MH:	M-803-040	DS MH:	M-803-041
		Total Length Surveyed (ft):	220.1

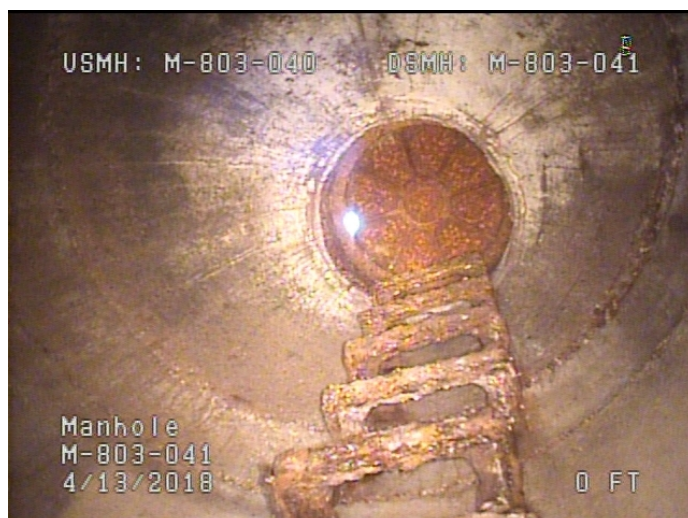
Code:	AMH
Description:	Manhole
Distance (ft):	.0
Structural Grade:	0
O&M Grade:	0
Clock Start/From:	
Clock To:	
1st Value:	
2nd Value:	
Value Percent:	
Continuous Index:	
Within 8" of Joint:	NO
Remarks:	M-803-041

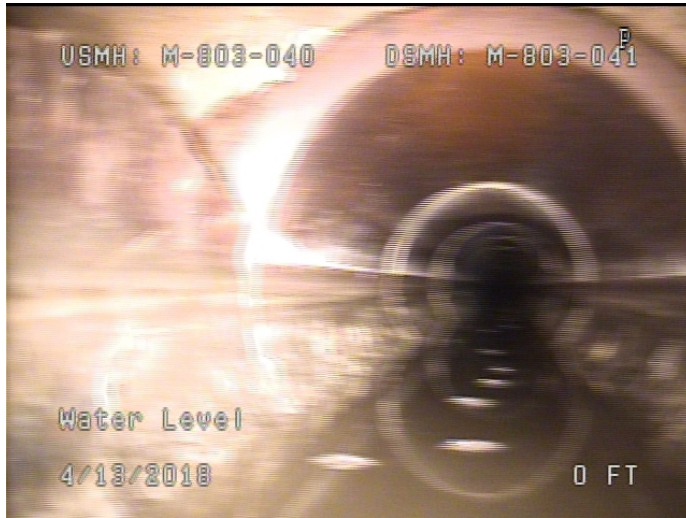
Code:	MWL
Description:	Water Level
Distance (ft):	.0
Structural Grade:	0
O&M Grade:	0
Clock Start/From:	
Clock To:	
1st Value:	
2nd Value:	
Value Percent:	10.000
Continuous Index:	
Within 8" of Joint:	NO
Remarks:

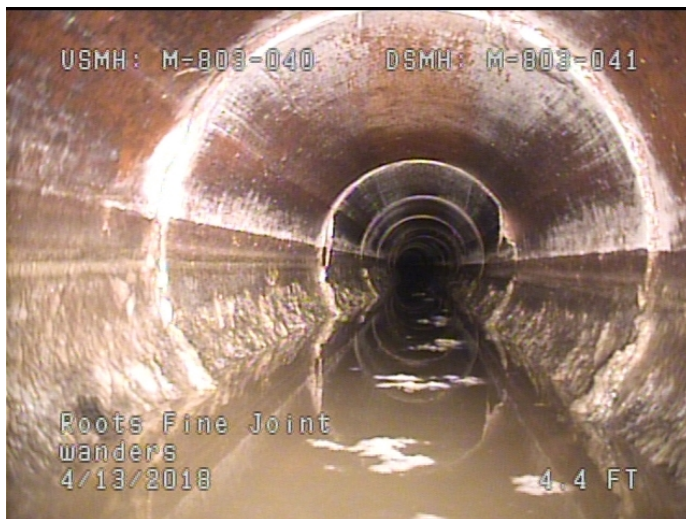
Code:	RFJ
Description:	Roots Fine Joint
Distance (ft):	4.4
Structural Grade:	0
O&M Grade:	1
Clock Start/From:	9
Clock To:	3
1st Value:	
2nd Value:	
Value Percent:	
Continuous Index:	S01
Within 8" of Joint:	YES
Remarks:	wanders

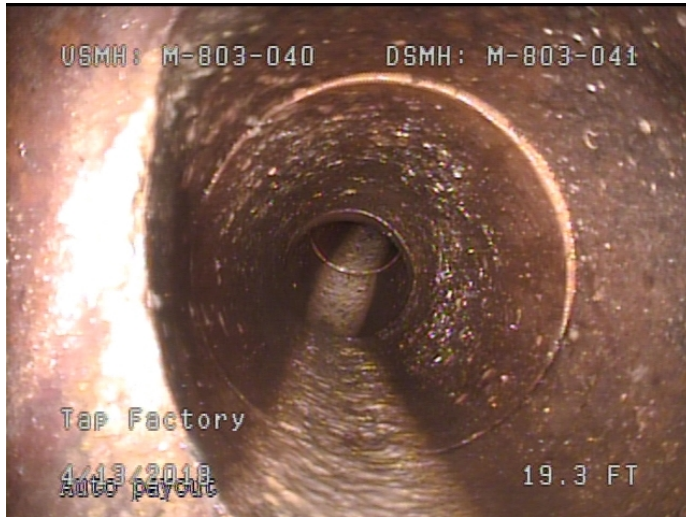
Code: **TF**
 Description: **Tap Factory**

Distance (ft): **19.3**
 Structural Grade: **0**
 O&M Grade: **0**
 Clock Start/From: **2**
 Clock To:
 1st Value: **6.000**
 2nd Value:
 Value Percent:
 Continuous Index:
 Within 8" of Joint: **NO**
 Remarks:

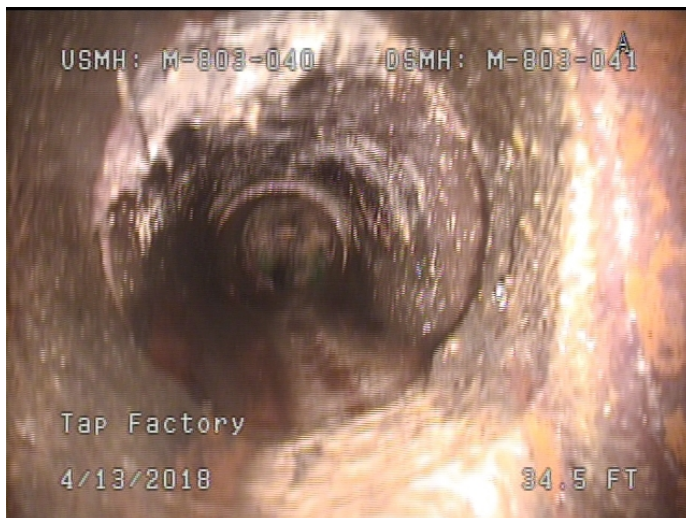
Code: **TF**
 Description: **Tap Factory**

Distance (ft): **34.5**
 Structural Grade: **0**
 O&M Grade: **0**
 Clock Start/From: **10**
 Clock To:
 1st Value: **6.000**
 2nd Value:
 Value Percent:
 Continuous Index:
 Within 8" of Joint: **NO**
 Remarks:

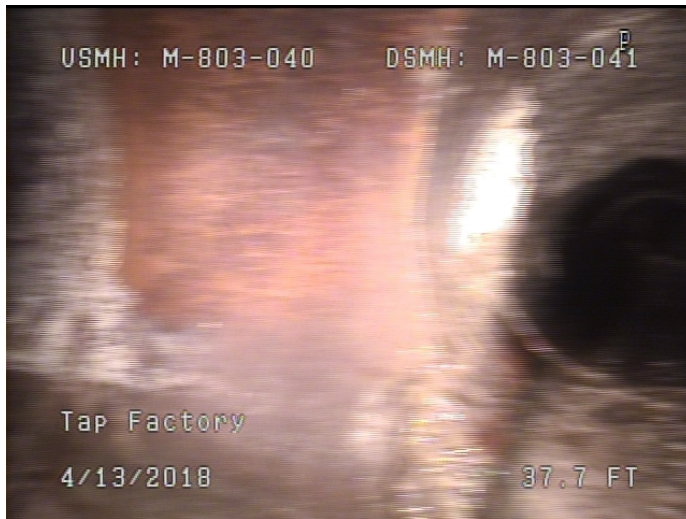
Code:	TF
Description:	Tap Factory
Distance (ft):	37.7
Structural Grade:	0
O&M Grade:	0
Clock Start/From:	2
Clock To:	
1st Value:	6.000
2nd Value:	
Value Percent:	
Continuous Index:	
Within 8" of Joint:	NO
Remarks:

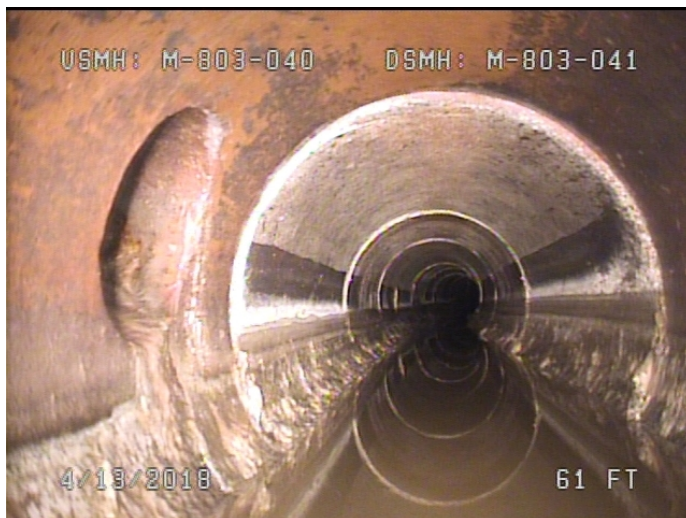
Code:	TF
Description:	Tap Factory
Distance (ft):	61.0
Structural Grade:	0
O&M Grade:	0
Clock Start/From:	9
Clock To:	
1st Value:	6.000
2nd Value:	
Value Percent:	
Continuous Index:	
Within 8" of Joint:	NO
Remarks:

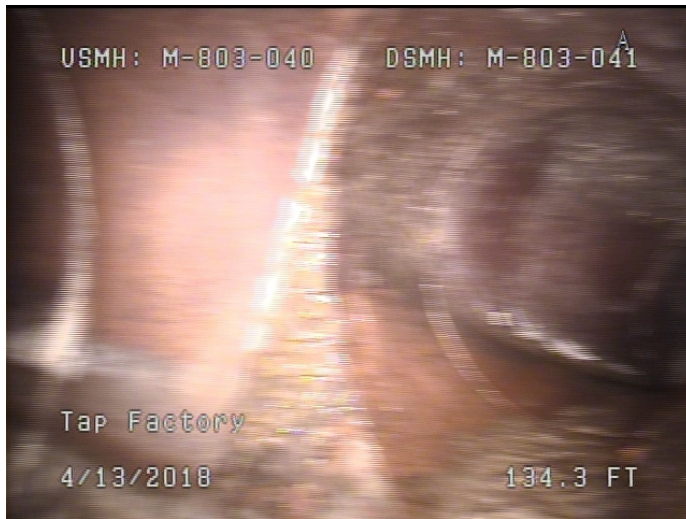
Code: **TF**
Description: **Tap Factory**

Distance (ft): **134.3**
Structural Grade: **0**
O&M Grade: **0**
Clock Start/From: **3**
Clock To:
1st Value: **6.000**
2nd Value:
Value Percent:
Continuous Index:
Within 8" of Joint: **NO**
Remarks:

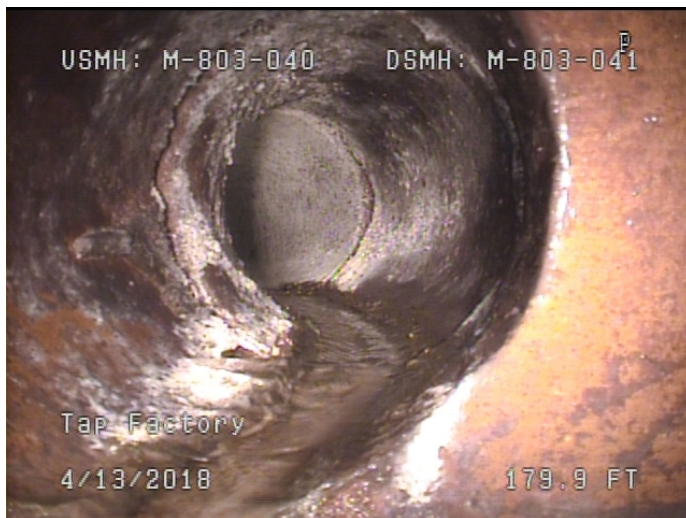
Code: **TF**
Description: **Tap Factory**

Distance (ft): **179.9**
Structural Grade: **0**
O&M Grade: **0**
Clock Start/From: **9**
Clock To:
1st Value: **6.000**
2nd Value:
Value Percent:
Continuous Index:
Within 8" of Joint: **NO**
Remarks:

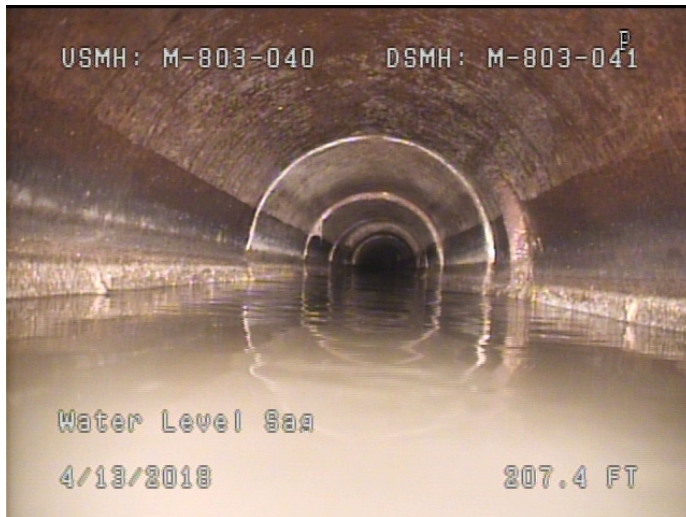
Code: **MWLS**
 Description: **Water Level Sag**

Distance (ft): **207.4**
 Structural Grade: **3**
 O&M Grade: **3**
 Clock Start/From:
 Clock To:
 1st Value:
 2nd Value:
 Value Percent: **35.000**
 Continuous Index: **S02**
 Within 8" of Joint: **NO**
 Remarks:

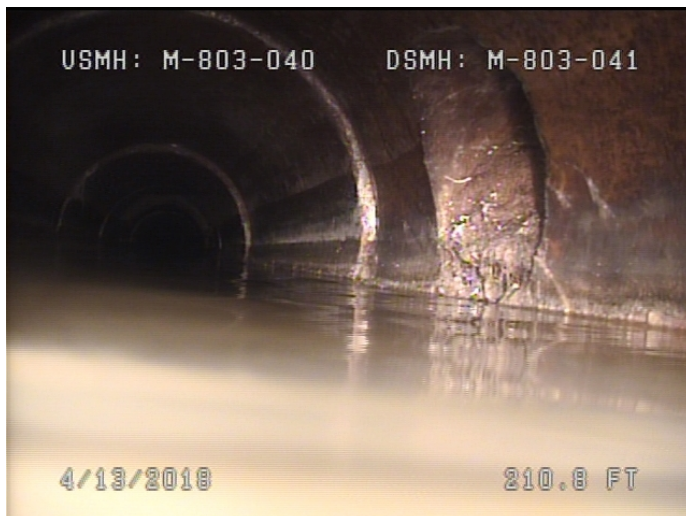
Code: **TFD**
 Description: **Tap Factory Defective**

Distance (ft): **210.7**
 Structural Grade: **0**
 O&M Grade: **2**
 Clock Start/From: **3**
 Clock To:
 1st Value: **6.000**
 2nd Value:
 Value Percent:
 Continuous Index:
 Within 8" of Joint: **NO**
 Remarks: **roots in tap**

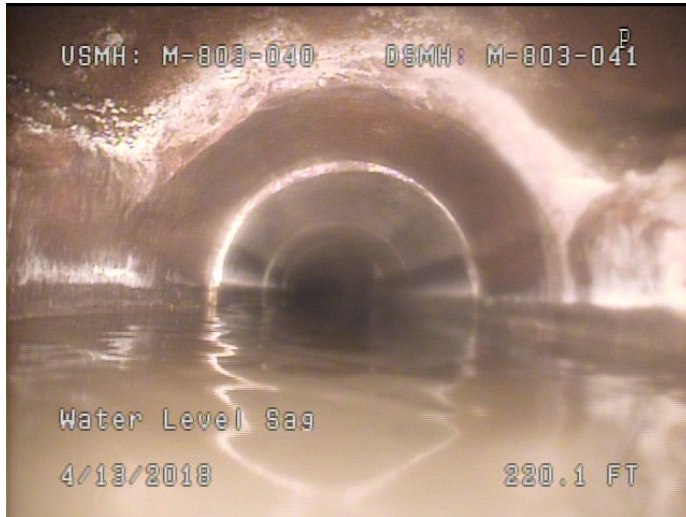
Code: **MWLS**
Description: **Water Level Sag**

Distance (ft): **220.1**
Structural Grade: **3**
O&M Grade: **3**
Clock Start/From:
Clock To:
1st Value:
2nd Value:
Value Percent: **35.000**
Continuous Index: **F02**
Within 8" of Joint: **NO**
Remarks:

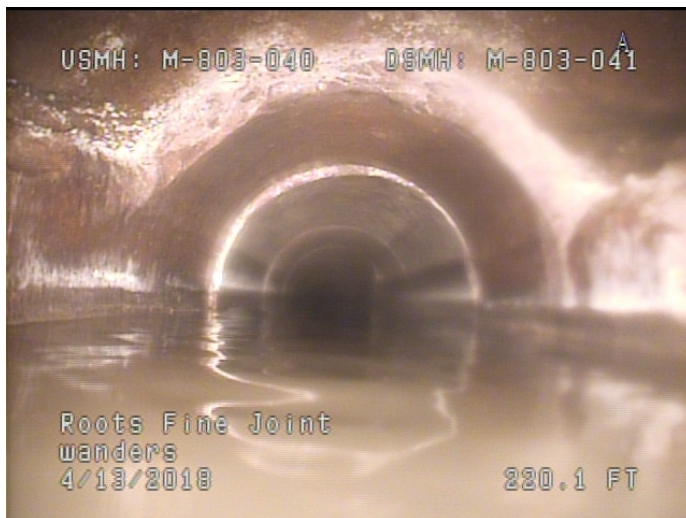
Code: **RFJ**
Description: **Roots Fine Joint**

Distance (ft): **220.1**
Structural Grade: **0**
O&M Grade: **1**
Clock Start/From: **9**
Clock To: **3**
1st Value:
2nd Value:
Value Percent:
Continuous Index: **F01**
Within 8" of Joint: **YES**
Remarks: **wanders**

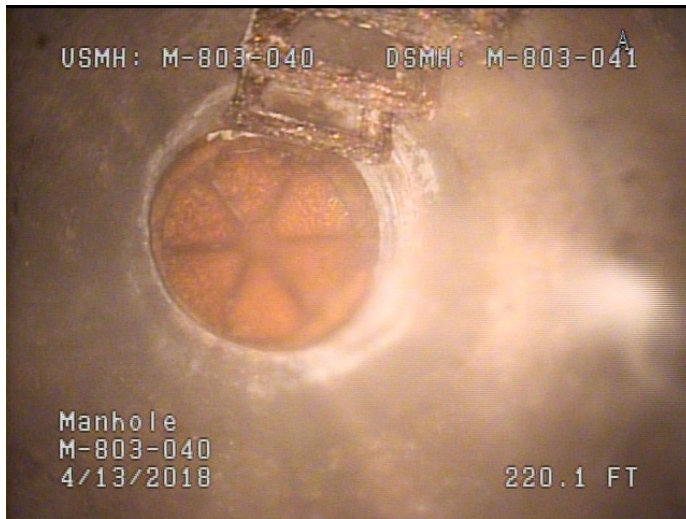
Code:	AMH
Description:	Manhole
Distance (ft):	220.1
Structural Grade:	0
O&M Grade:	0
Clock Start/From:	
Clock To:	
1st Value:	
2nd Value:	
Value Percent:	
Continuous Index:	
Within 8" of Joint:	NO
Remarks:	M-803-040
