Profile/Photo Observation Report

Date:	04/13/2018	Weather:		Coding:	PACP 4.2
Pipe Length (ft):	220.0	Owner:	City of Hobart	Pre Clean:	No Pre-Cleaning
P.O.#:	2004	Surveyor:	SAN	PSR:	P-803-041-042
Customer:	Red Zone	Clean Date:		Shape:	C

Street:	510 Indiana St	Flow Control:	Not Controlled
City:	Hobart In	Year Renewed:	
Location:	Easement/Right of Way	Tape/Media #:	Deliverable 1
Purpose:	Routine Assessment	Dia/Height:	15"
Use:	Sanitary	Material:	VCP
Drain Area:	Northeast	Lining:	
Category:	NA		
Comment:	411-1		
Location Details:	Flows through easement	Direction of Survey:	Upstream
US MH:	M-803-041	DS MH:	M-803-042
		Total Length Surveyed (ft):	220.0

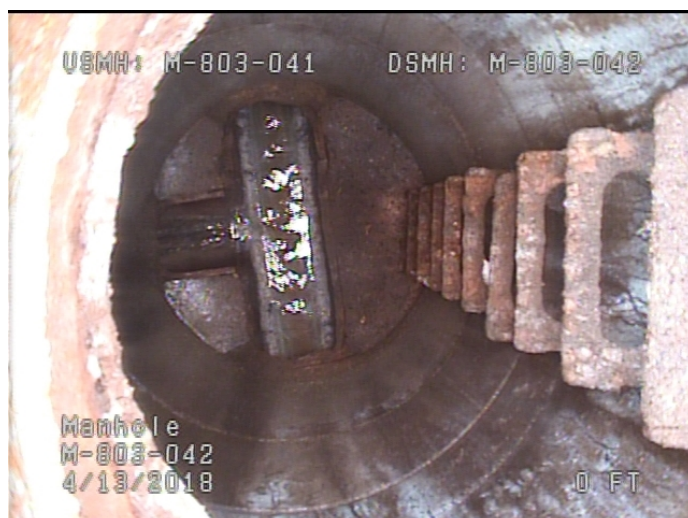
Code:	AMH
Description:	Manhole
Distance (ft):	.0
Structural Grade:	0
O&M Grade:	0
Clock Start/From:	
Clock To:	
1st Value:	
2nd Value:	
Value Percent:	
Continuous Index:	
Within 8" of Joint:	NO
Remarks:	M-803-042

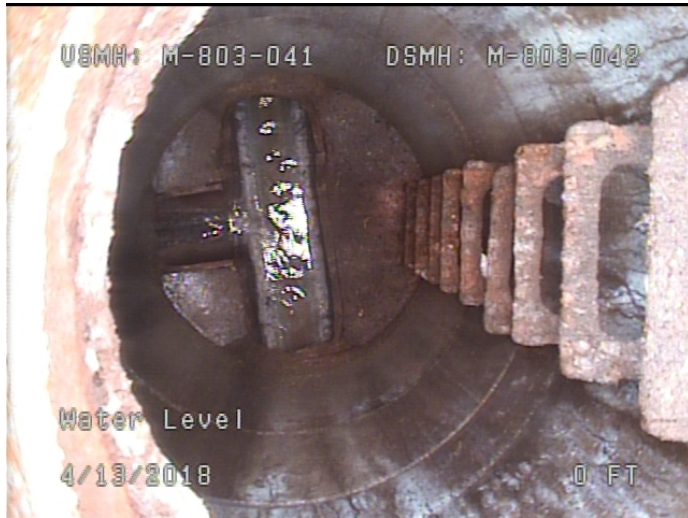
Code: **MWL**
 Description: **Water Level**

Distance (ft): **.0**
 Structural Grade: **0**
 O&M Grade: **0**
 Clock Start/From:
 Clock To:
 1st Value:
 2nd Value:
 Value Percent: **5.000**
 Continuous Index:
 Within 8" of Joint: **NO**
 Remarks:

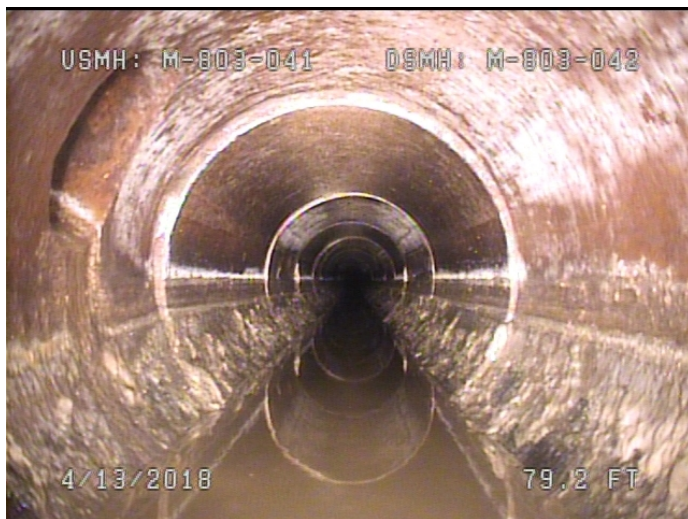
Code: **TF**
 Description: **Tap Factory**

Distance (ft): **79.2**
 Structural Grade: **0**
 O&M Grade: **0**
 Clock Start/From: **10**
 Clock To:
 1st Value: **6.000**
 2nd Value:
 Value Percent:
 Continuous Index:
 Within 8" of Joint: **NO**
 Remarks:

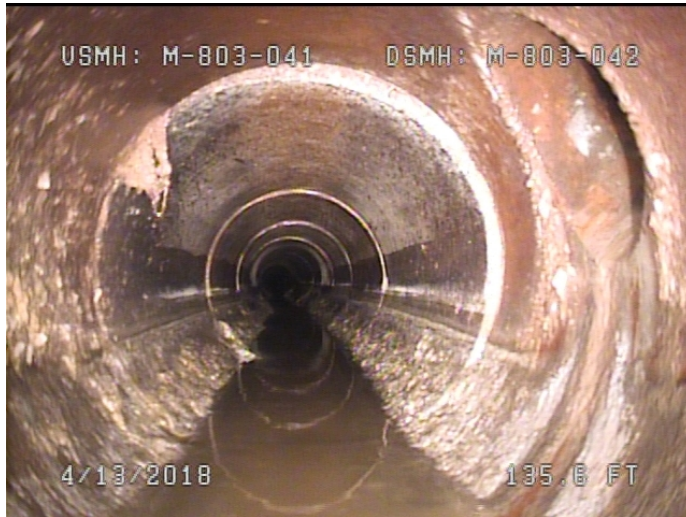
Code: **TF**
 Description: **Tap Factory**

Distance (ft): **135.7**
 Structural Grade: **0**
 O&M Grade: **0**
 Clock Start/From: **2**
 Clock To:
 1st Value: **6.000**
 2nd Value:
 Value Percent:
 Continuous Index:
 Within 8" of Joint: **NO**
 Remarks:

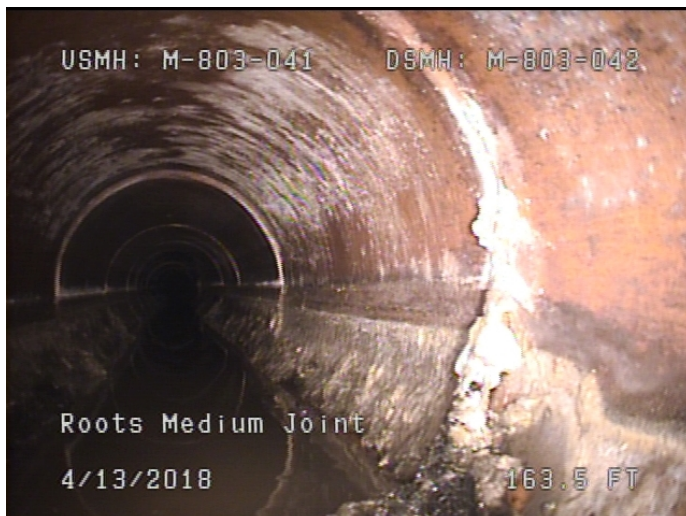
Code: **RMJ**
 Description: **Roots Medium Joint**

Distance (ft): **163.5**
 Structural Grade: **0**
 O&M Grade: **3**
 Clock Start/From: **4**
 Clock To: **8**
 1st Value:
 2nd Value:
 Value Percent: **10.000**
 Continuous Index: **S01**
 Within 8" of Joint: **YES**
 Remarks:

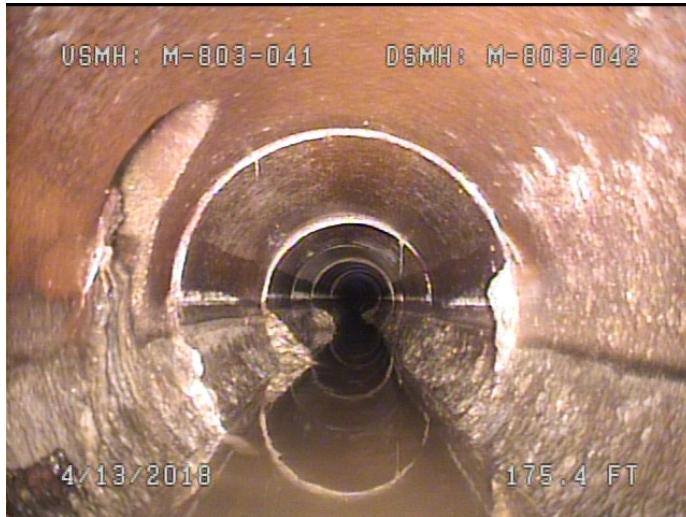
Code: **TFD**
 Description: **Tap Factory Defective**

Distance (ft): **175.4**
 Structural Grade: **0**
 O&M Grade: **2**
 Clock Start/From: **11**
 Clock To:
 1st Value: **4.000**
 2nd Value:
 Value Percent:
 Continuous Index:
 Within 8" of Joint: **NO**
 Remarks: **Defective**

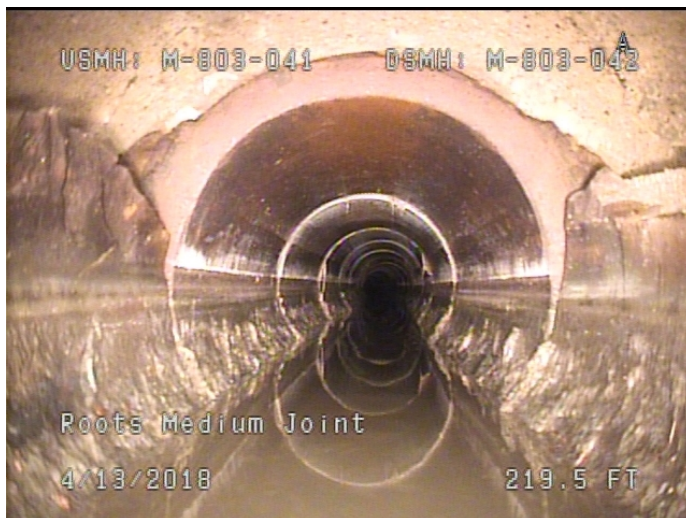
Code: **RMJ**
 Description: **Roots Medium Joint**

Distance (ft): **219.5**
 Structural Grade: **0**
 O&M Grade: **3**
 Clock Start/From: **4**
 Clock To: **8**
 1st Value:
 2nd Value:
 Value Percent: **10.000**
 Continuous Index: **F01**
 Within 8" of Joint: **YES**
 Remarks:

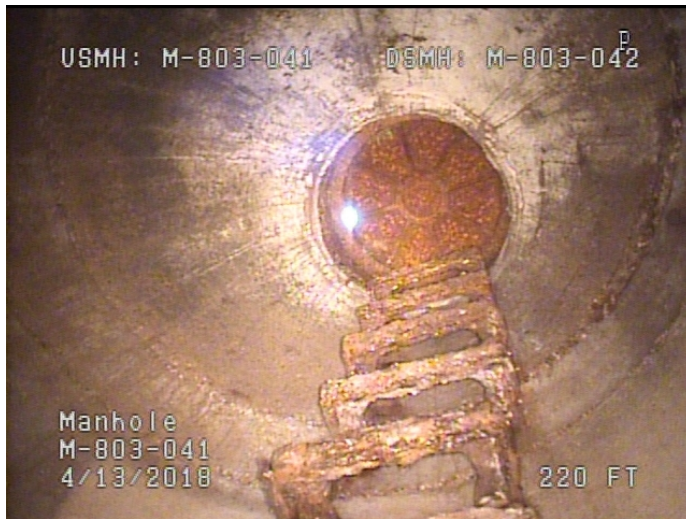
Code:	AMH
Description:	Manhole
Distance (ft):	220.0
Structural Grade:	0
O&M Grade:	0
Clock Start/From:	
Clock To:	
1st Value:	
2nd Value:	
Value Percent:	
Continuous Index:	
Within 8" of Joint:	NO
Remarks:	M-803-041
