Profile/Photo Observation Report

Date:	04/18/2018	Weather:		Coding:	PACP 4.2
Pipe Length (ft):	190.9	Owner:	City of Hobart	Pre Clean:	No Pre-Cleaning
P.O.#:	2004	Surveyor:	SAN	PSR:	P-803-042-043
Customer:	Red Zone	Clean Date:		Shape:	C

Street:	E 40th Ave	Flow Control:	Not Controlled
City:	Hobart In	Year Renewed:	
Location:	Light Highway	Tape/Media #:	Deliverable 1
Purpose:	Routine Assessment	Dia/Height:	15"
Use:	Sanitary	Material:	VCP
Drain Area:	Northeast	Lining:	
Category:	NA		
Comment:	413-1

Location Details:	Flows through easement from 40th	Direction of Survey:	Downstream
US MH:	M-803-042	DS MH:	M-803-043
		Total Length Surveyed (ft):	190.9

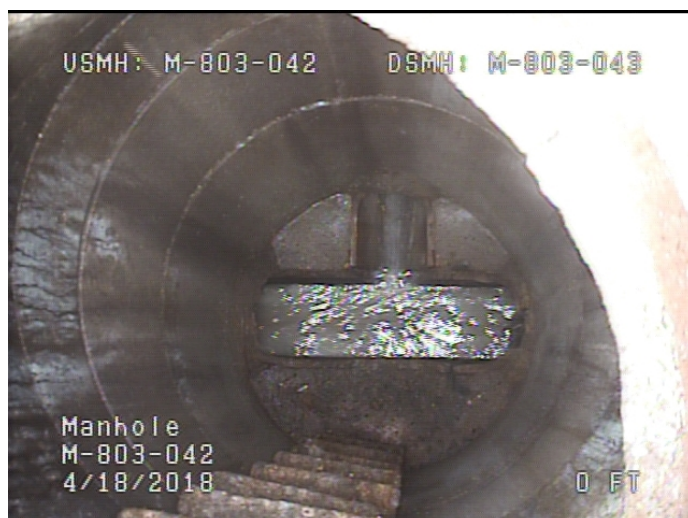
Code:	AMH
Description:	Manhole
Distance (ft):	.0
Structural Grade:	0
O&M Grade:	0
Clock Start/From:	
Clock To:	
1st Value:	
2nd Value:	
Value Percent:	
Continuous Index:	
Within 8" of Joint:	NO
Remarks:	M-803-042

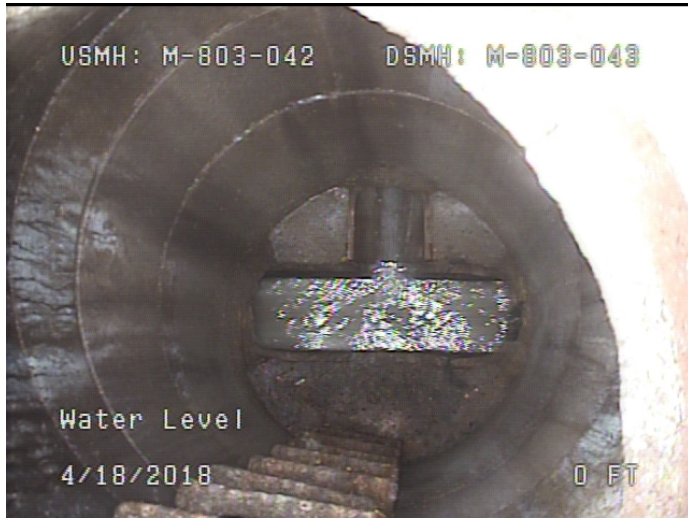
Code:	MWL
Description:	Water Level
Distance (ft):	.0
Structural Grade:	0
O&M Grade:	0
Clock Start/From:	
Clock To:	
1st Value:	
2nd Value:	
Value Percent:	25.000
Continuous Index:	
Within 8" of Joint:	NO
Remarks:

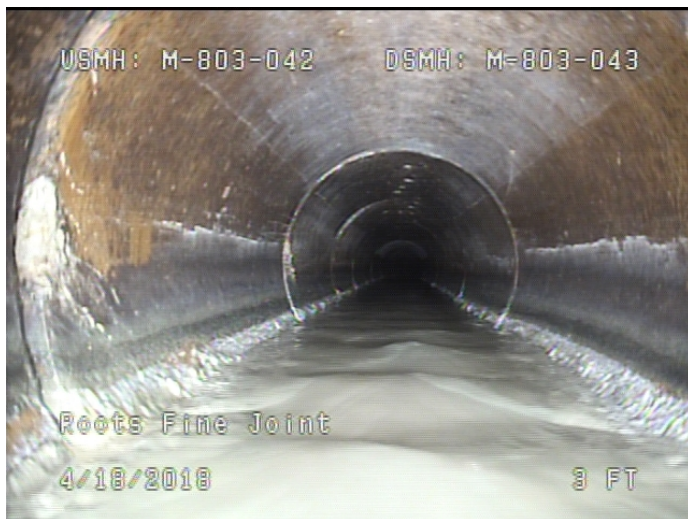
Code:	RFJ
Description:	Roots Fine Joint
Distance (ft):	3.0
Structural Grade:	0
O&M Grade:	1
Clock Start/From:	8
Clock To:	9
1st Value:	
2nd Value:	
Value Percent:	
Continuous Index:	S01
Within 8" of Joint:	YES
Remarks:

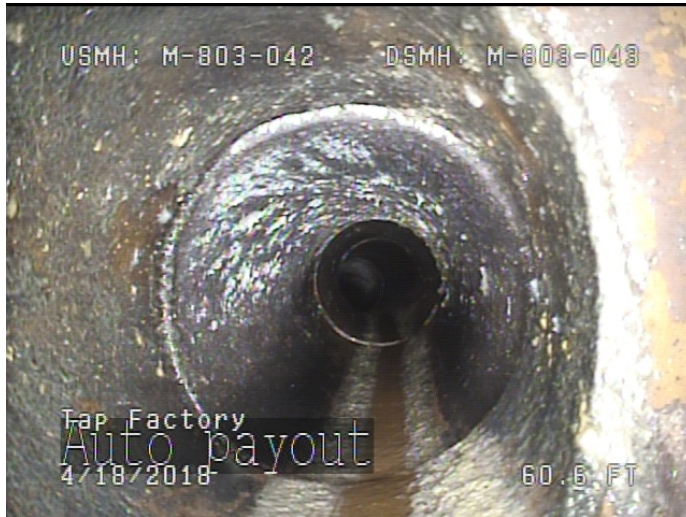
Code: **TF**
 Description: **Tap Factory**

Distance (ft): **60.6**
 Structural Grade: **0**
 O&M Grade: **0**
 Clock Start/From: **2**
 Clock To:
 1st Value: **6.000**
 2nd Value:
 Value Percent:
 Continuous Index:
 Within 8" of Joint: **NO**
 Remarks:

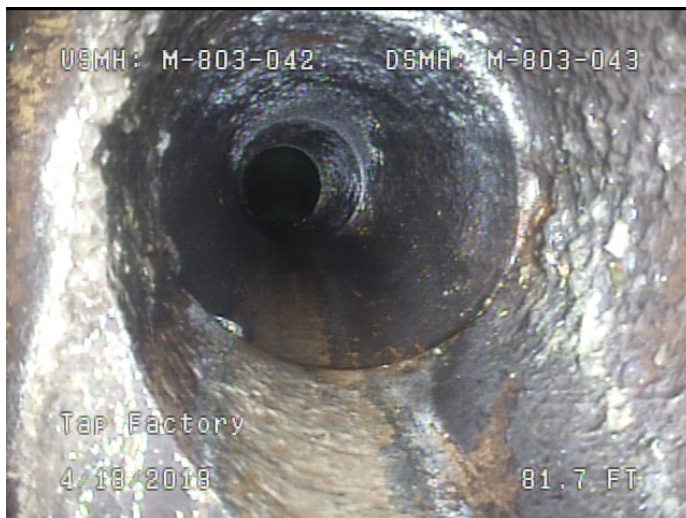
Code: **TF**
 Description: **Tap Factory**

Distance (ft): **81.7**
 Structural Grade: **0**
 O&M Grade: **0**
 Clock Start/From: **10**
 Clock To:
 1st Value: **6.000**
 2nd Value:
 Value Percent:
 Continuous Index:
 Within 8" of Joint: **NO**
 Remarks:

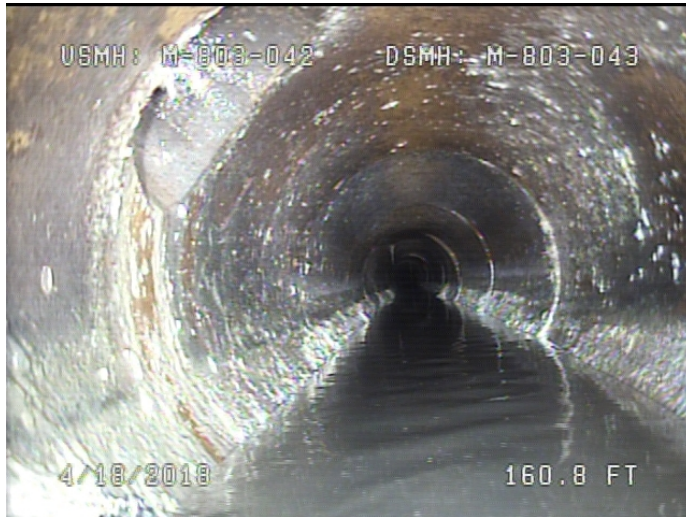
Code:	TF
Description:	Tap Factory
Distance (ft):	160.6
Structural Grade:	0
O&M Grade:	0
Clock Start/From:	10
Clock To:	
1st Value:	6.000
2nd Value:	
Value Percent:	
Continuous Index:	
Within 8" of Joint:	NO
Remarks:

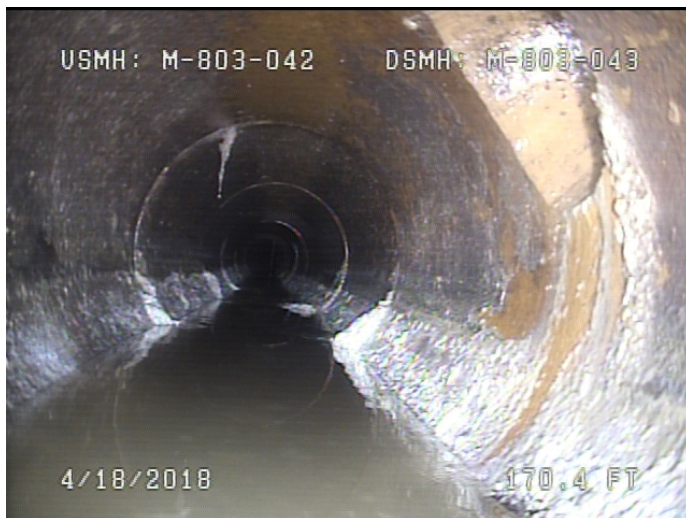
Code:	TFD
Description:	Tap Factory Defective
Distance (ft):	170.4
Structural Grade:	0
O&M Grade:	2
Clock Start/From:	10
Clock To:	
1st Value:	6.000
2nd Value:	
Value Percent:	
Continuous Index:	
Within 8" of Joint:	NO
Remarks:	roots in tap

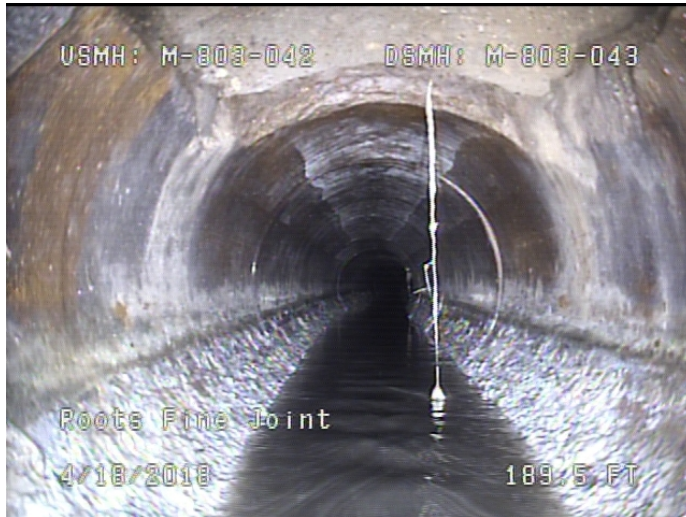
Code:	RFJ
Description:	Roots Fine Joint
Distance (ft):	189.5
Structural Grade:	0
O&M Grade:	1
Clock Start/From:	8
Clock To:	9
1st Value:	
2nd Value:	
Value Percent:	
Continuous Index:	F01
Within 8" of Joint:	YES
Remarks:

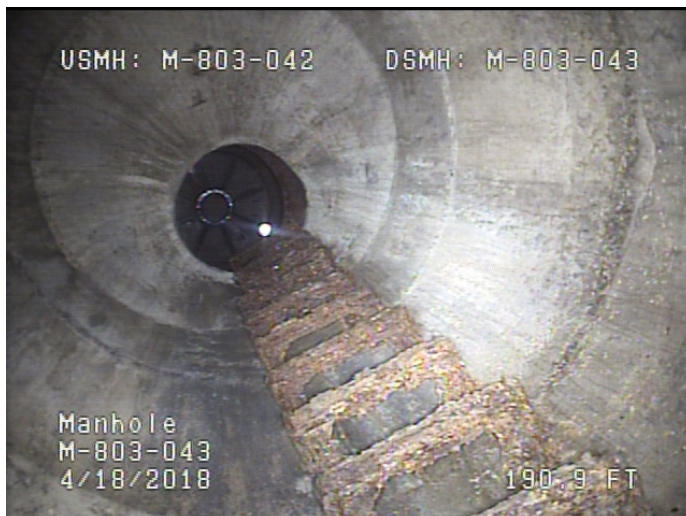
Code:	AMH
Description:	Manhole
Distance (ft):	190.9
Structural Grade:	0
O&M Grade:	0
Clock Start/From:	
Clock To:	
1st Value:	
2nd Value:	
Value Percent:	
Continuous Index:	
Within 8" of Joint:	NO
Remarks:	M-803-043
