## Profile/Photo Observation Report

Date:	<b>10/02/2018</b>	Weather:		Coding:	<b>PACP 6.0</b>
Pipe Length (ft):	<b>175.2</b>	Owner:	<b>NA</b>	Pre Clean:	<b>Not Known</b>
P.O.#:		Surveyor:	<b>Justin Gonzales</b>	PSR:	<b>P-803-051-042</b>
Customer:		Clean Date:	<b>01/01/1900</b>	Shape:	<b>C</b>

Street:	<b>E 40TH AVE &amp; N KELLY ST</b>	Flow Control:	<b>Not Controlled</b>
City:	<b>Hobart, IN</b>	Year Renewed:	
Location:	<b>Light Highway</b>	Tape/Media #:	
Purpose:	<b>Routine Assessment</b>	Dia/Height:	<b>12"</b>
Use:	<b>Sanitary</b>	Material:	<b>VCP</b>
Drain Area:	<b>NA</b>	Lining:	
Category:	<b>NA</b>		
Comment:

Location Details:		Direction of Survey:	<b>Downstream</b>
US MH:	<b>M-803-042</b>	DS MH:	<b>M-803-051</b>
		Total Length Surveyed (ft):	<b>166.2</b>

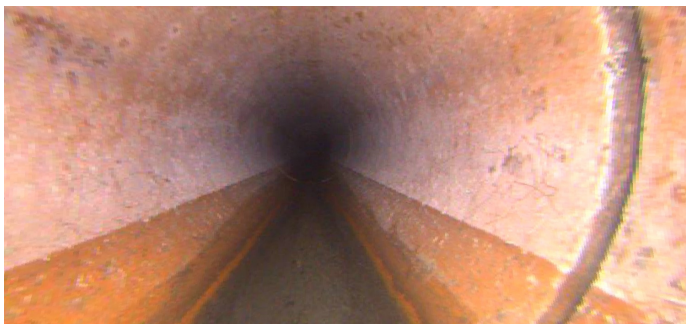
Code: **AMH**  
Description: **Manhole**

Distance (ft): **.0**  
Structural Grade: **0**  
O&M Grade: **0**  
Clock Start/From:  
Clock To:  
1st Value:  
2nd Value:  
Value Percent:  
Continuous Index:  
Within 8" of Joint: **NO**  
Remarks: **M-803-042**

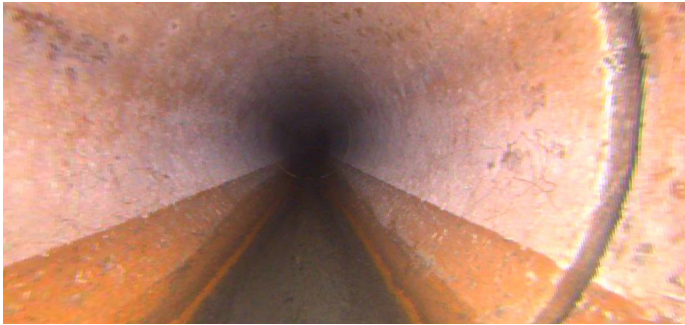
Code:	<b>MWL</b>
Description:	<b>Water Level</b>

Distance (ft):	<b>.0</b>
Structural Grade:	<b>0</b>
O&M Grade:	<b>0</b>
Clock Start/From:	
Clock To:	
1st Value:	
2nd Value:	
Value Percent:	<b>5.000</b>
Continuous Index:	
Within 8" of Joint:	<b>NO</b>
Remarks:

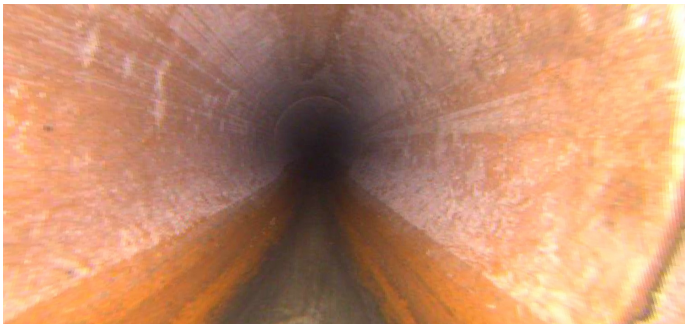
Code:	<b>DAGS</b>
Description:	<b>Deposits Attached Grease</b>

Distance (ft):	<b>9.7</b>
Structural Grade:	<b>0</b>
O&M Grade:	<b>2</b>
Clock Start/From:	<b>7</b>
Clock To:	<b>5</b>
1st Value:	
2nd Value:	
Value Percent:	<b>5.000</b>
Continuous Index:	<b>S01</b>
Within 8" of Joint:	<b>YES</b>
Remarks:	<b>WANDER</b>

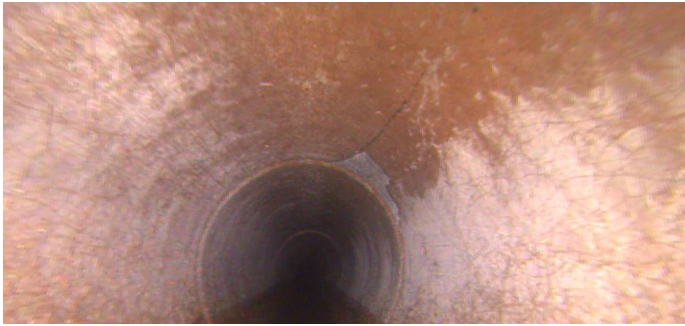
Code: **FL**  
Description: **Fracture Longitudinal**

Distance (ft): **80.9**  
Structural Grade: **3**  
O&M Grade: **0**  
Clock Start/From: **1**  
Clock To:  
1st Value:  
2nd Value:  
Value Percent:  
Continuous Index:  
Within 8" of Joint:  
Remarks:

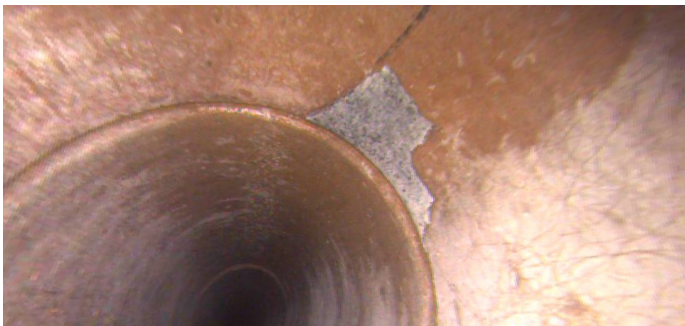
Code: **FS**  
Description: **Fracture Spiral**

Distance (ft): **81.6**  
Structural Grade: **3**  
O&M Grade: **0**  
Clock Start/From: **1**  
Clock To: **3**  
1st Value:  
2nd Value:  
Value Percent:  
Continuous Index:  
Within 8" of Joint: **YES**  
Remarks:

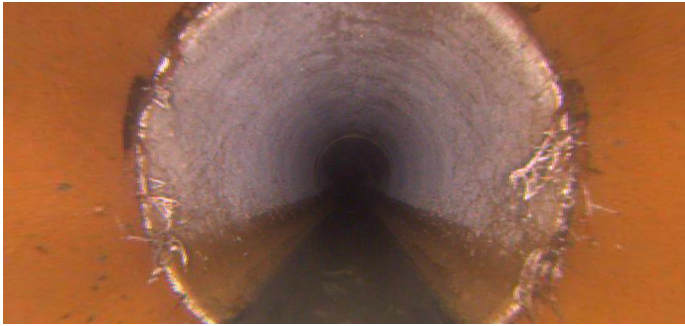
Code: **RFJ**  
Description: **Roots Fine Joint**

Distance (ft): **145.4**  
Structural Grade: **0**  
O&M Grade: **1**  
Clock Start/From: **7**  
Clock To: **5**  
1st Value:  
2nd Value:  
Value Percent:  
Continuous Index:  
Within 8" of Joint: **YES**  
Remarks:

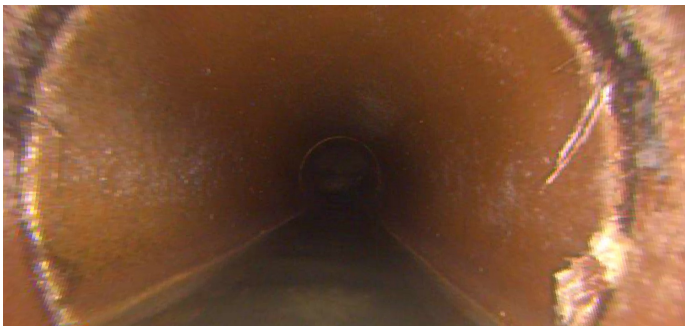
Code: **RFJ**  
Description: **Roots Fine Joint**

Distance (ft): **160.1**  
Structural Grade: **0**  
O&M Grade: **1**  
Clock Start/From: **7**  
Clock To: **5**  
1st Value:  
2nd Value:  
Value Percent:  
Continuous Index:  
Within 8" of Joint: **YES**  
Remarks:

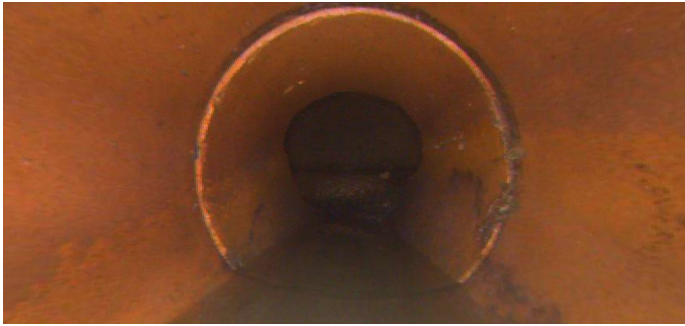
Code: **RFJ**  
Description: **Roots Fine Joint**

Distance (ft): **162.6**  
Structural Grade: **0**  
O&M Grade: **1**  
Clock Start/From: **8**  
Clock To: **4**  
1st Value:  
2nd Value:  
Value Percent:  
Continuous Index:  
Within 8" of Joint: **YES**  
Remarks:

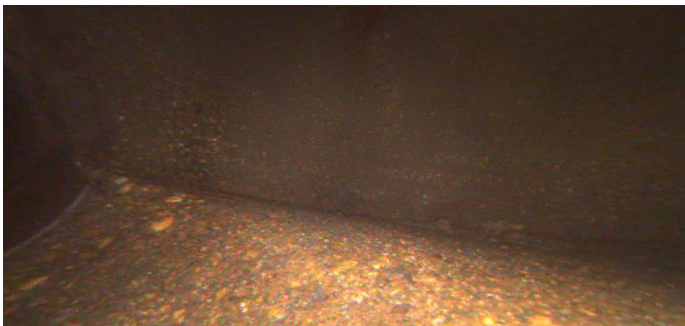
Code: **AMH**  
Description: **Manhole**

Distance (ft): **166.2**  
Structural Grade: **0**  
O&M Grade: **0**  
Clock Start/From:  
Clock To:  
1st Value:  
2nd Value:  
Value Percent:  
Continuous Index:  
Within 8" of Joint: **NO**  
Remarks: **M-803-051**

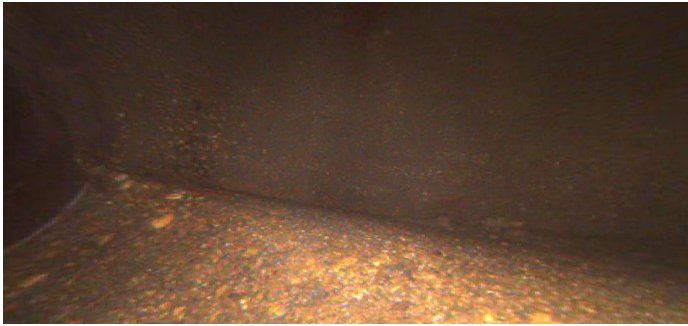
Code:	<b>DAGS</b>
Description:	<b>Deposits Attached Grease</b>
Distance (ft):	<b>166.2</b>
Structural Grade:	<b>0</b>
O&M Grade:	<b>2</b>
Clock Start/From:	<b>7</b>
Clock To:	<b>5</b>
1st Value:	
2nd Value:	
Value Percent:	<b>5.000</b>
Continuous Index:	<b>F01</b>
Within 8" of Joint:	<b>YES</b>
Remarks:	<b>WANDER</b>
