Profile/Photo Observation Report

Date:	04/18/2018	Weather:		Coding:	PACP 4.2
Pipe Length (ft):	182.1	Owner:	City of Hobart	Pre Clean:	No Pre-Cleaning
P.O.#:	2004	Surveyor:	SAN	PSR:	P-803-045-046
Customer:	Red Zone	Clean Date:		Shape:	C

Street:	415 Kelly st	Flow Control:	Not Controlled
City:	Hobart In	Year Renewed:	
Location:	Light Highway	Tape/Media #:	Deliverable 1
Purpose:	Routine Assessment	Dia/Height:	15"
Use:	Sanitary	Material:	VCP
Drain Area:	Northeast	Lining:	
Category:	NA		
Comment:	413-4		
Location Details:	Edge of street	Direction of Survey:	Downstream
US MH:	M-803-045	DS MH:	M-803-046
		Total Length Surveyed (ft):	182.1

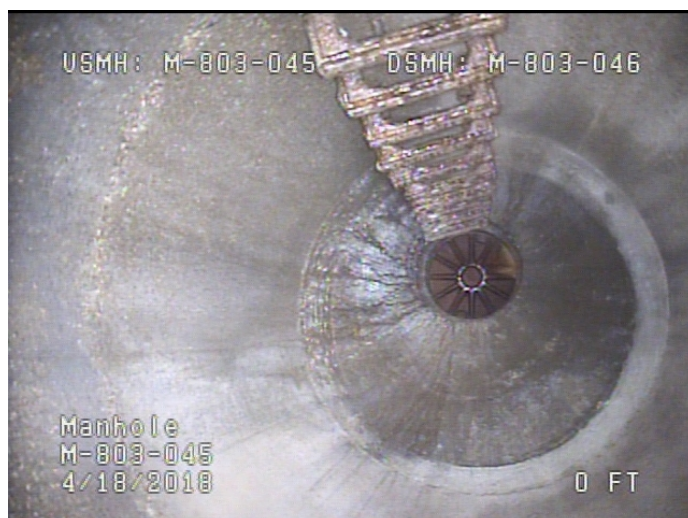
Code: **AMH**
Description: **Manhole**

Distance (ft): **.0**
Structural Grade: **0**
O&M Grade: **0**
Clock Start/From:
Clock To:
1st Value:
2nd Value:
Value Percent:
Continuous Index:
Within 8" of Joint: **NO**
Remarks: **M-803-045**

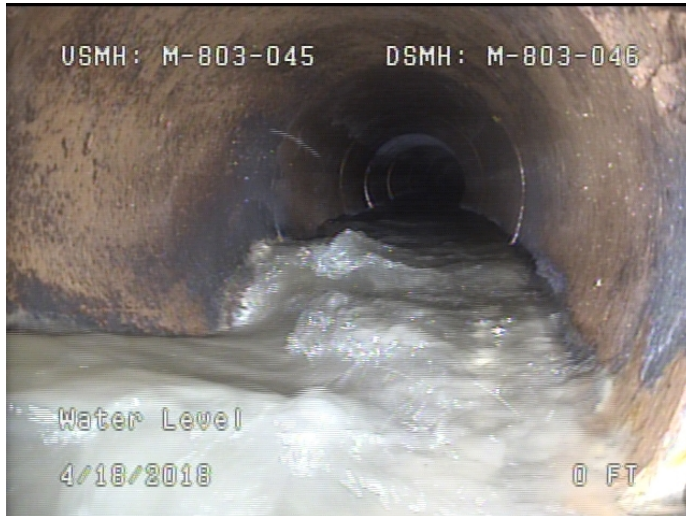
Code:	MWL
Description:	Water Level
Distance (ft):	.0
Structural Grade:	0
O&M Grade:	0
Clock Start/From:	
Clock To:	
1st Value:	
2nd Value:	
Value Percent:	15.000
Continuous Index:	
Within 8" of Joint:	NO
Remarks:

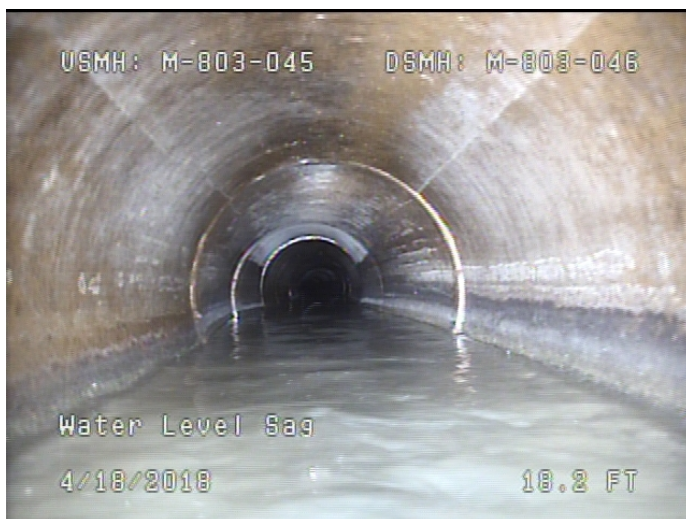
Code:	MWLS
Description:	Water Level Sag
Distance (ft):	18.1
Structural Grade:	2
O&M Grade:	3
Clock Start/From:	
Clock To:	
1st Value:	
2nd Value:	
Value Percent:	30.000
Continuous Index:	S01
Within 8" of Joint:	NO
Remarks:

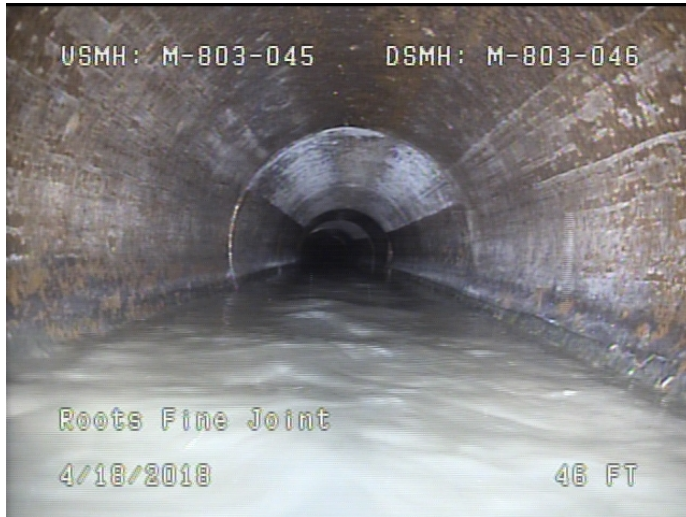
Code:	RFJ
Description:	Roots Fine Joint
Distance (ft):	46.0
Structural Grade:	0
O&M Grade:	1
Clock Start/From:	4
Clock To:	
1st Value:	
2nd Value:	
Value Percent:	
Continuous Index:	
Within 8" of Joint:	YES
Remarks:

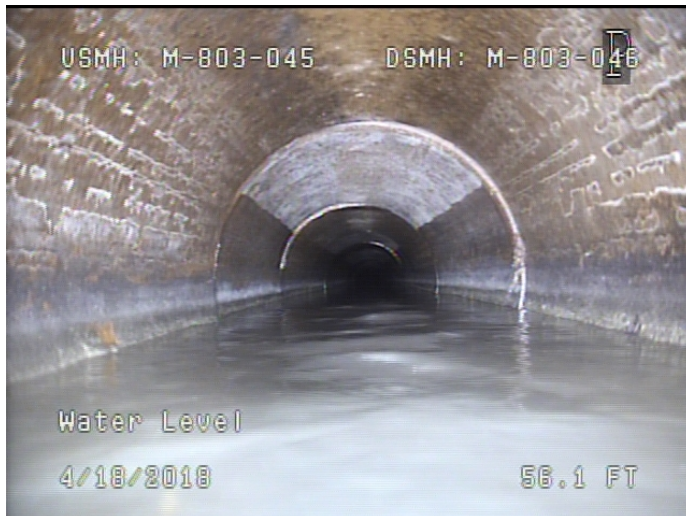
Code:	MWL
Description:	Water Level
Distance (ft):	56.1
Structural Grade:	0
O&M Grade:	0
Clock Start/From:	
Clock To:	
1st Value:	
2nd Value:	
Value Percent:	35.000
Continuous Index:	
Within 8" of Joint:	NO
Remarks:

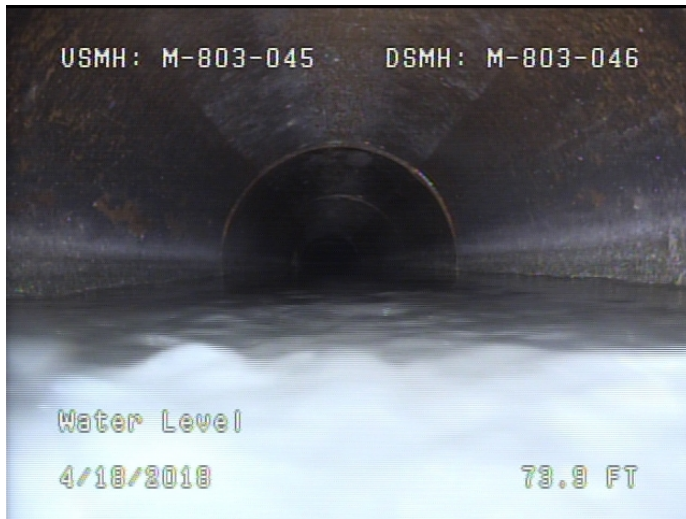
Code: **MWL**
Description: **Water Level**

Distance (ft): **73.9**
Structural Grade: **0**
O&M Grade: **0**
Clock Start/From:
Clock To:
1st Value:
2nd Value:
Value Percent: **45.000**
Continuous Index:
Within 8" of Joint: **NO**
Remarks:

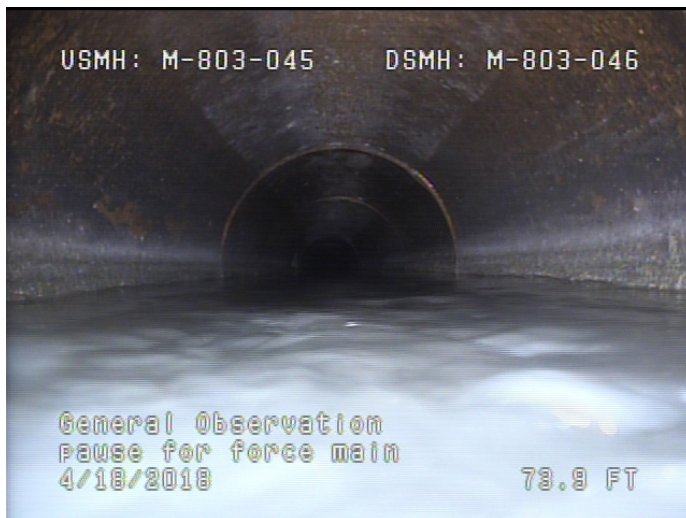
Code: **MGO**
Description: **General Observation**

Distance (ft): **73.9**
Structural Grade: **0**
O&M Grade: **0**
Clock Start/From:
Clock To:
1st Value:
2nd Value:
Value Percent:
Continuous Index:
Within 8" of Joint: **NO**
Remarks: **pause for force main**

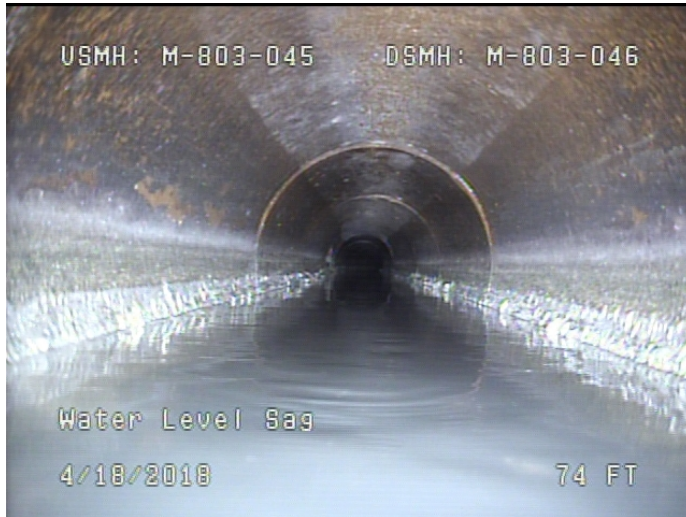
Code:	MWLS
Description:	Water Level Sag
Distance (ft):	74.0
Structural Grade:	2
O&M Grade:	3
Clock Start/From:	
Clock To:	
1st Value:	
2nd Value:	
Value Percent:	30.000
Continuous Index:	F01
Within 8" of Joint:	NO
Remarks:

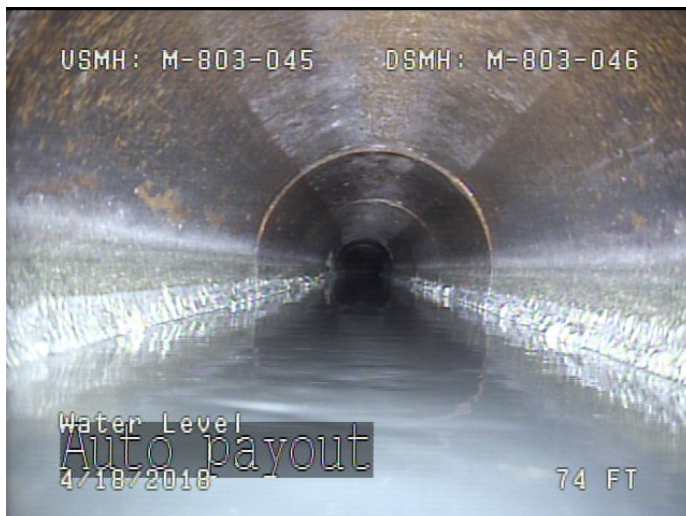
Code:	MWL
Description:	Water Level
Distance (ft):	74.0
Structural Grade:	0
O&M Grade:	0
Clock Start/From:	
Clock To:	
1st Value:	
2nd Value:	
Value Percent:	25.000
Continuous Index:	
Within 8" of Joint:	NO
Remarks:

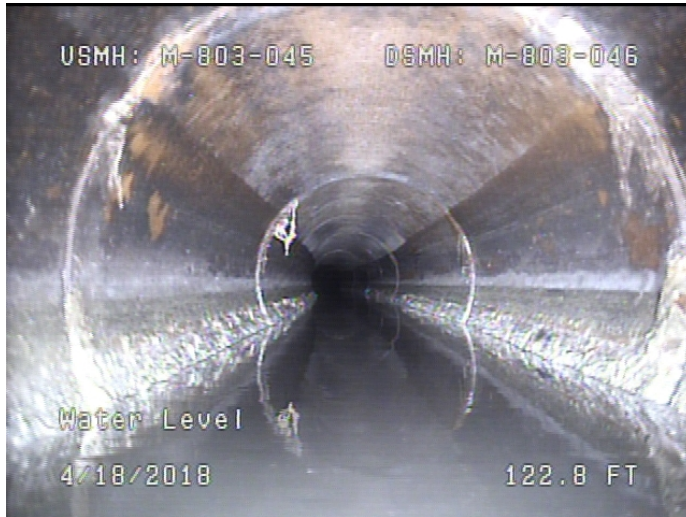
Code:	MWL
Description:	Water Level
Distance (ft):	122.8
Structural Grade:	0
O&M Grade:	0
Clock Start/From:	
Clock To:	
1st Value:	
2nd Value:	
Value Percent:	20.000
Continuous Index:	
Within 8" of Joint:	NO
Remarks:

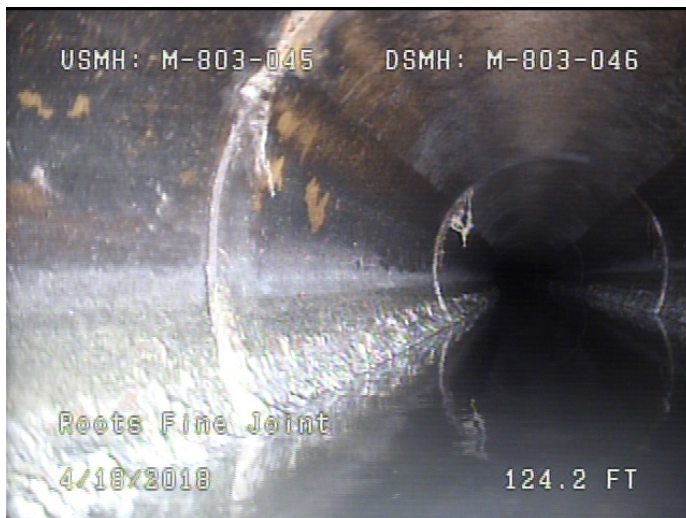
Code:	RFJ
Description:	Roots Fine Joint
Distance (ft):	124.2
Structural Grade:	0
O&M Grade:	1
Clock Start/From:	10
Clock To:	
1st Value:	
2nd Value:	
Value Percent:	
Continuous Index:	
Within 8" of Joint:	YES
Remarks:

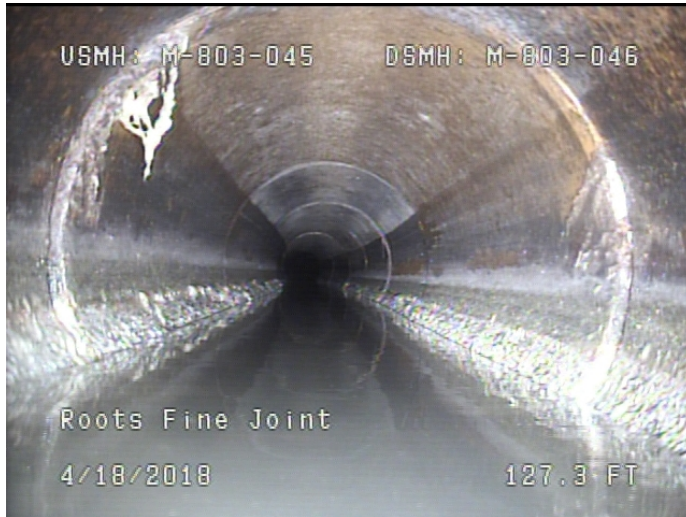
Code: **RFJ**
 Description: **Roots Fine Joint**

Distance (ft): **127.3**
 Structural Grade: **0**
 O&M Grade: **1**
 Clock Start/From: **10**
 Clock To:
 1st Value:
 2nd Value:
 Value Percent:
 Continuous Index:
 Within 8" of Joint: **YES**
 Remarks:

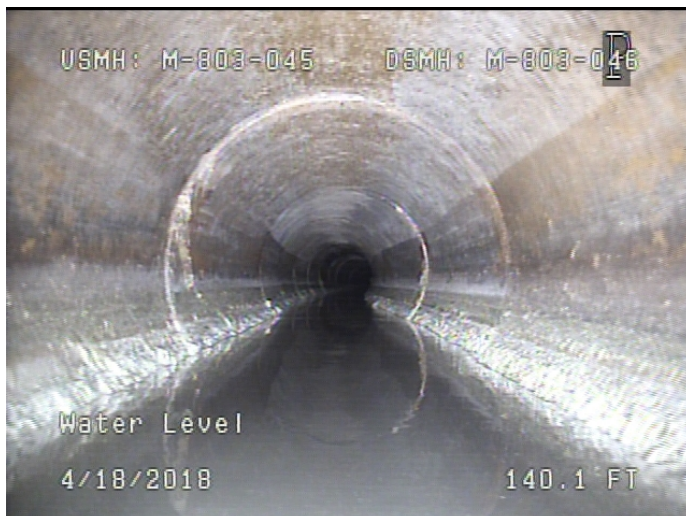
Code: **MWL**
 Description: **Water Level**

Distance (ft): **140.1**
 Structural Grade: **0**
 O&M Grade: **0**
 Clock Start/From:
 Clock To:
 1st Value:
 2nd Value:
 Value Percent: **10.000**
 Continuous Index:
 Within 8" of Joint: **NO**
 Remarks:

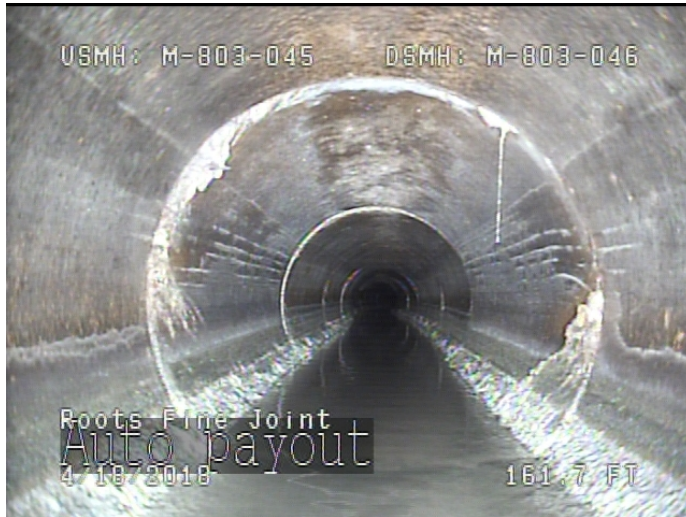
Code: **RFJ**
 Description: **Roots Fine Joint**

Distance (ft): **161.7**
 Structural Grade: **0**
 O&M Grade: **1**
 Clock Start/From: **4**
 Clock To: **11**
 1st Value:
 2nd Value:
 Value Percent:
 Continuous Index: **S02**
 Within 8" of Joint: **YES**
 Remarks:

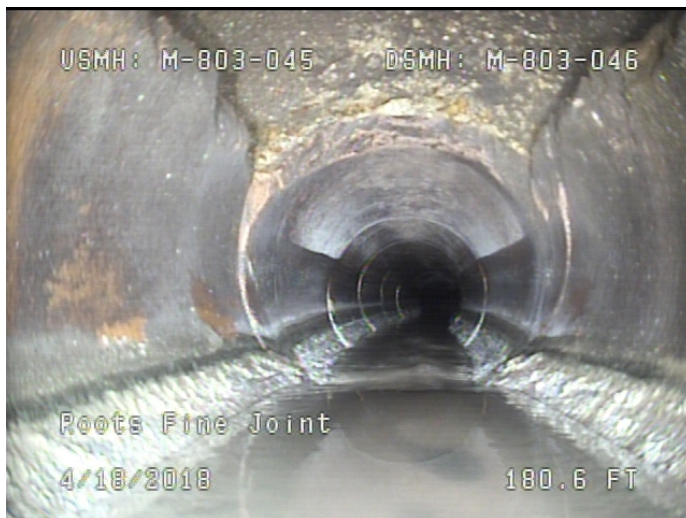
Code: **RFJ**
 Description: **Roots Fine Joint**

Distance (ft): **180.6**
 Structural Grade: **0**
 O&M Grade: **1**
 Clock Start/From: **4**
 Clock To: **11**
 1st Value:
 2nd Value:
 Value Percent:
 Continuous Index: **F02**
 Within 8" of Joint: **YES**
 Remarks:

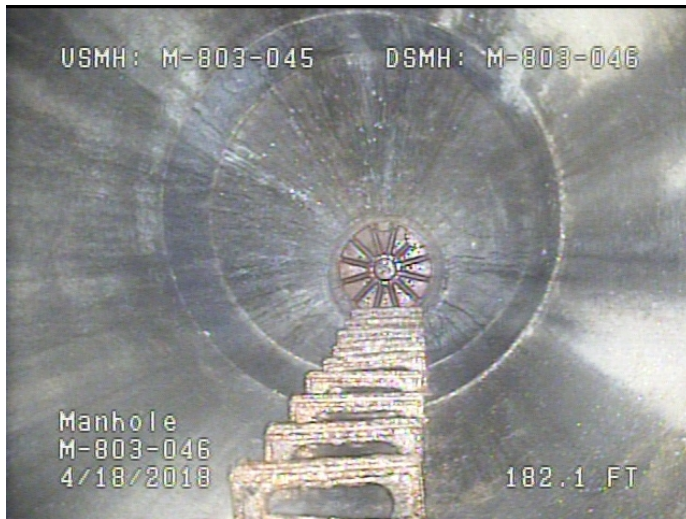
Code:	AMH
Description:	Manhole
Distance (ft):	182.1
Structural Grade:	0
O&M Grade:	0
Clock Start/From:	
Clock To:	
1st Value:	
2nd Value:	
Value Percent:	
Continuous Index:	
Within 8" of Joint:	NO
Remarks:	M-803-046
