Profile/Photo Observation Report

Date:	04/18/2018	Weather:		Coding:	PACP 4.2
Pipe Length (ft):	220.5	Owner:	City of Hobart	Pre Clean:	No Pre-Cleaning
P.O.#:	2004	Surveyor:	SAN	PSR:	P-803-046-052
Customer:	Red Zone	Clean Date:		Shape:	C

Street:	High St	Flow Control:	Not Controlled
City:	Hobart In	Year Renewed:	
Location:	Light Highway	Tape/Media #:	Deliverable 1
Purpose:	Routine Assessment	Dia/Height:	15"
Use:	Sanitary	Material:	VCP
Drain Area:	Northeast	Lining:	
Category:	NA		
Comment:	413-5		
Location Details:	Edge of street	Direction of Survey:	Downstream
US MH:	M-803-046	DS MH:	M-803-052
		Total Length Surveyed (ft):	220.5

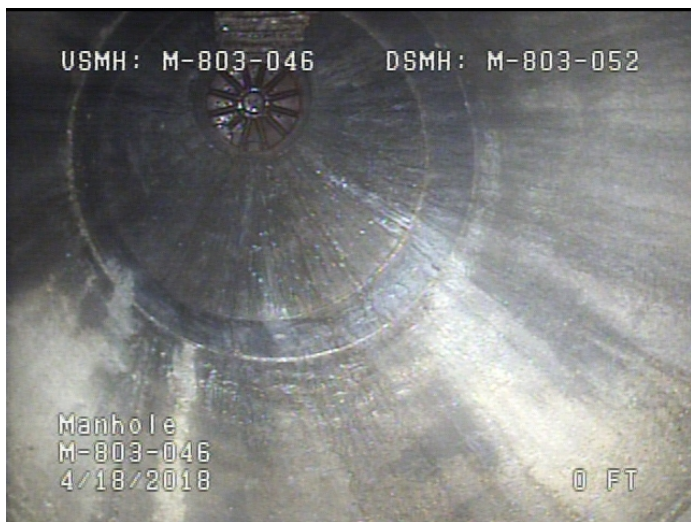
Code:	AMH
Description:	Manhole
Distance (ft):	.0
Structural Grade:	0
O&M Grade:	0
Clock Start/From:	
Clock To:	
1st Value:	
2nd Value:	
Value Percent:	
Continuous Index:	
Within 8" of Joint:	NO
Remarks:	M-803-046

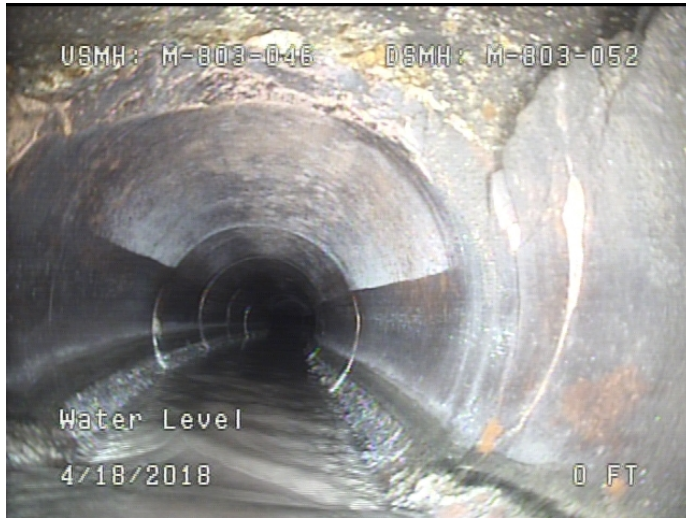
Code: **MWL**
 Description: **Water Level**

Distance (ft): **.0**
 Structural Grade: **0**
 O&M Grade: **0**
 Clock Start/From:
 Clock To:
 1st Value:
 2nd Value:
 Value Percent: **10.000**
 Continuous Index:
 Within 8" of Joint: **NO**
 Remarks:

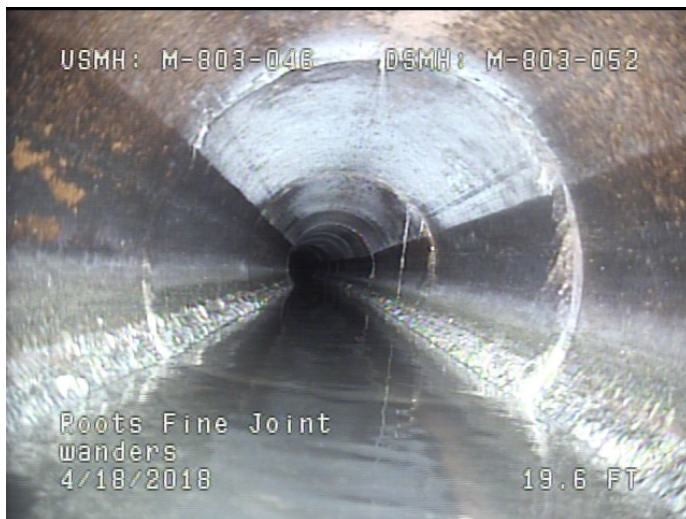
Code: **RFJ**
 Description: **Roots Fine Joint**

Distance (ft): **19.6**
 Structural Grade: **0**
 O&M Grade: **1**
 Clock Start/From: **11**
 Clock To: **3**
 1st Value:
 2nd Value:
 Value Percent:
 Continuous Index: **S01**
 Within 8" of Joint: **YES**
 Remarks: **wanders**

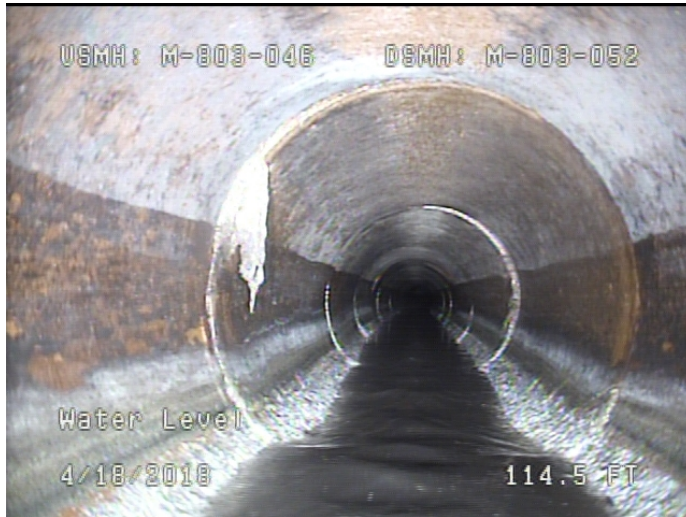
Code: **MWL**
 Description: **Water Level**

Distance (ft): **114.5**
 Structural Grade: **0**
 O&M Grade: **0**
 Clock Start/From:
 Clock To:
 1st Value:
 2nd Value:
 Value Percent: **5.000**
 Continuous Index:
 Within 8" of Joint: **NO**
 Remarks:

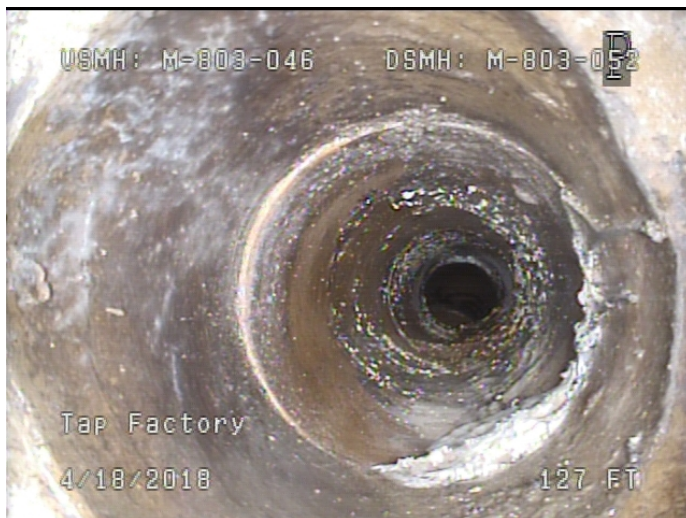
Code: **TF**
 Description: **Tap Factory**

Distance (ft): **127.0**
 Structural Grade: **0**
 O&M Grade: **0**
 Clock Start/From: **1**
 Clock To:
 1st Value: **6.000**
 2nd Value:
 Value Percent:
 Continuous Index:
 Within 8" of Joint: **NO**
 Remarks:

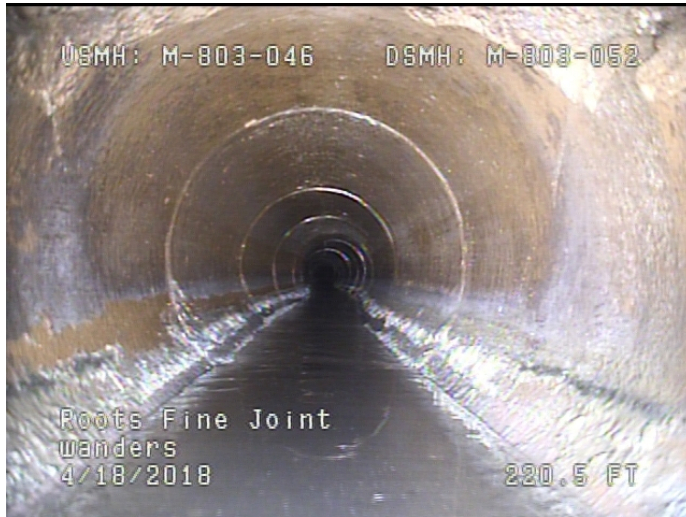
Code:	RFJ
Description:	Roots Fine Joint
Distance (ft):	220.5
Structural Grade:	0
O&M Grade:	1
Clock Start/From:	11
Clock To:	3
1st Value:	
2nd Value:	
Value Percent:	
Continuous Index:	F01
Within 8" of Joint:	YES
Remarks:	wanders

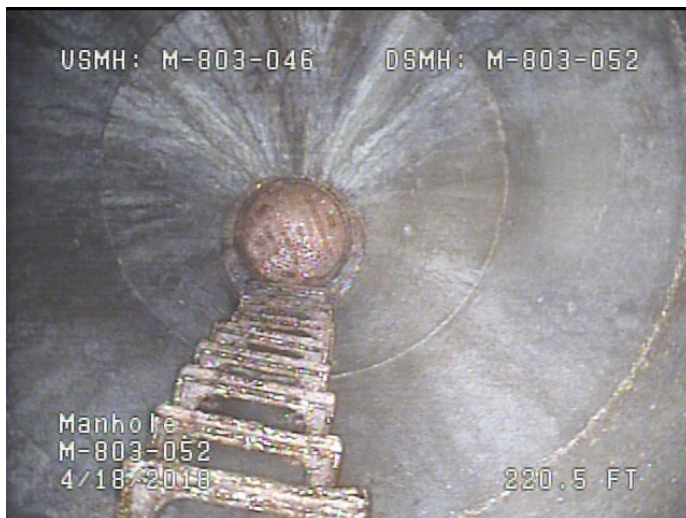
Code:	AMH
Description:	Manhole
Distance (ft):	220.5
Structural Grade:	0
O&M Grade:	0
Clock Start/From:	
Clock To:	
1st Value:	
2nd Value:	
Value Percent:	
Continuous Index:	
Within 8" of Joint:	NO
Remarks:	M-803-052
