Profile/Photo Observation Report

Street:	N Kelly Ave.	Flow Control:	Not Controlled
City:	Hobart, IN	Year Renewed:	
Location:	Other	Tape/Media #:	
Purpose:	Not Known	Dia/Height:	12"
Use:	Sanitary	Material:	VCP
Drain Area:	NA	Lining:	
Category:	NA		
Comment:

Location Details:		Direction of Survey:	Upstream
US MH:	M-803-046	DS MH:	M-804-056
		Total Length Surveyed (ft):	14.9

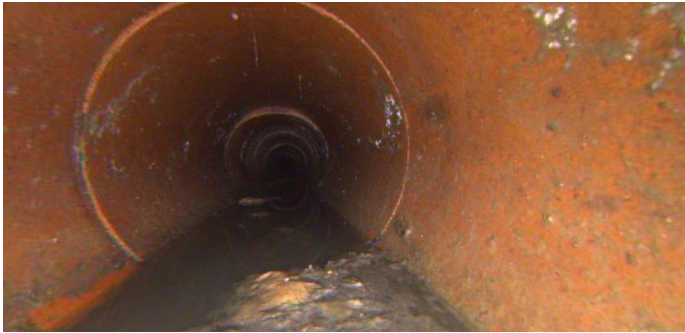
Code:	MWL
Description:	Water Level

Distance (ft):	.0
Structural Grade:	0
O&M Grade:	0
Clock Start/From:	
Clock To:	
1st Value:	
2nd Value:	
Value Percent:	20.000
Continuous Index:	
Within 8" of Joint:	NO
Remarks:

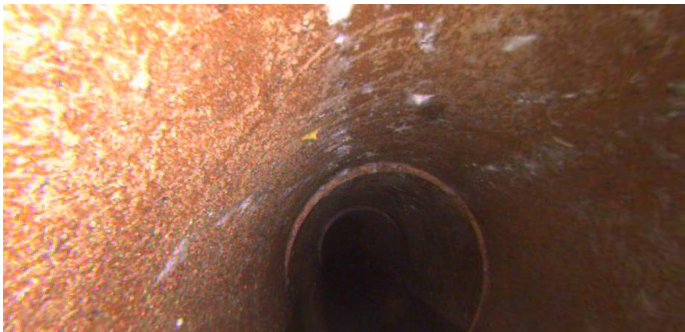
Code:	MSA
Description:	Abandoned Survey

Distance (ft):	14.9
Structural Grade:	0
O&M Grade:	0
Clock Start/From:	
Clock To:	
1st Value:	
2nd Value:	
Value Percent:	
Continuous Index:	
Within 8" of Joint:	NO
Remarks:	UNKNOWN
