Profile/Photo Observation Report

Street:	N Kelly Ave.	Flow Control:	Not Controlled
City:	Hobart, IN	Year Renewed:	
Location:	Other	Tape/Media #:	
Purpose:	Not Known	Dia/Height:	12"
Use:	Sanitary	Material:	VCP
Drain Area:	NA	Lining:	
Category:	NA		
Comment:

Location Details:		Direction of Survey:	Downstream
US MH:	M-803-046	DS MH:	M-804-056
		Total Length Surveyed (ft):	3.5

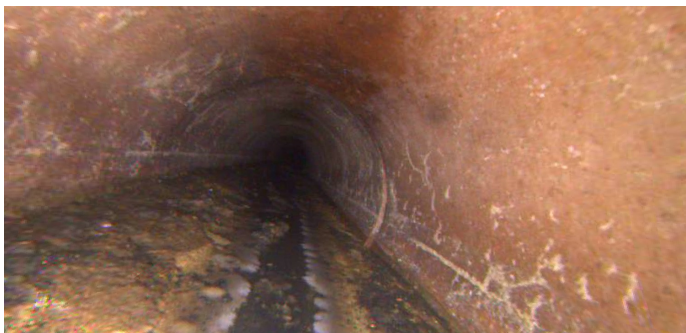
Code: **AMH**
Description: **Manhole**

Distance (ft): **.0**
Structural Grade: **0**
O&M Grade: **0**
Clock Start/From:
Clock To:
1st Value:
2nd Value:
Value Percent:
Continuous Index:
Within 8" of Joint: **NO**
Remarks: **M-803-046**

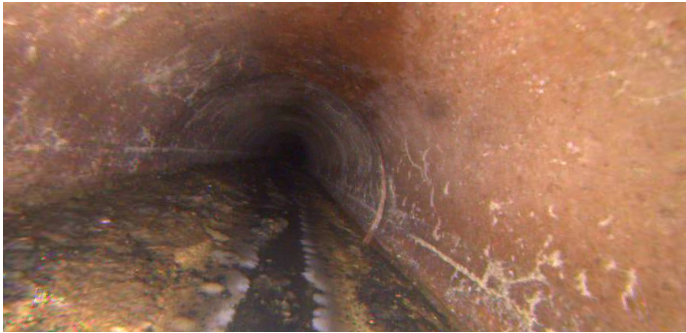
Code:	MWL
Description:	Water Level

Distance (ft):	.0
Structural Grade:	0
O&M Grade:	0
Clock Start/From:	
Clock To:	
1st Value:	
2nd Value:	
Value Percent:	10.000
Continuous Index:	
Within 8" of Joint:	NO
Remarks:

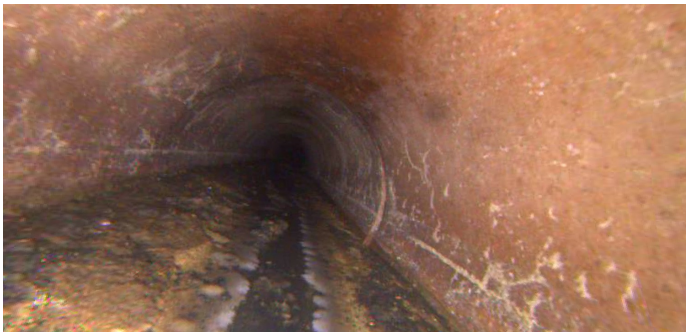
Code:	DSF
Description:	Deposits Settled Fine

Distance (ft):	.0
Structural Grade:	0
O&M Grade:	3
Clock Start/From:	4
Clock To:	8
1st Value:	
2nd Value:	
Value Percent:	20.000
Continuous Index:	
Within 8" of Joint:	NO
Remarks:

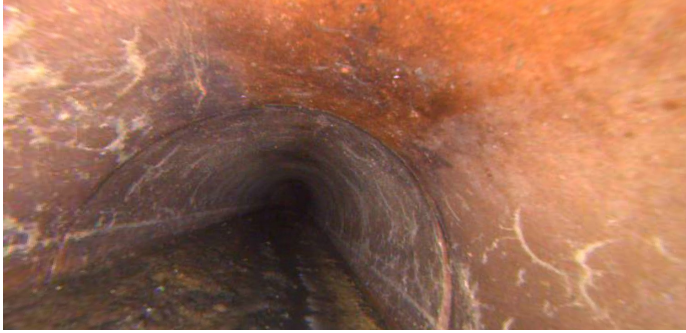
Code: **CM**
Description: **Crack Multiple**

Distance (ft): **1.4**
Structural Grade: **3**
O&M Grade: **0**
Clock Start/From: **8**
Clock To: **4**
1st Value:
2nd Value:
Value Percent:
Continuous Index:
Within 8" of Joint: **YES**
Remarks:

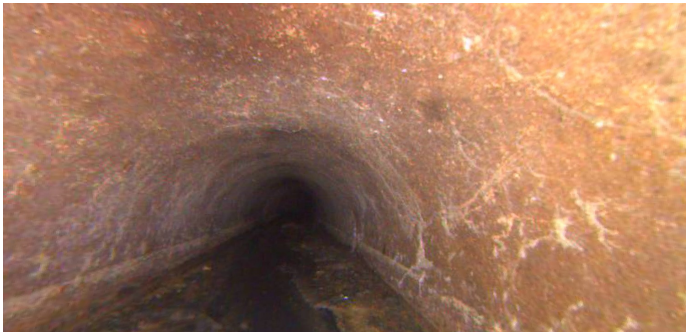
Code: **MSA**
Description: **Abandoned Survey**

Distance (ft): **3.5**
Structural Grade: **0**
O&M Grade: **0**
Clock Start/From:
Clock To:
1st Value:
2nd Value:
Value Percent:
Continuous Index:
Within 8" of Joint: **NO**
Remarks: **dsf**
